**SUBCONTRACTOR REPORTS  
FINAL GEOTECHNICAL  
SITE CHARACTERIZATION**

**SAN FRANCISCO-OAKLAND BAY BRIDGE  
EAST SPAN SEISMIC SAFETY PROJECT**

**VOLUME 2 OF 3  
(GeoTest Unlimited)**

Letter Report  
San Francisco Oakland Bay Bridge  
East Span Replacement Project  
Rock Testing Program

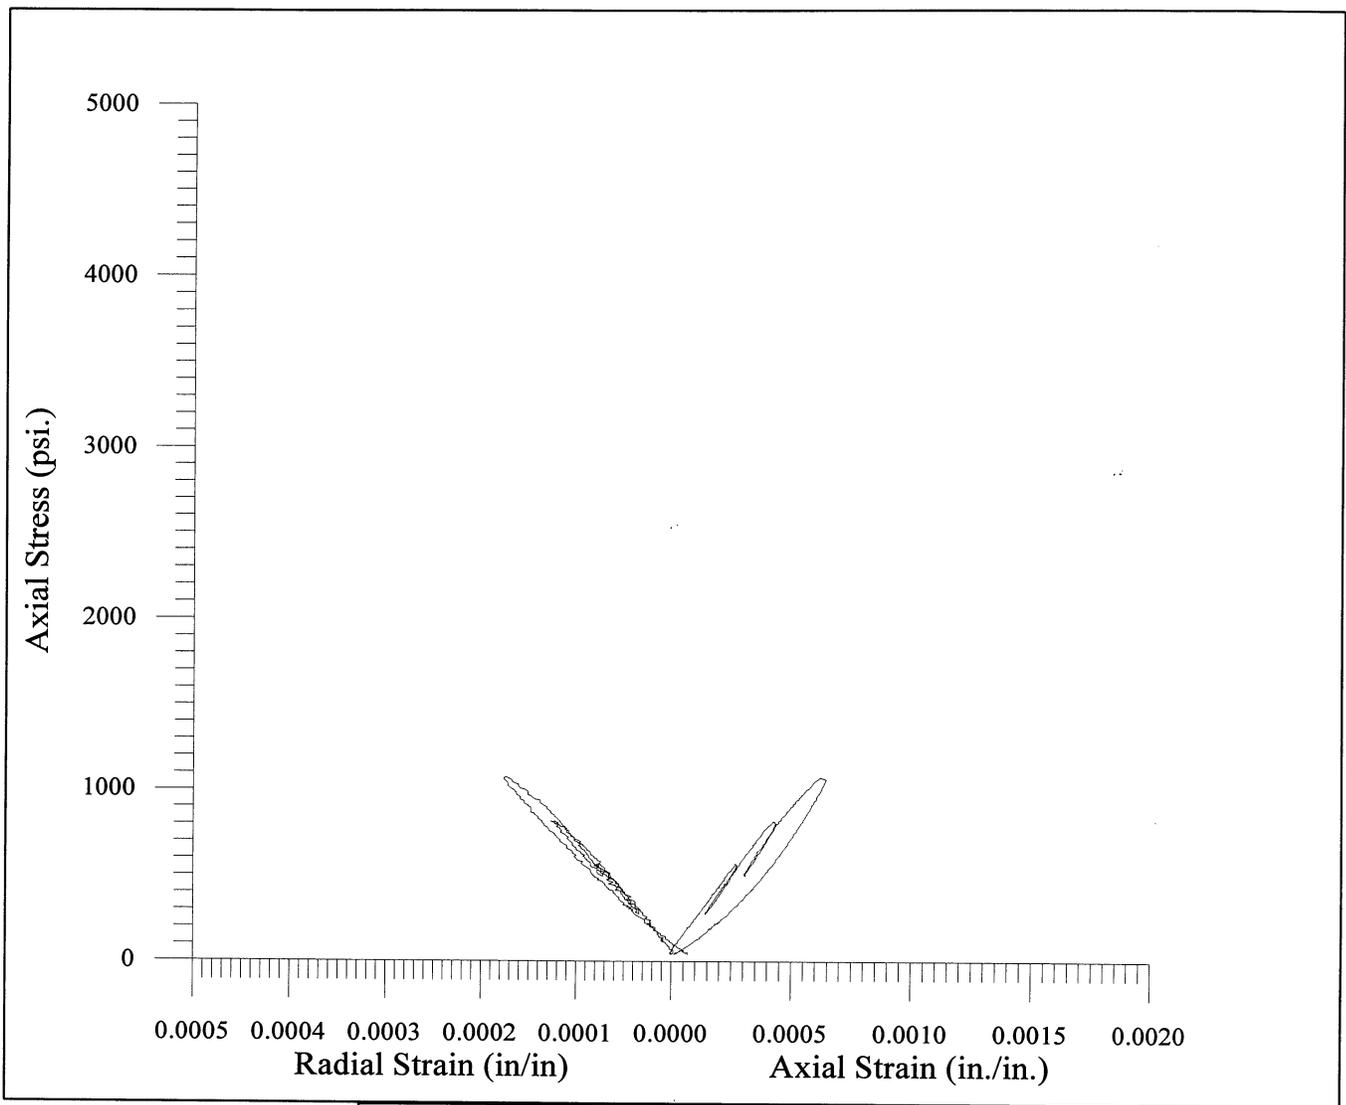
**ELASTIC MODULUS TEST**  
**Axial Stress vs. Axial & Radial Strain**

<p><b>SAMPLE ID:</b> Boring: 98-23  Sample: 20b  Depth: 74.5'</p> <p><b>DESCRIPTION</b>  Dark gray claystone and siltstone with numerous calcite healed hairline fractures parallel to the bedding, 62 degrees to the core axis.</p> <p><b>MODULUS:</b> 2,140,000 psi  <b>POISSON'S RATIO:</b> .33</p>	<p align="center"> <i>Geo</i>

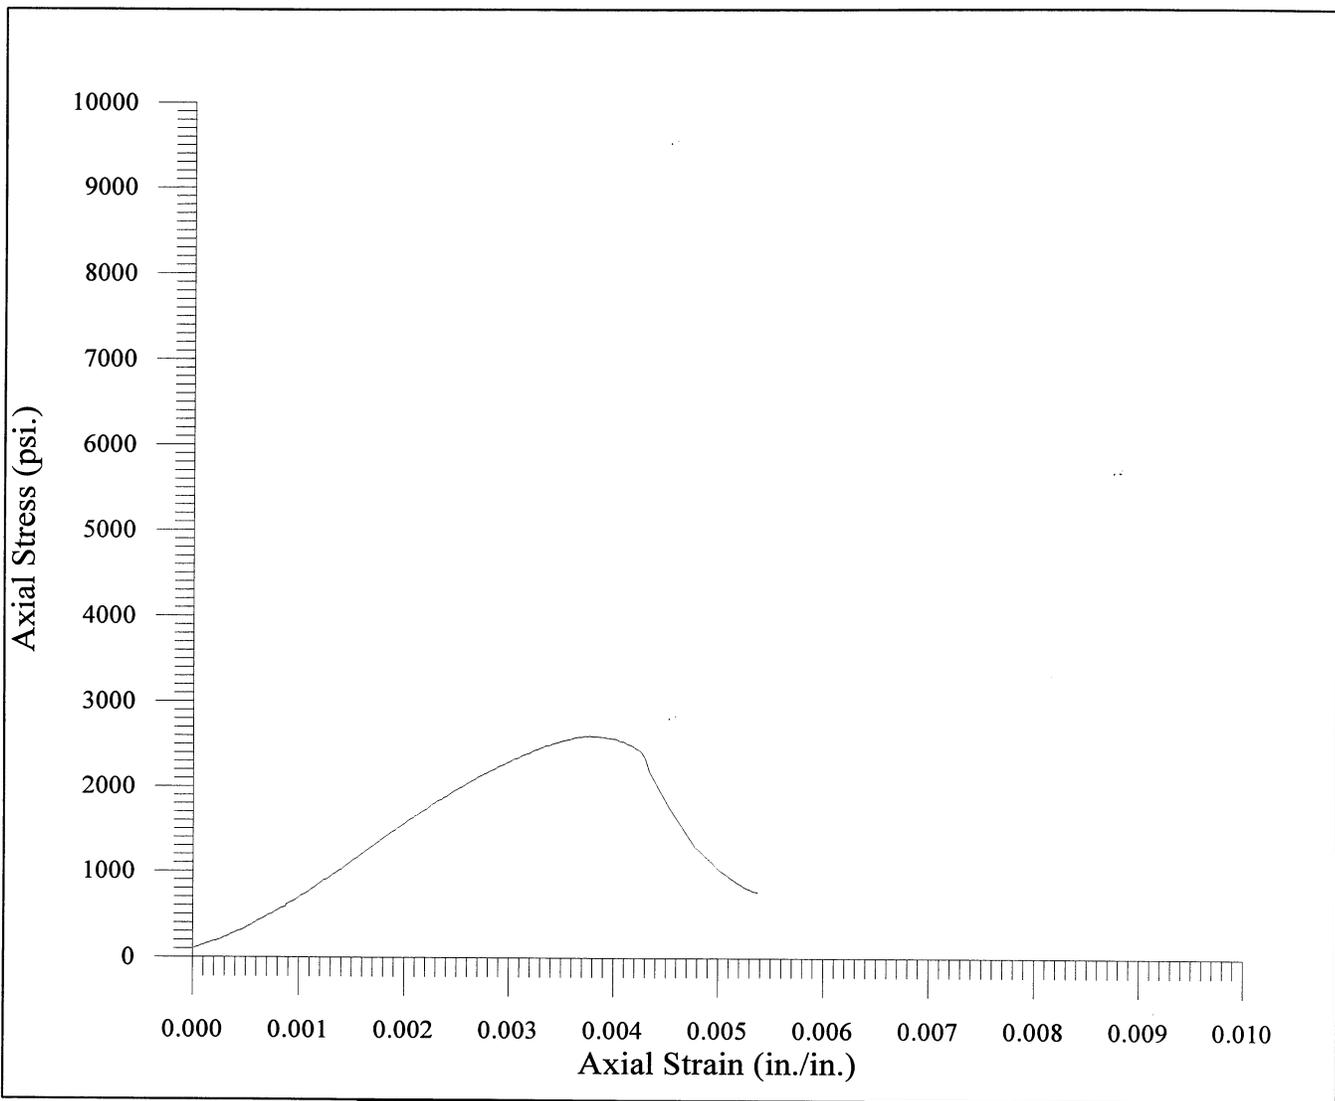
**UNCONFINED COMPRESSION TEST  
Axial Stress vs. Axial Strain**

<p><b>SAMPLE ID:</b> Boring : 98-23 Sample: 20b Depth: 74.5'</p> <p align="center"><b>DESCRIPTION</b></p> <p>Dark gray claystone and siltstone with numerous calcite healed hairline fractures parallel to the bedding, 62 degrees to the core axis.</p> <p><b>STRENGTH:</b> 2602 psi</p>	<p align="center"> <i>Geo</i>

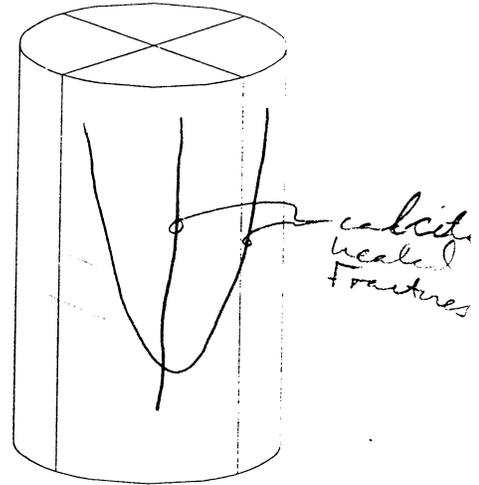
Sample Description: medium gray sandstone <sup>Finely</sup> inter bedded with dark gray siltstone/claystone, bedding about 65° to the core axis. Contains a few calcite healed axial fractures.

Comments: Failed by a shear wedge.

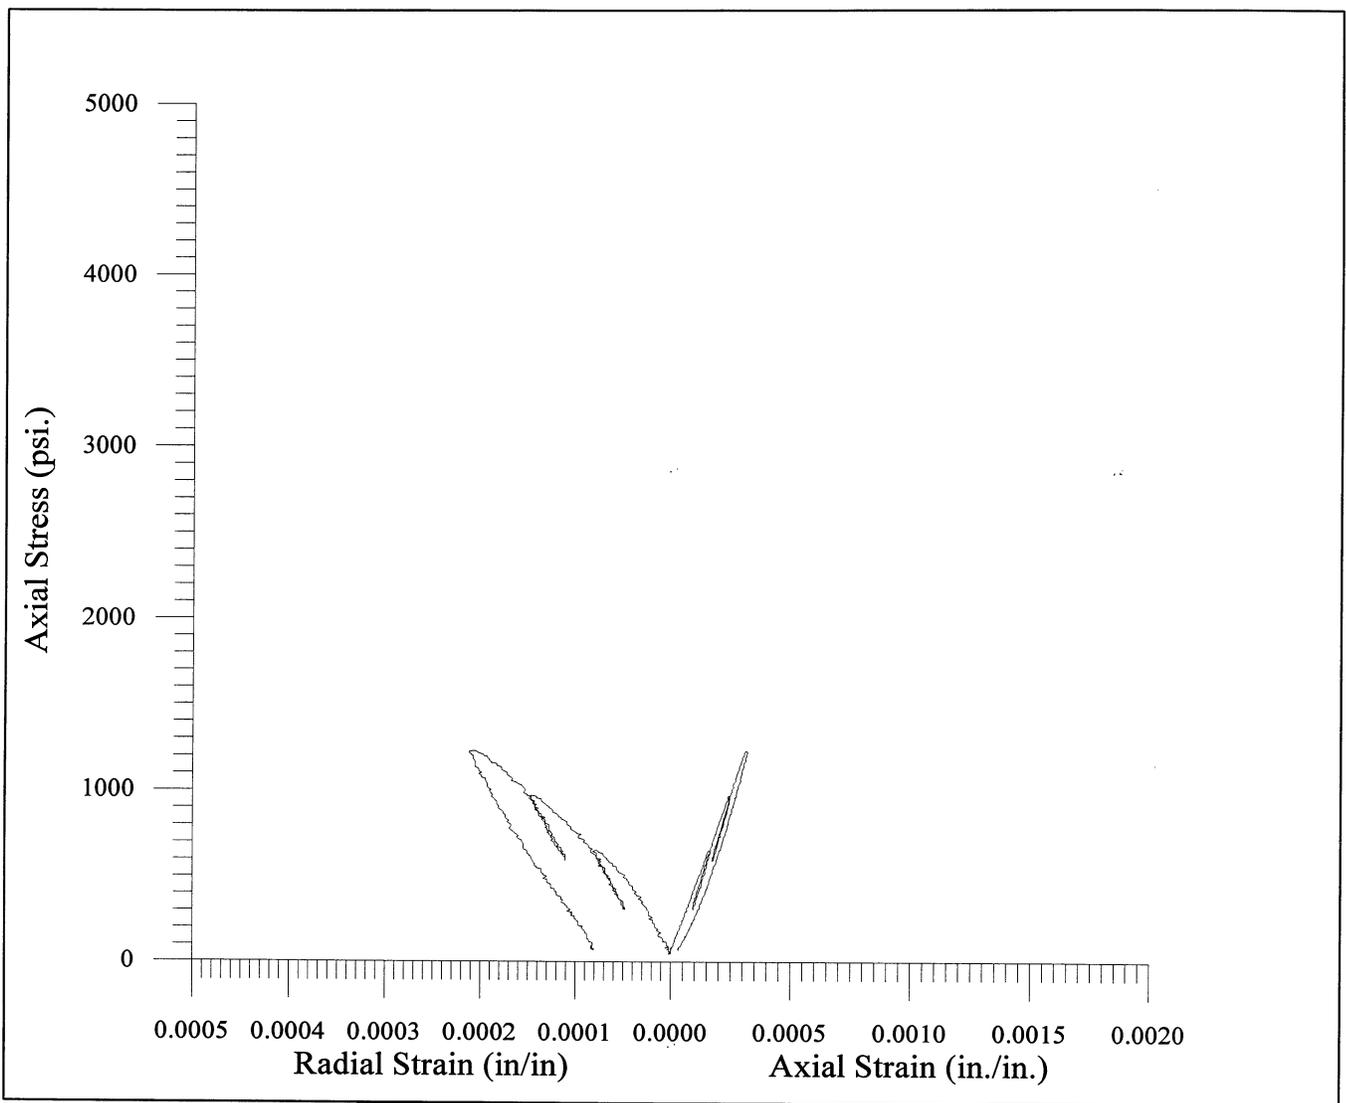
**ELASTIC MODULUS TEST**  
**Axial Stress vs. Axial & Radial Strain**

**SAMPLE ID:** Boring: 98-23  
 Sample: 21a  
 Depth: 78'

**DESCRIPTION**  
 Medium gray sandstone finely interbedded with dark gray siltstone and claystone, with bedding about 65 degrees to the core axis. Also contains a few calcite healed axial hairline fractures.

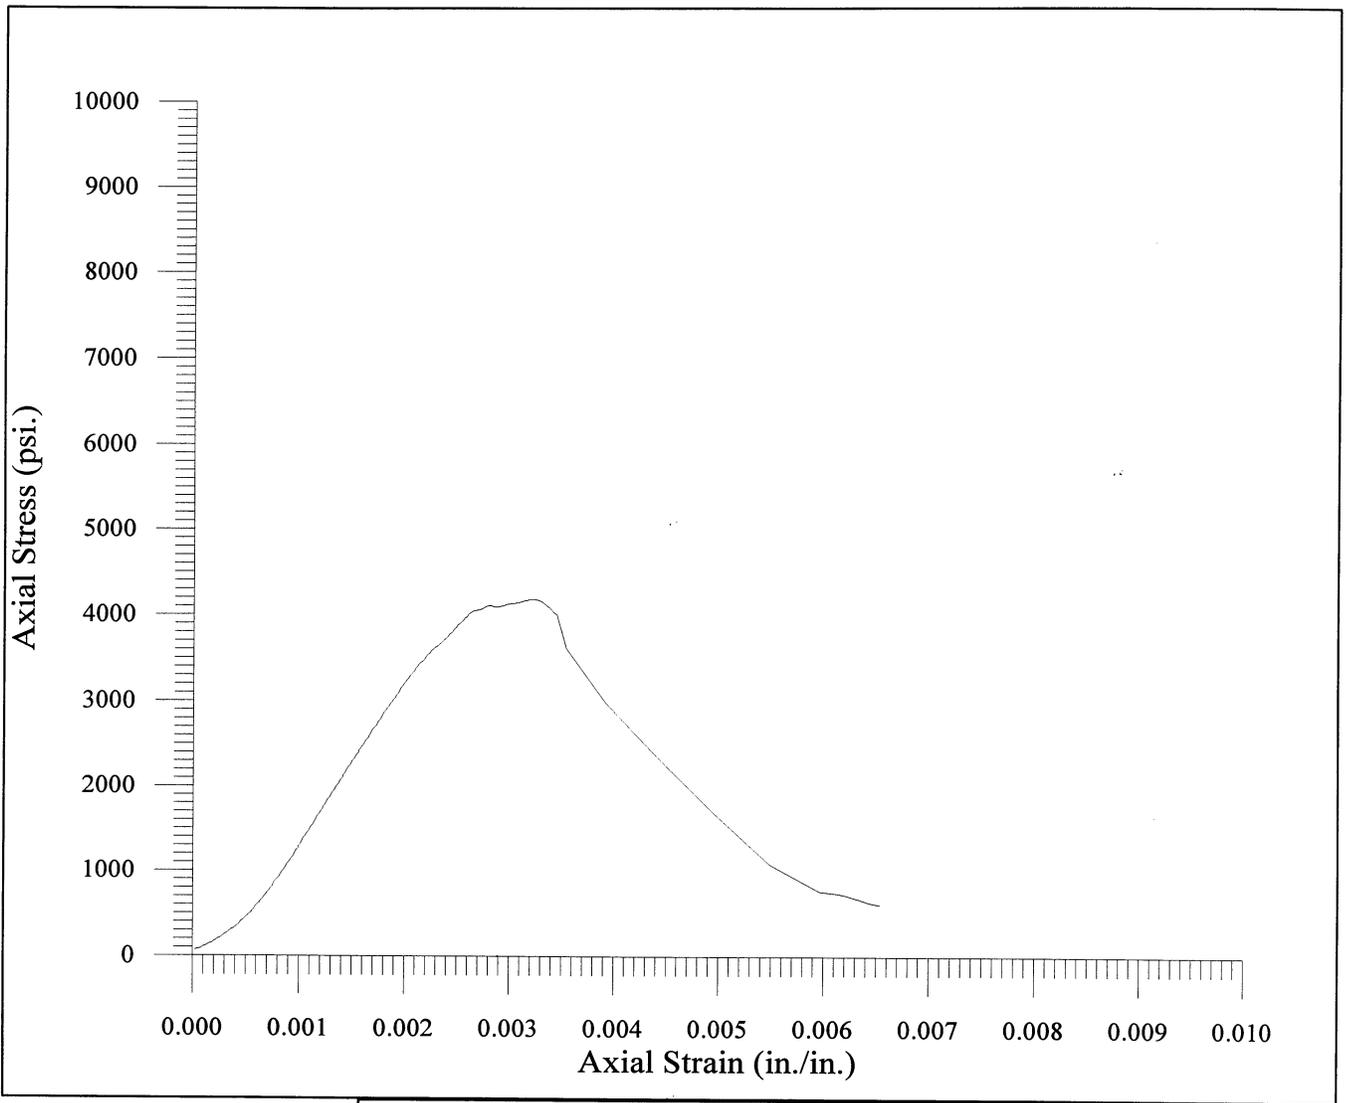
**UNCONFINED COMPRESSION TEST  
Axial Stress vs. Axial Strain**

<p><b>SAMPLE ID:</b> Boring : 98-23 Sample: 21a Depth: 78'</p> <p align="center"><b>DESCRIPTION</b></p> <p>Medium gray sandstone finely interbedded with dark gray siltstone and claystone, with bedding about 65 degrees to the core axis. Also contains a few calcite healed axial hairline fractures.</p> <p><b>STRENGTH:</b> 4177 psi</p>	<p align="center"><i>Geo</i>

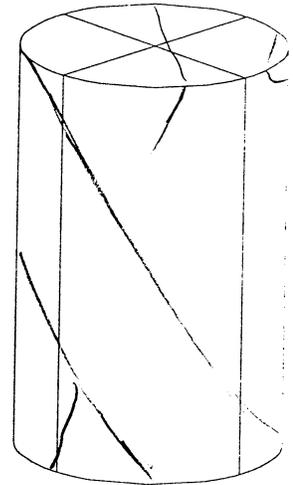
Sample Description: medium gray sandstone with a few calcite healed hairline fractures, 27° to the core axis.

Comments: Failed by axial splitting - not along healed joints. Note the ridges on top diagonal\* indicates vertical splitting columns, not shear. explosive failure.

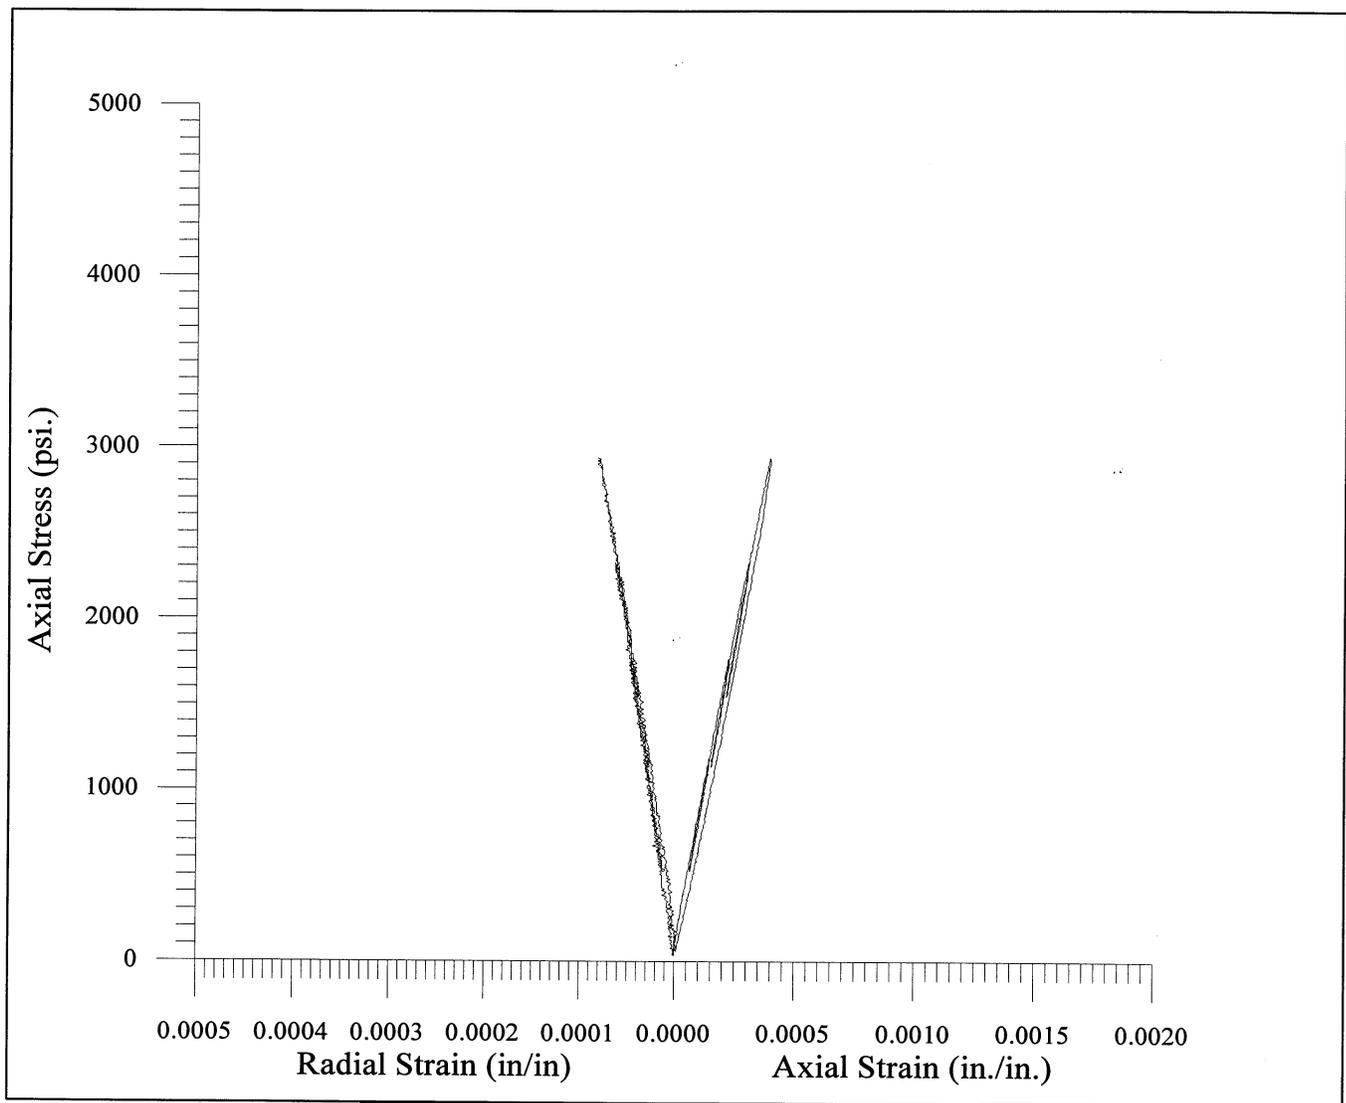
**ELASTIC MODULUS TEST**  
**Axial Stress vs. Axial & Radial Strain**

**SAMPLE ID:** Boring: 98-23  
 Sample: 22a  
 Depth: 85'

**DESCRIPTION**  
 Medium gray sandstone with a few calcite healed hairline fractures, 27 degrees to the core axis.

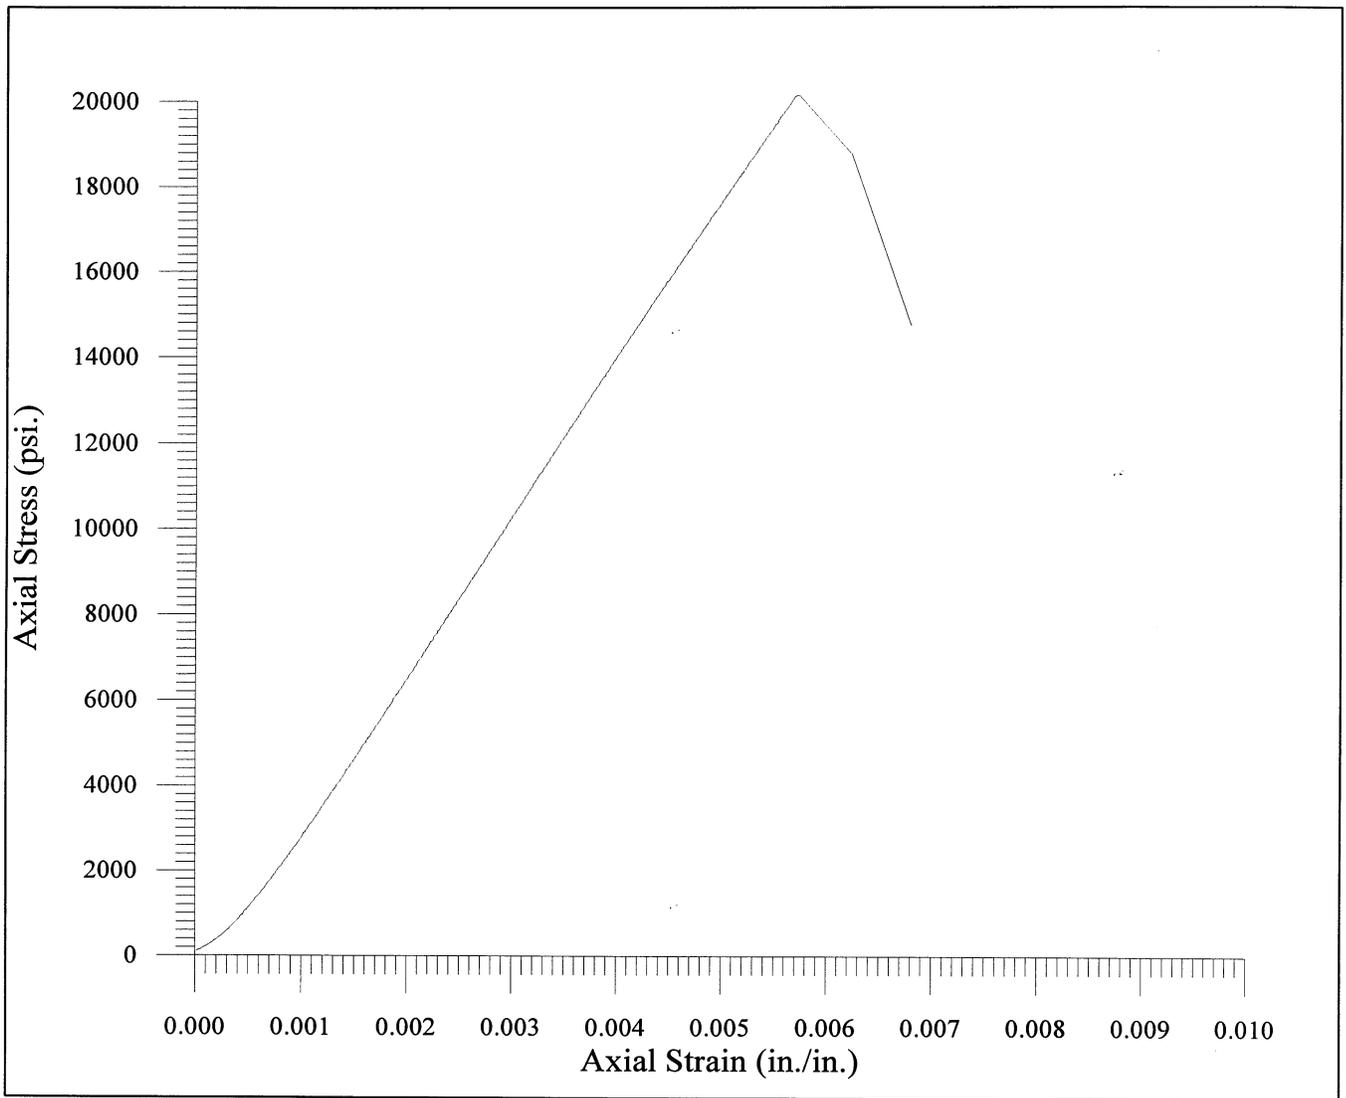
**UNCONFINED COMPRESSION TEST  
Axial Stress vs. Axial Strain**

<p><b>SAMPLE ID:</b> Boring : 98-23 Sample: 22a Depth: 85'</p> <p align="center"><b>DESCRIPTION</b></p> <p>Medium gray sandstone with a few calcite healed hairline fractures, 27 degrees to the core axis.</p> <p><b>STRENGTH:</b> 20,140 psi</p>	<p align="center"> <i>Geo</i>

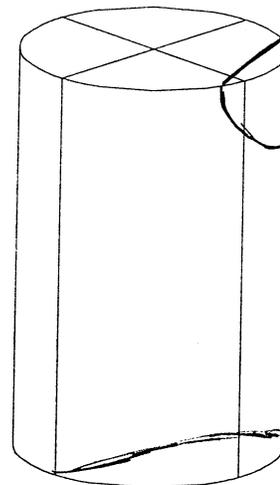
Sample Description: Dark grey fine sandy siltstone, generally massive with only two minor calcite healed vein-like fractures

Comments: failed by shear on what must have been a pre-existing (not seen in sample) joint. 28° to core axis

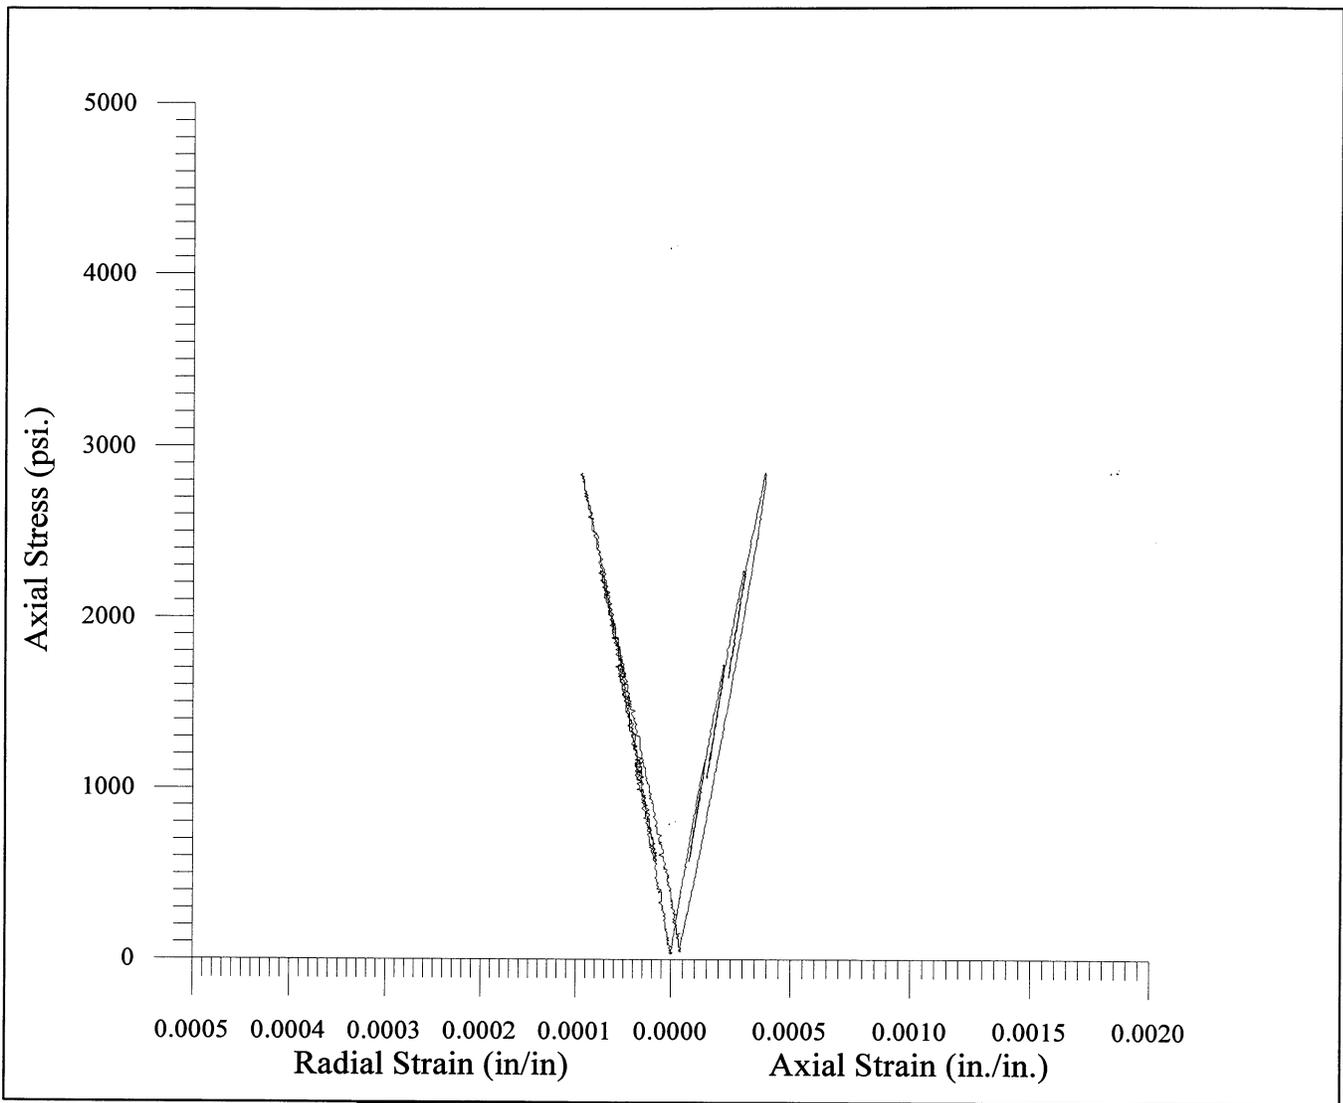
**ELASTIC MODULUS TEST**  
**Axial Stress vs. Axial & Radial Strain**

**SAMPLE ID:** Boring: 98-23  
 Sample: 27a  
 Depth: 106.5'

**DESCRIPTION**  
 Dark gray fine sandy siltstone, with two minor calcite healed hairline fractures.

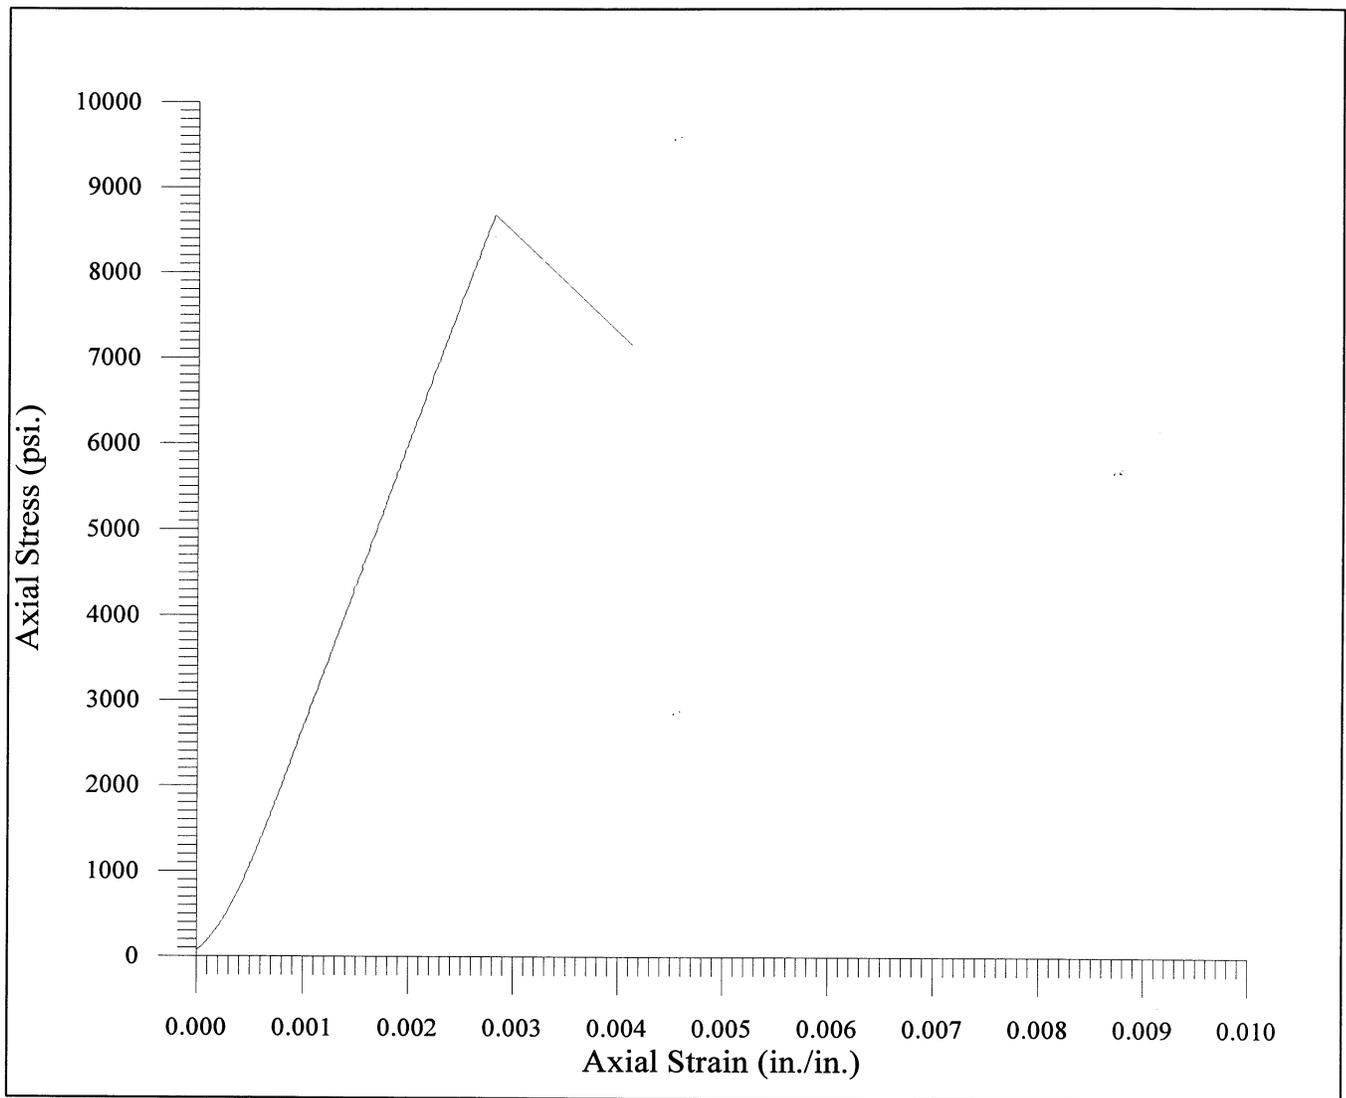
**UNCONFINED COMPRESSION TEST**  
**Axial Stress vs. Axial Strain**

<p><b>SAMPLE ID:</b> Boring : 98-23  Sample: 27a  Depth: 106.5'</p> <p align="center"><b>DESCRIPTION</b></p> <p>Dark gray fine sandy siltstone, with two minor calcite healed hairline fractures.</p> <p><b>STRENGTH:</b> 8673 psi</p>	<div style="text-align: center;"> <p><i>Geo</i>

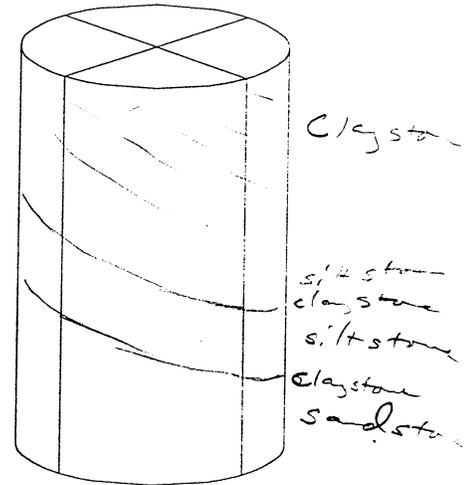
started to fail in modulus test

E<sub>r</sub> @ sandstone - E<sub>c</sub> on claystone ⇒ V is not valid?

Failed by axial splitting

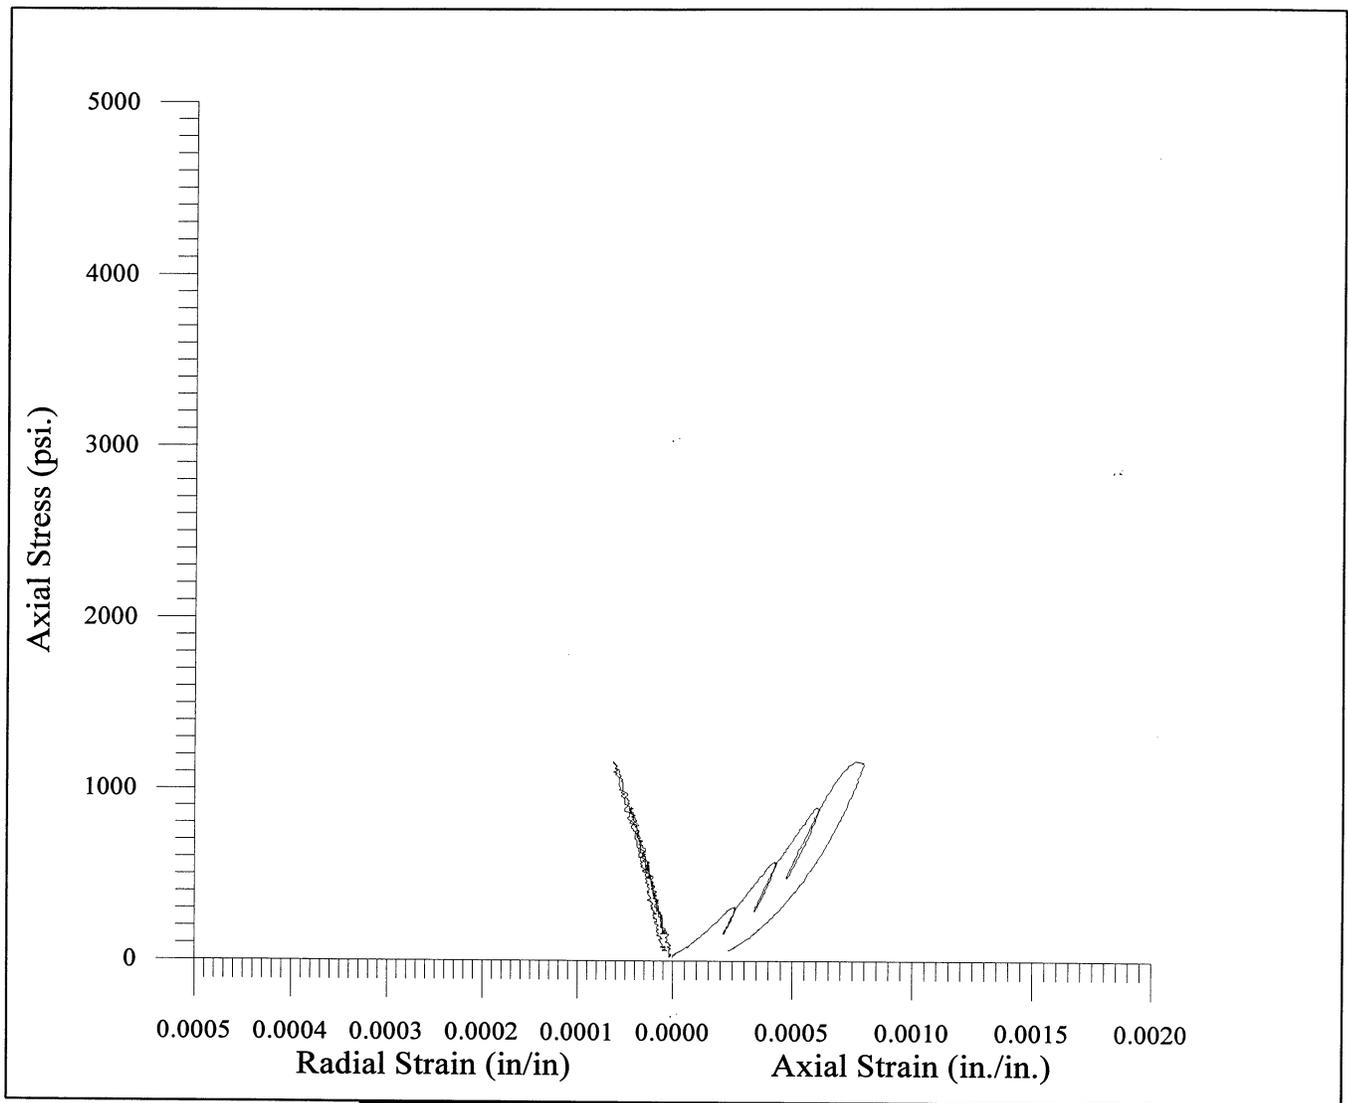
**ELASTIC MODULUS TEST**  
**Axial Stress vs. Axial & Radial Strain**

**SAMPLE ID:** Boring: 98-23  
 Sample: 28a  
 Depth: 114'

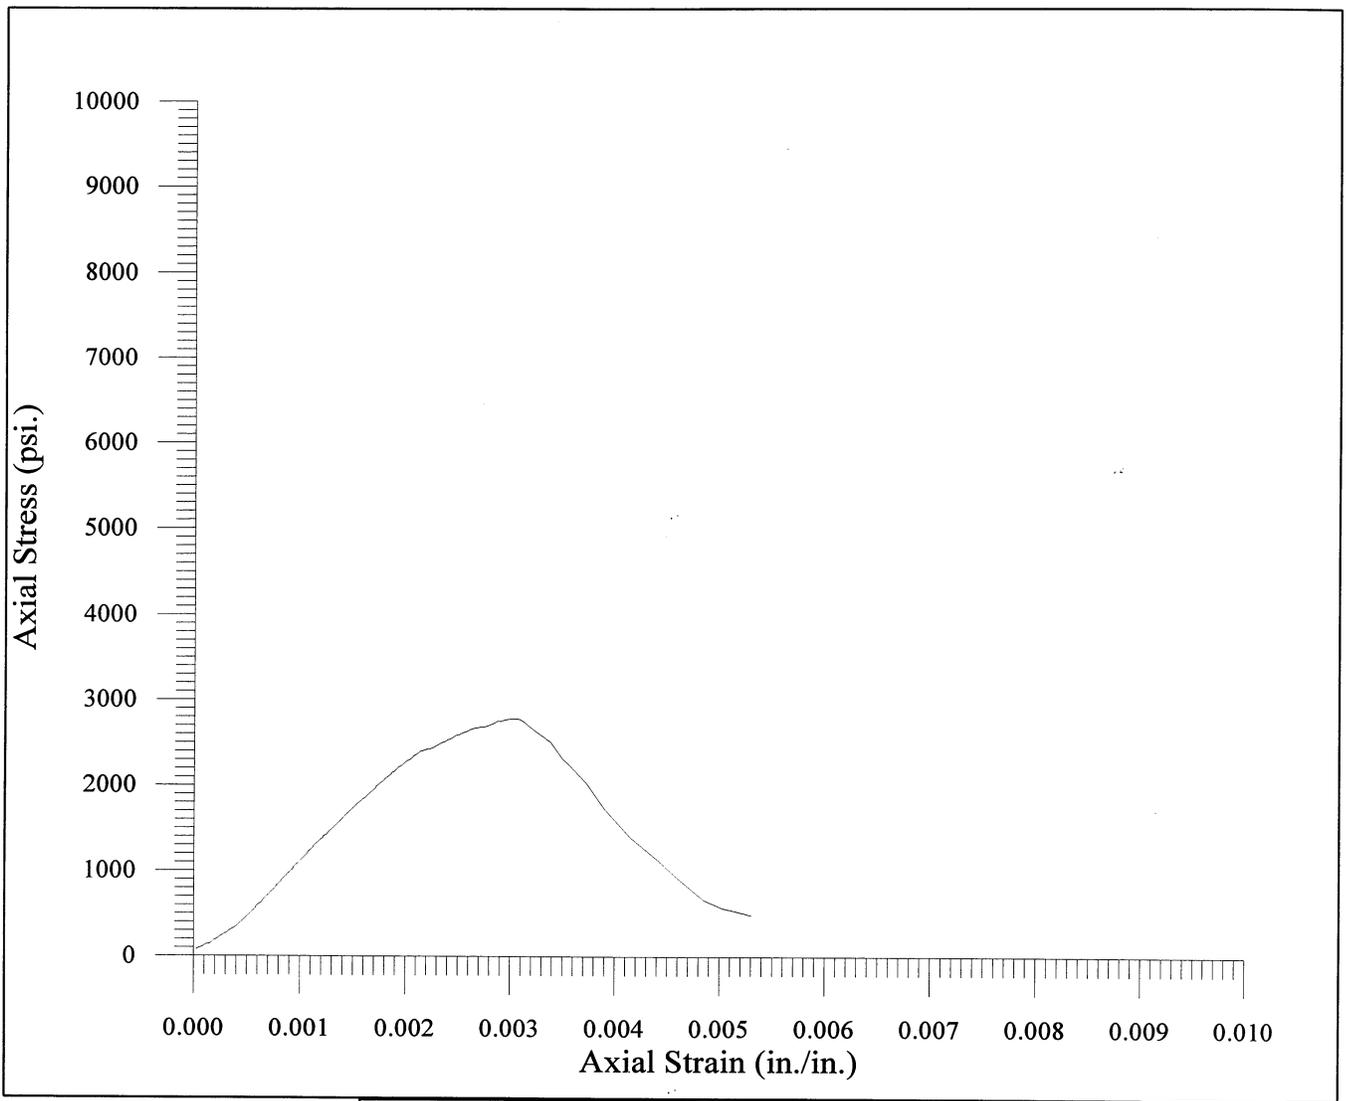
**UNCONFINED COMPRESSION TEST  
Axial Stress vs. Axial Strain**

<p><b>SAMPLE ID:</b> Boring : 98-23 Sample: 28a Depth: 114'</p> <p align="center"><b>DESCRIPTION</b></p> <p>Dark gray interbedded claystone, siltstone and sandstone, bedded about 70 degrees to the core axis.</p> <p><b>STRENGTH:</b> 2778 psi</p>	<div style="text-align: center;"> <p><i>Geo</i>

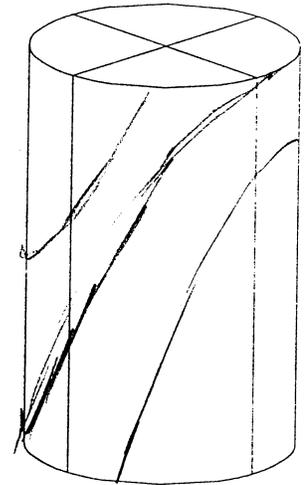
Sample Description: Medium gray fine sandy siltstone to sandstone with several calcite healed hairline fractures, about 15-25° to the core axis

Comments: started to fail in modulus test, but no clear indication of failure on sample.

UC: Failed by shear on existing joints.

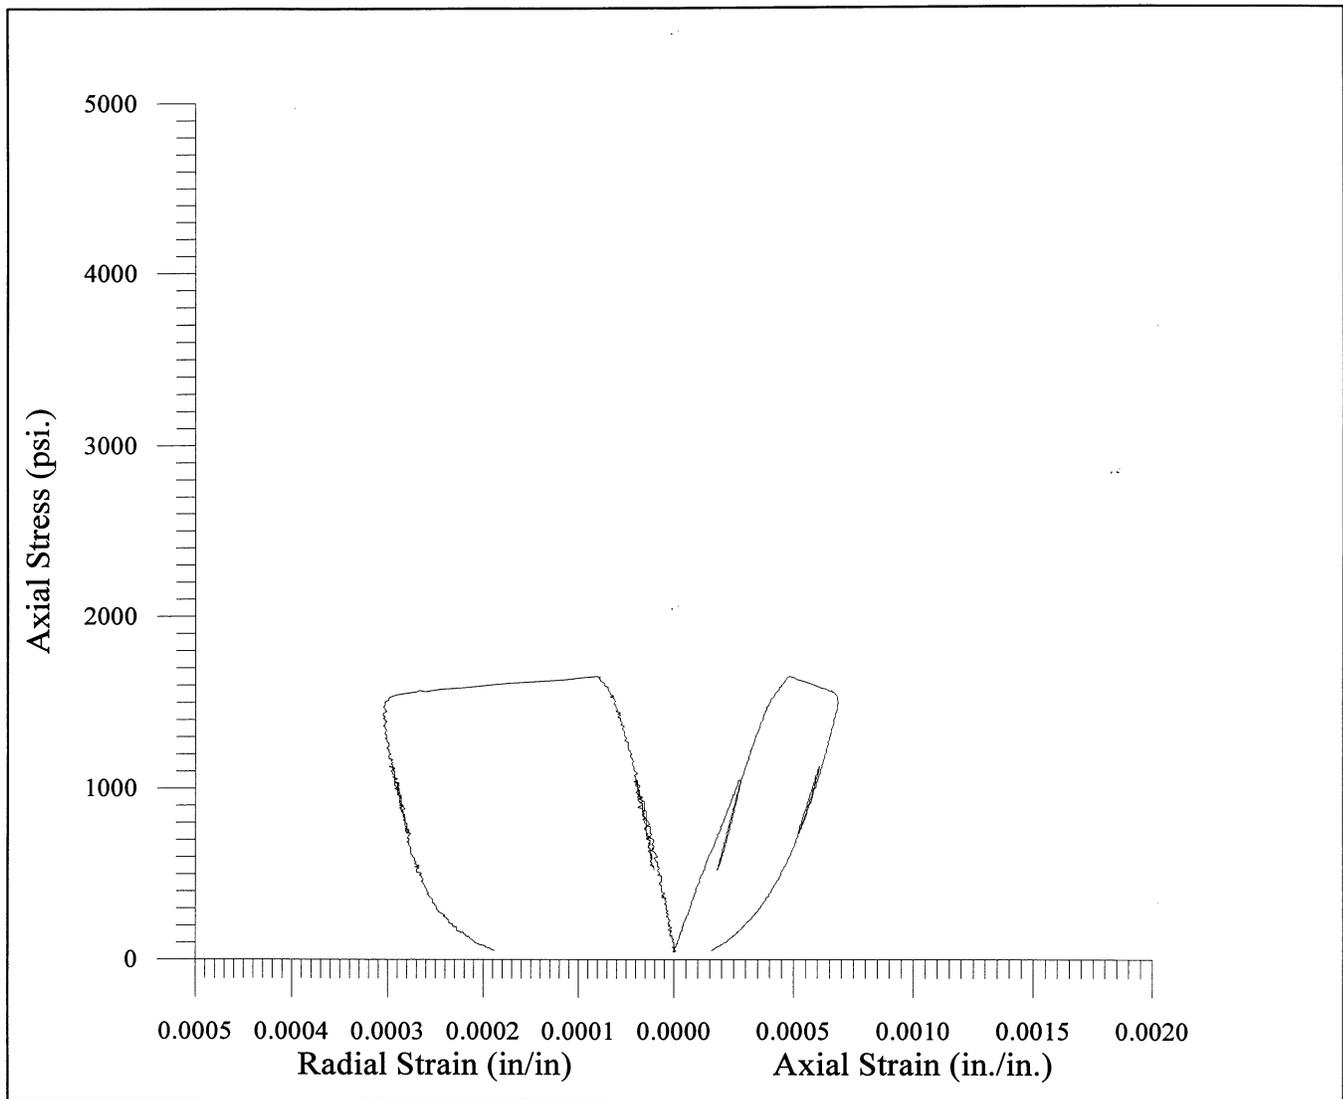
**ELASTIC MODULUS TEST**  
**Axial Stress vs. Axial & Radial Strain**

<p><b>SAMPLE ID:</b> Boring: 98-23  Sample: 29a  Depth: 120.5'</p> <p style="text-align: center;"><b>DESCRIPTION</b></p> <p>Medium gray fine sandy siltstone to sandstone with several calcite healed hairline fractures about 15 to 25 degrees to the core axis.</p> <p><b>MODULUS:</b> 5,480,000 psi  <b>POISSON'S RATIO:</b> .21</p>	<div style="text-align: center;">

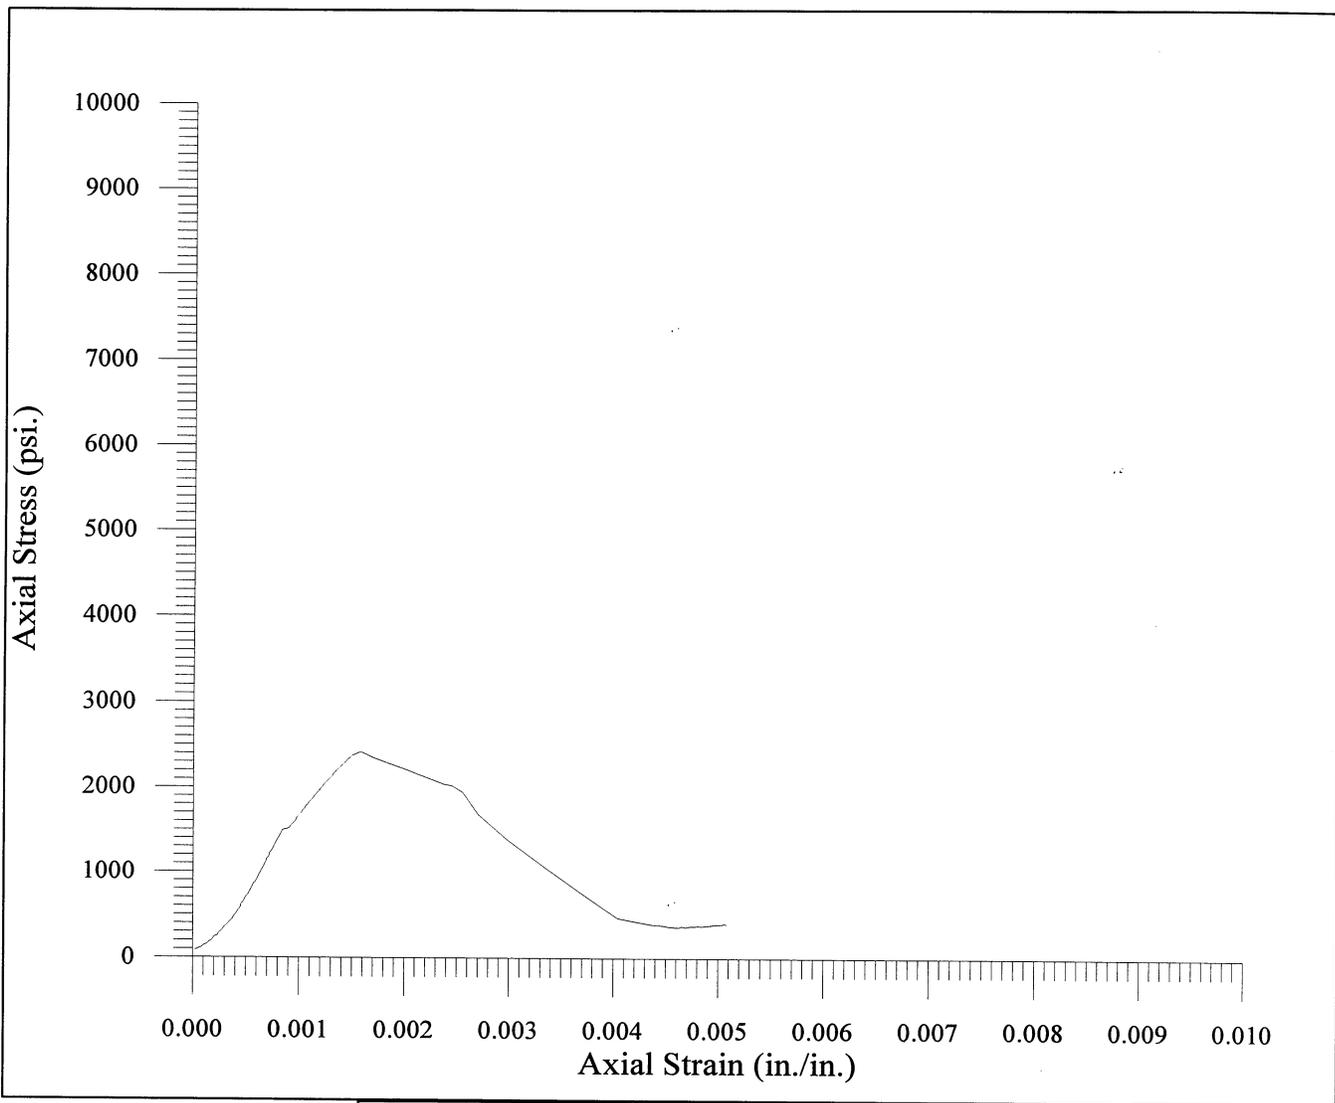
**UNCONFINED COMPRESSION TEST**  
**Axial Stress vs. Axial Strain**

**SAMPLE ID:** Boring : 98-23  
 Sample: 29a  
 Depth: 120.5'

**DESCRIPTION**  
 Medium gray fine sandy siltstone to sandstone with several calcite healed hairline fractures about 15 to 25 degrees to the core axis.

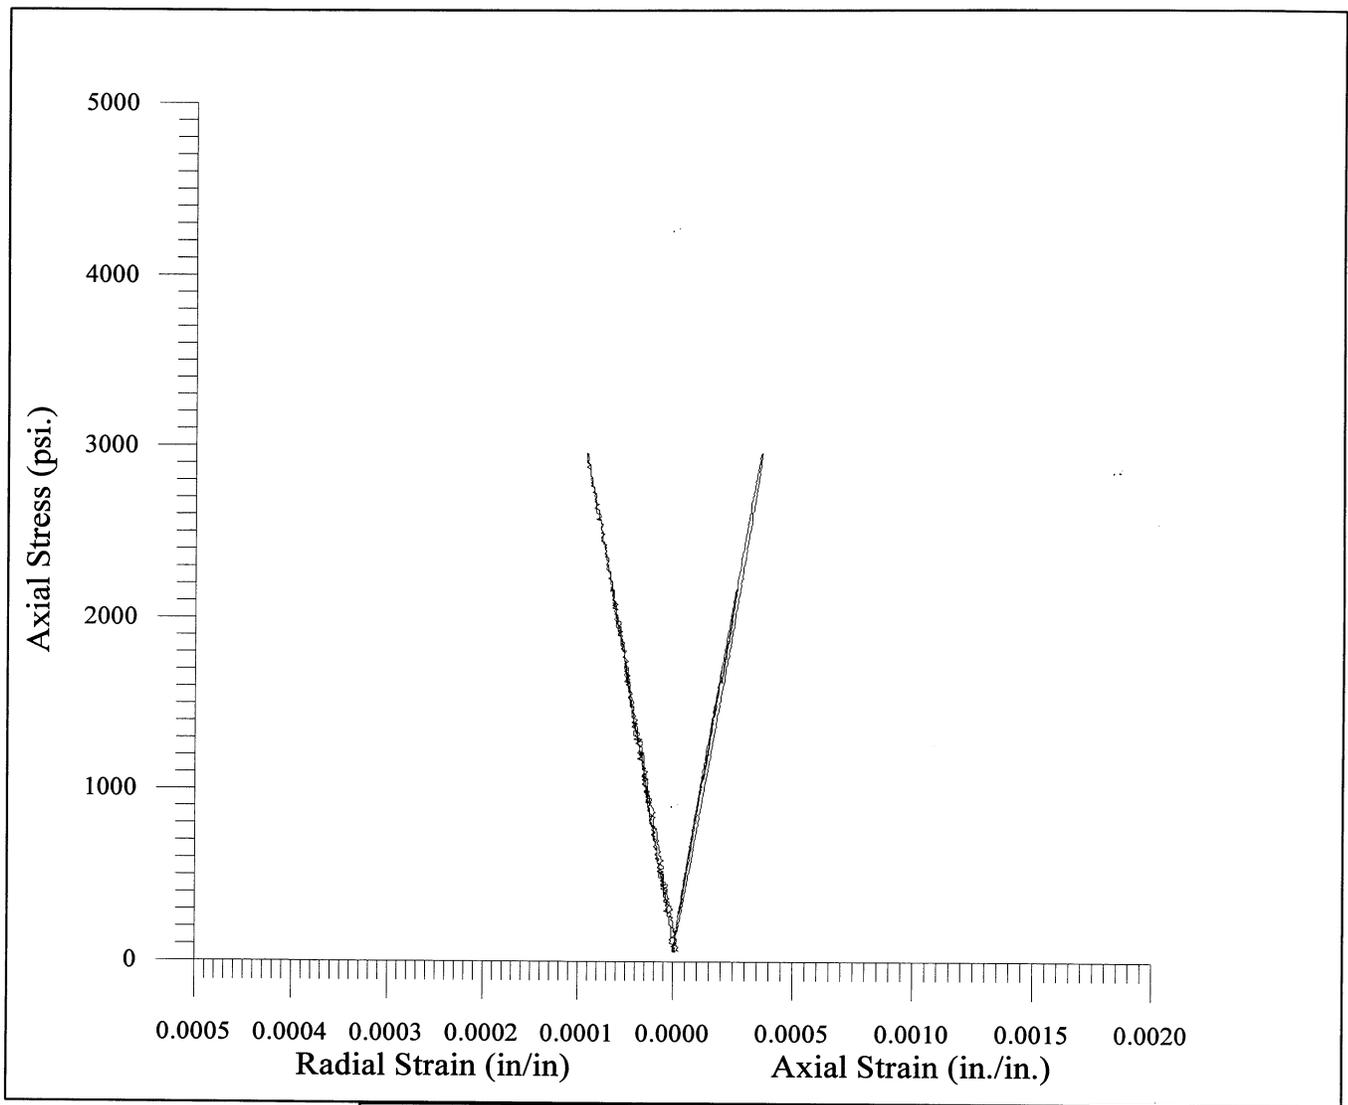
**ELASTIC MODULUS TEST**  
**Axial Stress vs. Axial & Radial Strain**

**SAMPLE ID:** Boring: 98-23  
 Sample: 30b  
 Depth: 128.5'

**DESCRIPTION**  
 Medium gray sandstone with a calcite healed hairline axial fracture.

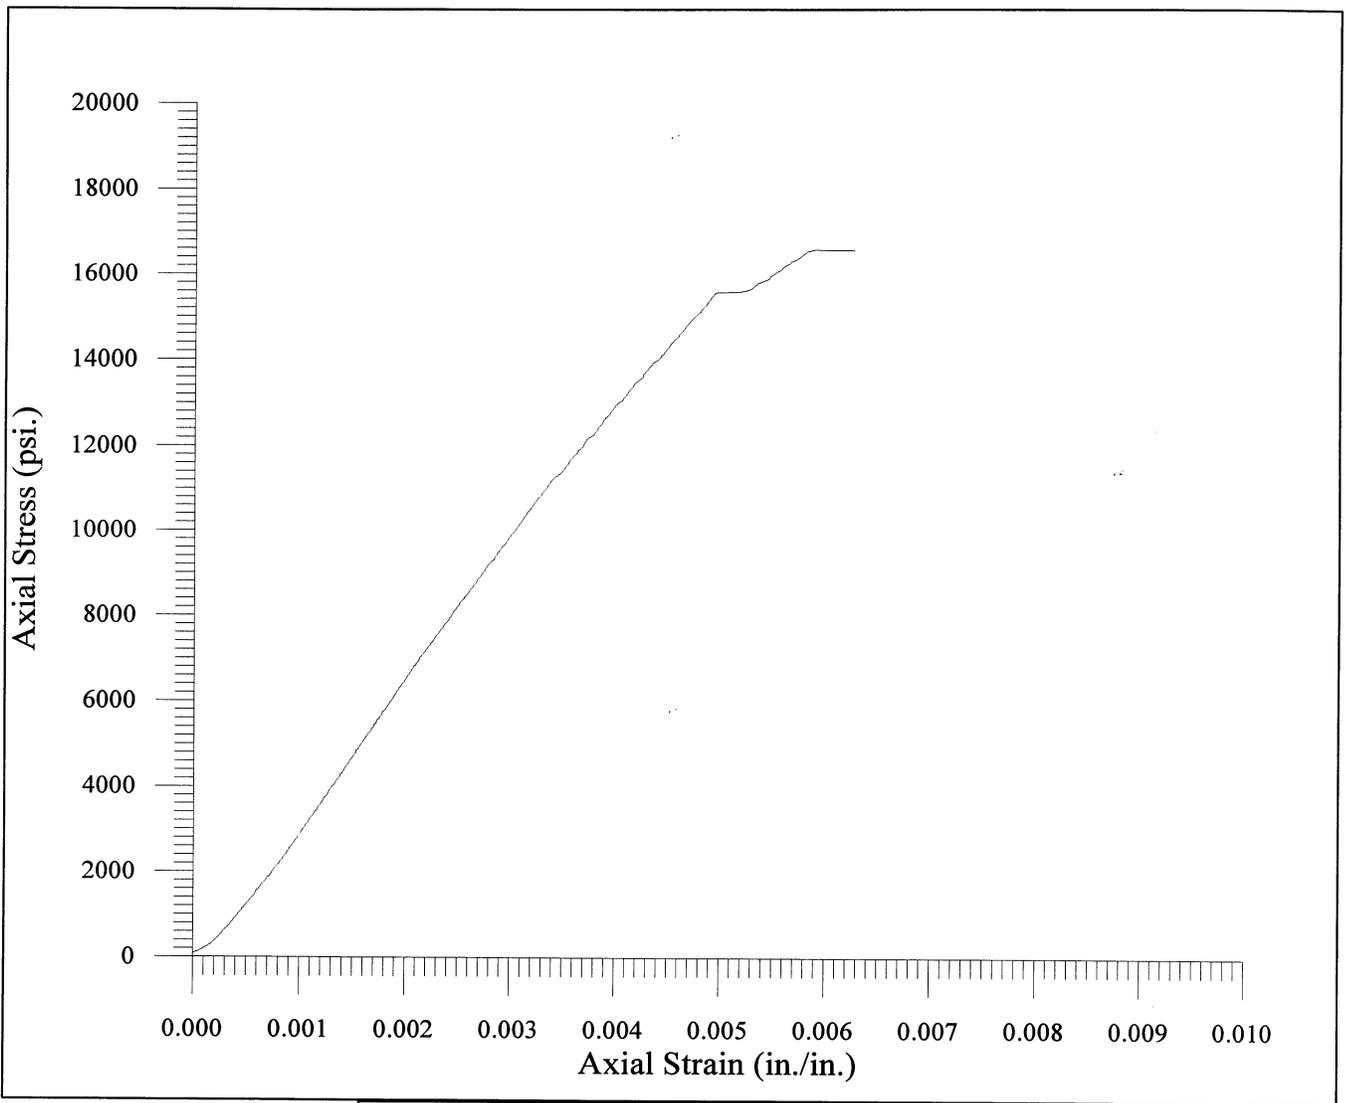
**UNCONFINED COMPRESSION TEST  
Axial Stress vs. Axial Strain**

<p><b>SAMPLE ID:</b> Boring : 98-23 Sample: 30b Depth: 128.5'</p> <p align="center"><b>DESCRIPTION</b></p> <p>Medium gray sandstone with a calcite healed hairline axial fracture.</p> <p><b>STRENGTH:</b> 16,579 psi</p>	<p align="center"> <i>Geo</i>

SFOBB - East Span Replacement Project  
Fugro - Earth Mechanics  
Unconfined Compression Test Sample  
Boring: 98-23 Depth: 128.5' Sample: 30b
