**SUBCONTRACTOR REPORTS  
FINAL GEOTECHNICAL  
SITE CHARACTERIZATION**

**SAN FRANCISCO-OAKLAND BAY BRIDGE  
EAST SPAN SEISMIC SAFETY PROJECT**

**VOLUME 2 OF 3  
(GeoTest Unlimited)**

Letter Report  
San Francisco Oakland Bay Bridge  
East Span Replacement Project  
Rock Testing Program

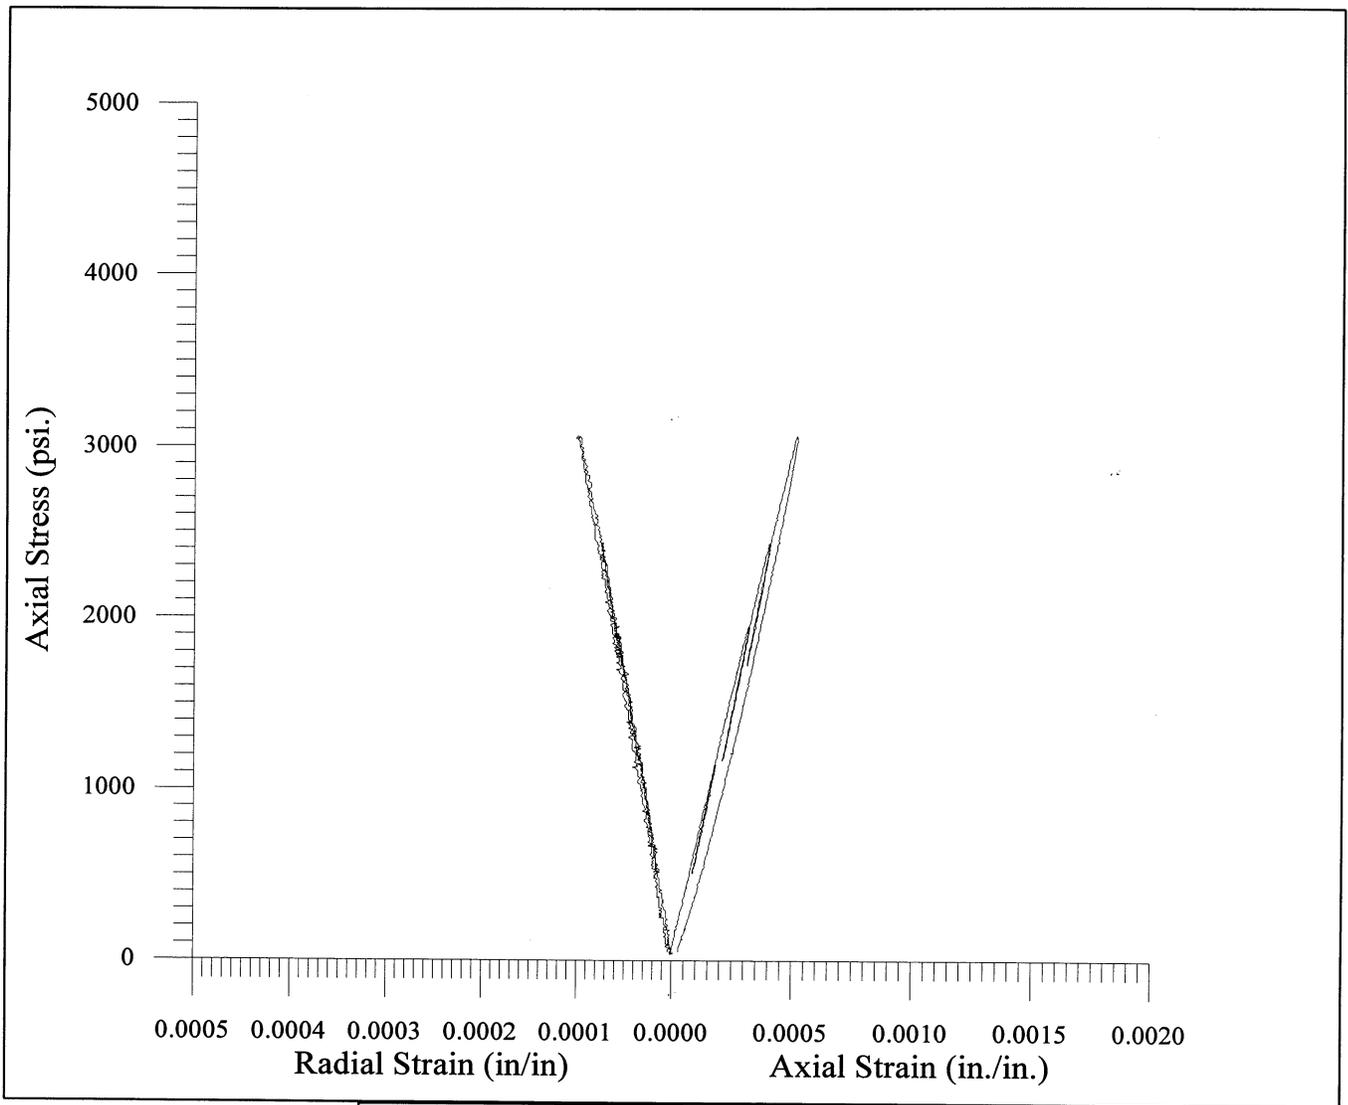
**ELASTIC MODULUS TEST**  
**Axial Stress vs. Axial & Radial Strain**

<p><b>SAMPLE ID:</b> Boring: 98-23  Sample: 31a  Depth: 135'</p> <p><b>DESCRIPTION</b>  Medium gray sandstone alternating with fine sandy siltstone. Contains numerous calcite healed hairline fractures about 24-37 degrees to the core axis and one axial healed fracture.</p> <p><b>MODULUS:</b> 6,940,000 psi</p> <p><b>POISSON'S RATIO:</b> .22</p>	<div style="text-align: center;">

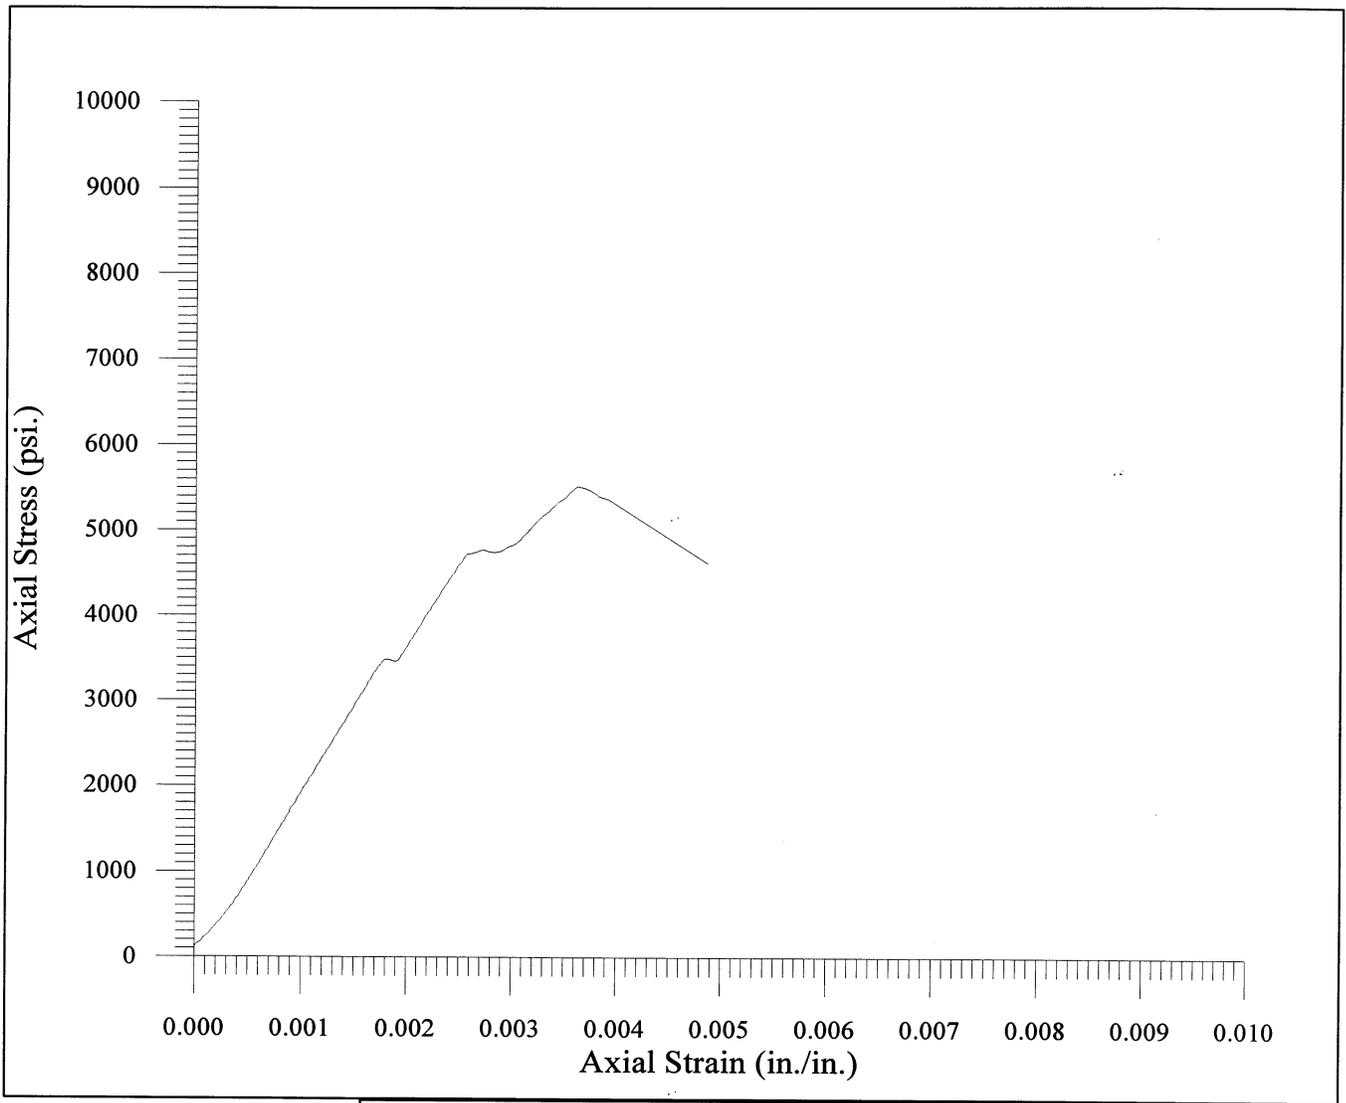
**UNCONFINED COMPRESSION TEST  
Axial Stress vs. Axial Strain**

<p><b>SAMPLE ID:</b> Boring : 98-23 Sample: 31a Depth: 135'</p> <p align="center"><b>DESCRIPTION</b></p> <p>Medium gray sandstone alternating with fine sandy siltstone. Contains numerous calcite healed hairline fractures about 24-37 degrees to the core axis and one axial healed fracture.</p> <p><b>STRENGTH:</b> 5512 psi</p>	<div style="text-align: center;"> <p><i>Geo</i>

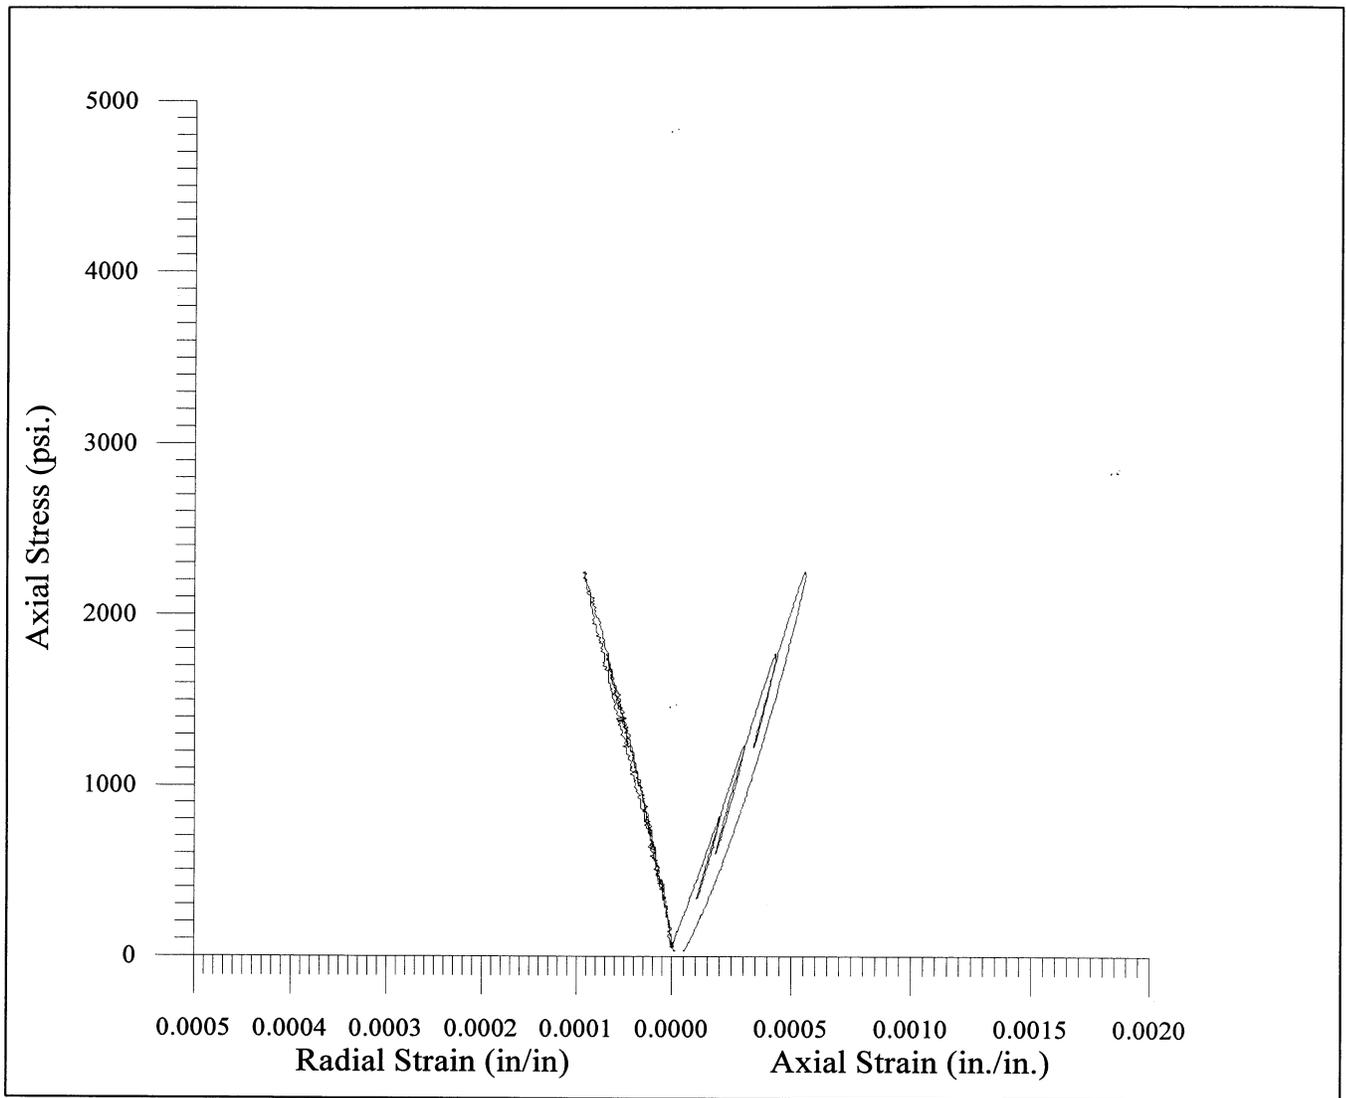
**ELASTIC MODULUS TEST**  
**Axial Stress vs. Axial & Radial Strain**

<p><b>SAMPLE ID:</b> Boring: 98-23  Sample: 32a  Depth: 142.8'</p> <p align="center"><b>DESCRIPTION</b></p> <p>Medium gray sandstone with an end zone of contorted dark gray to olive gray claystone and many calcite healed hairline fractures.</p> <p><b>MODULUS:</b> 5,380,000 psi  <b>POISSON'S RATIO:</b> .24</p>	<p align="center"> <i>Geo</i>

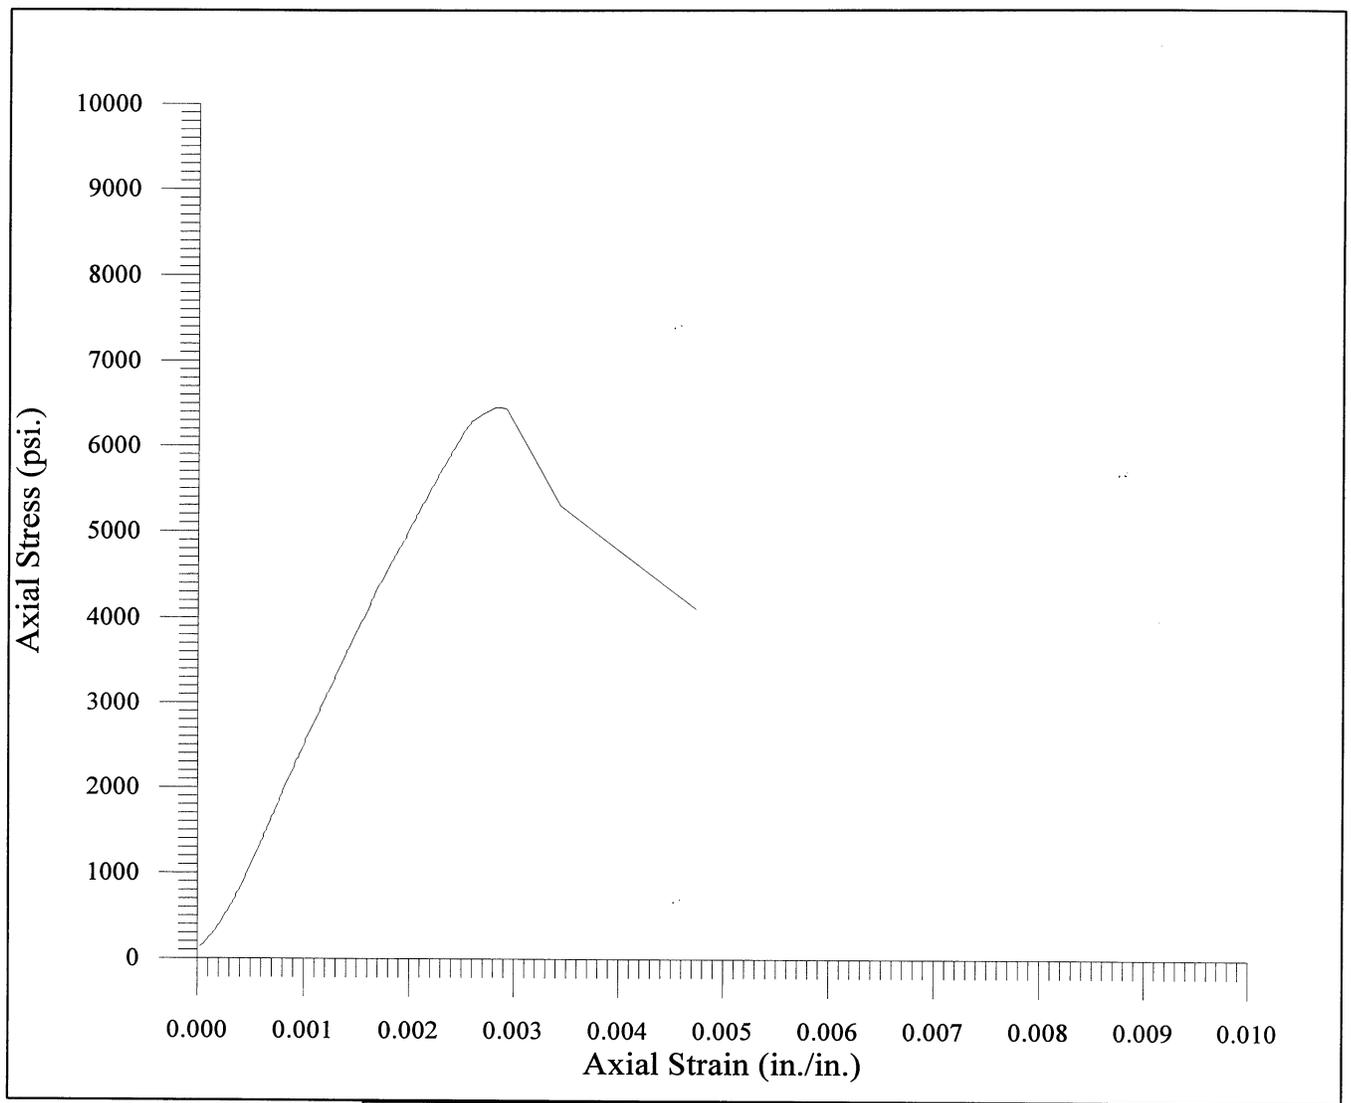
**UNCONFINED COMPRESSION TEST**  
**Axial Stress vs. Axial Strain**

<p><b>SAMPLE ID:</b> Boring : 98-23          Sample: 32a          Depth: 142.8'</p>	<p><i>Geo</i>

<i>Test</i>  <b>Unlimited</b> 800 Peralta Ave          San Leandro, CA 94577</p>
<p><b>DESCRIPTION</b>          Medium gray sandstone with an end zone of contorted dark gray to olive gray claystone and many calcite healed hairline fractures.</p>	<p><b>Client:</b> Fugro West, Inc.          5855 Olivas Park Dr.          Ventura, CA 93003</p>
<p><b>STRENGTH:</b> 6449 psi</p>	<p><b>Project:</b> San Francisco Oakland Bay Bridge          East Span Replacement Project</p>
	<p><b>Job Number:</b> 98-42-0053</p>
	<p><b>Test Date:</b> October 23, 1998</p>

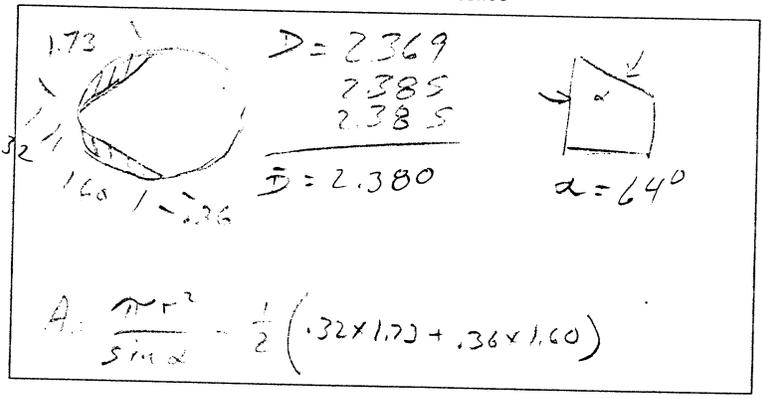
Sketch of Shear Surface

Sample Description: Slightly dry to moist with light tan clay coating on top and sides

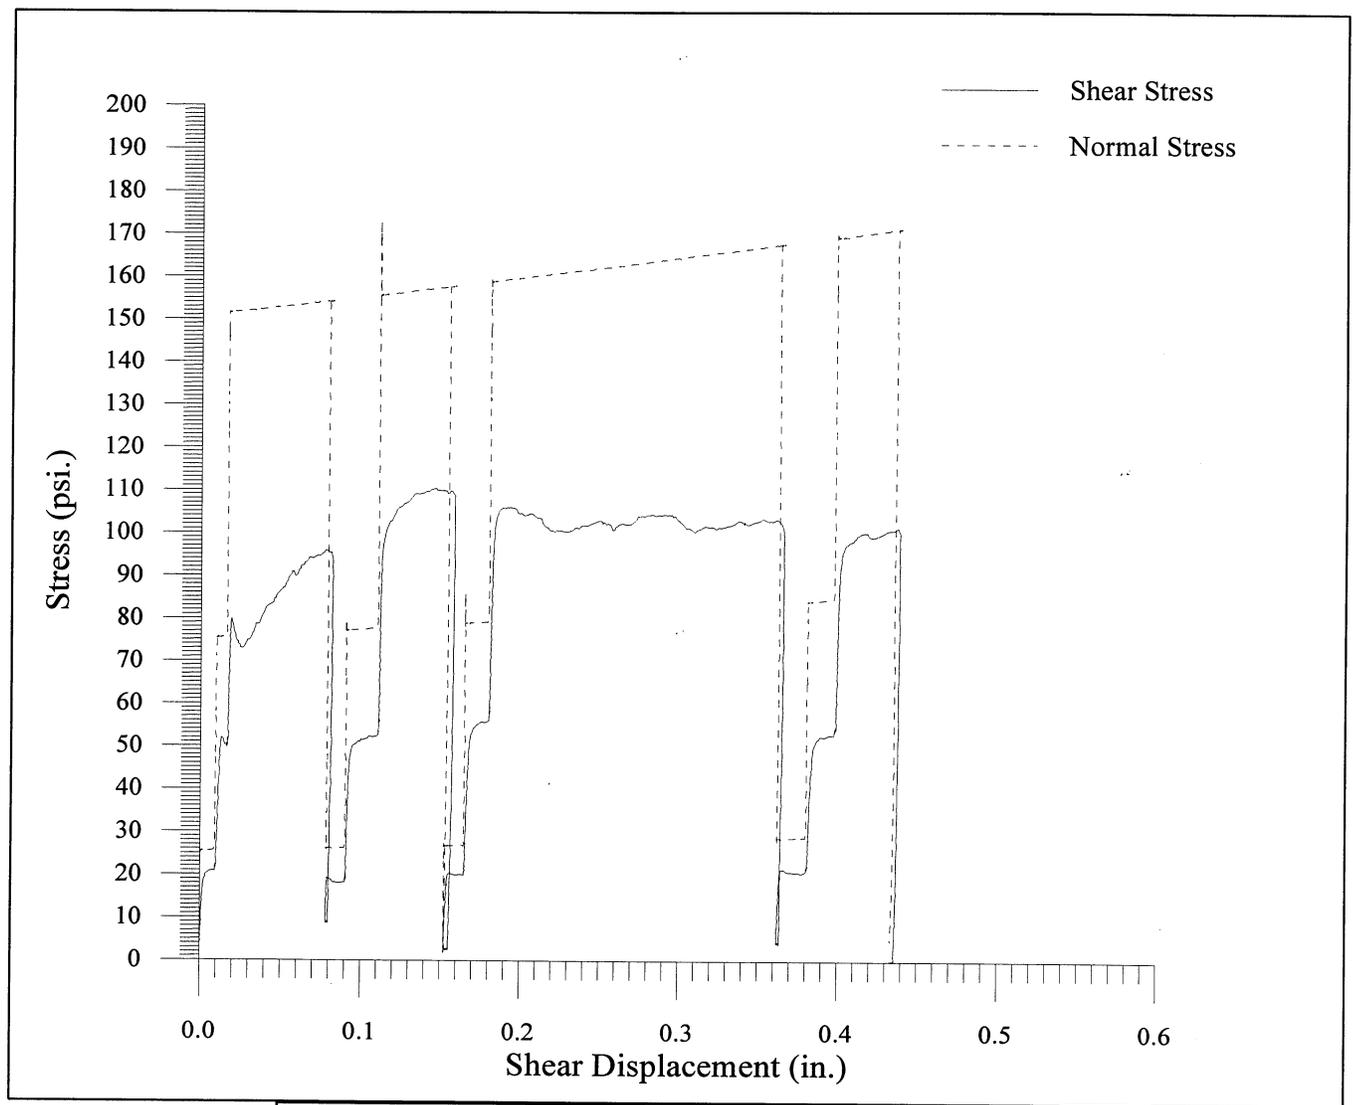
**DIRECT SHEAR TEST**  
**Shear and Normal Stress vs. Shear Displacement**

<p><b>SAMPLE ID:</b> Boring: 98-23          Sample: 7a          Depth: 17.5'</p> <p style="text-align: center;"><b>DESCRIPTION</b></p> <p>Slightly rough joint in tan sandstone,          with a light tan clay or silt coating.</p>

<p><b>800 Peralta Ave</b>  <b>San Leandro, CA 94577</b></p> </div> <hr/> <p><b>Client:</b> <b>Fugro West, Inc.</b>  <b>5855 Olivas Park Dr.</b>  <b>Ventura, CA 93003</b></p> <p><b>Project:</b> <b>San Francisco Oakland Bay Bridge</b>  <b>East Span Replacement Project</b></p> <p><b>Job Number:</b> <b>98-42-0053</b></p> <hr/> <p><b>Test Date:</b> <b>October 30, 1998</b></p>
	Normal Stress	Shear Strength																
Initial	26.5	20																
	78	56																
	157.5	106																
Final	29.5	21																
	85	53																
	170.5	100

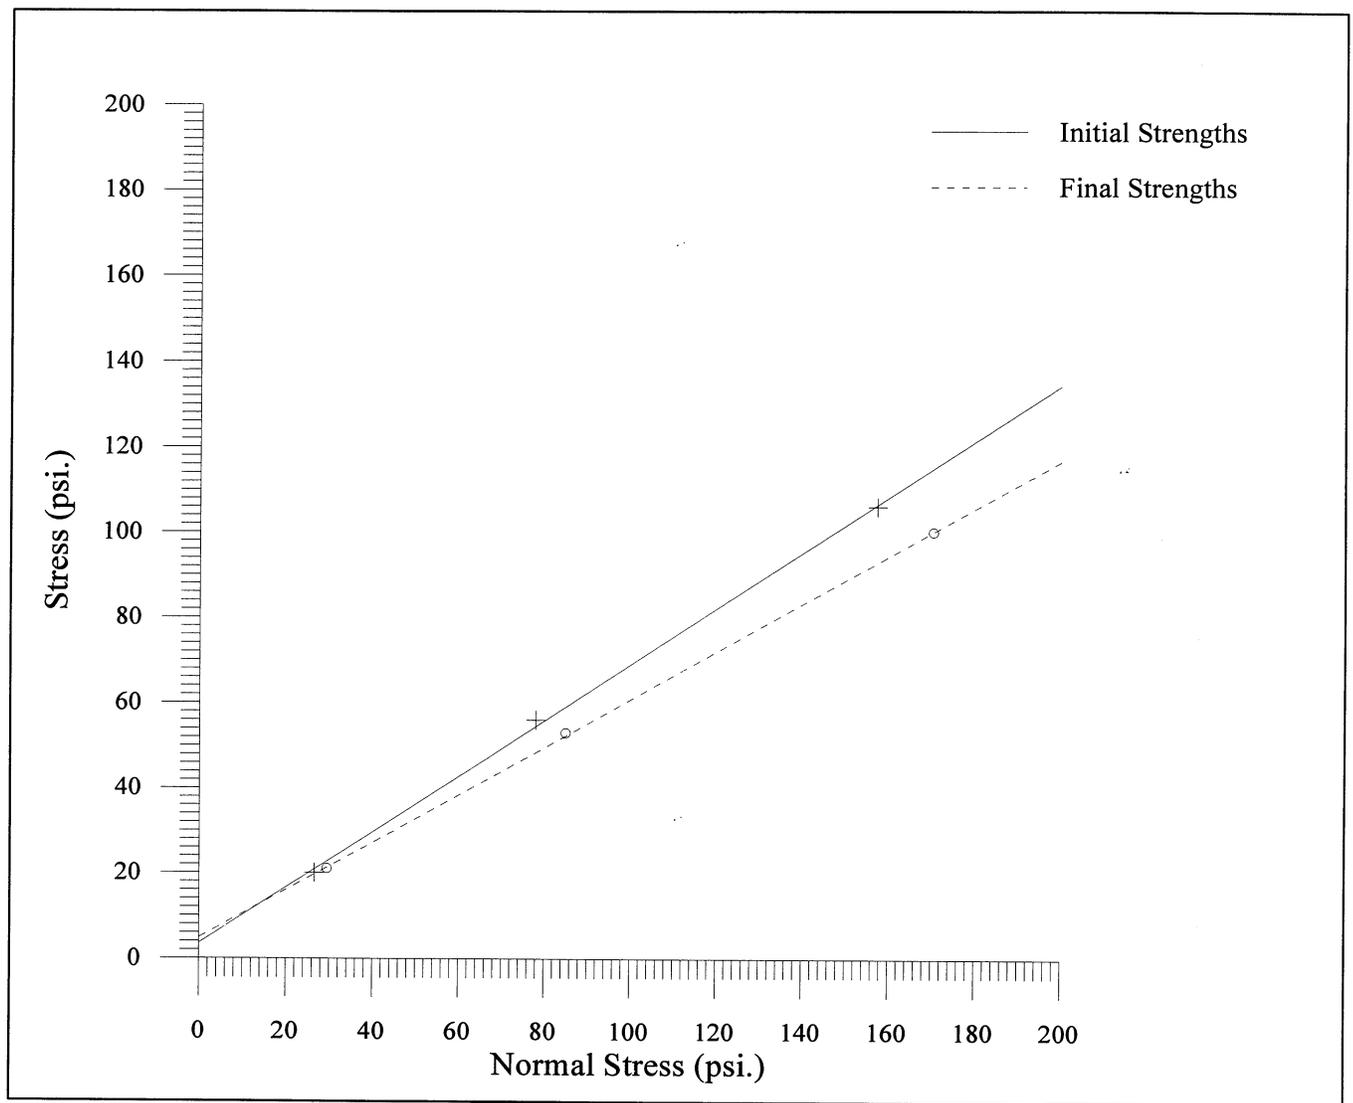
**DIRECT SHEAR TEST  
Failure Envelope**

<p><b>SAMPLE ID:</b> Boring: 98-23 Sample: 7a Depth: 17.5'</p> <p><b>DESCRIPTION</b></p> <p>Slightly rough joint in tan sandstone with a light tan clay or silt coating.</p>

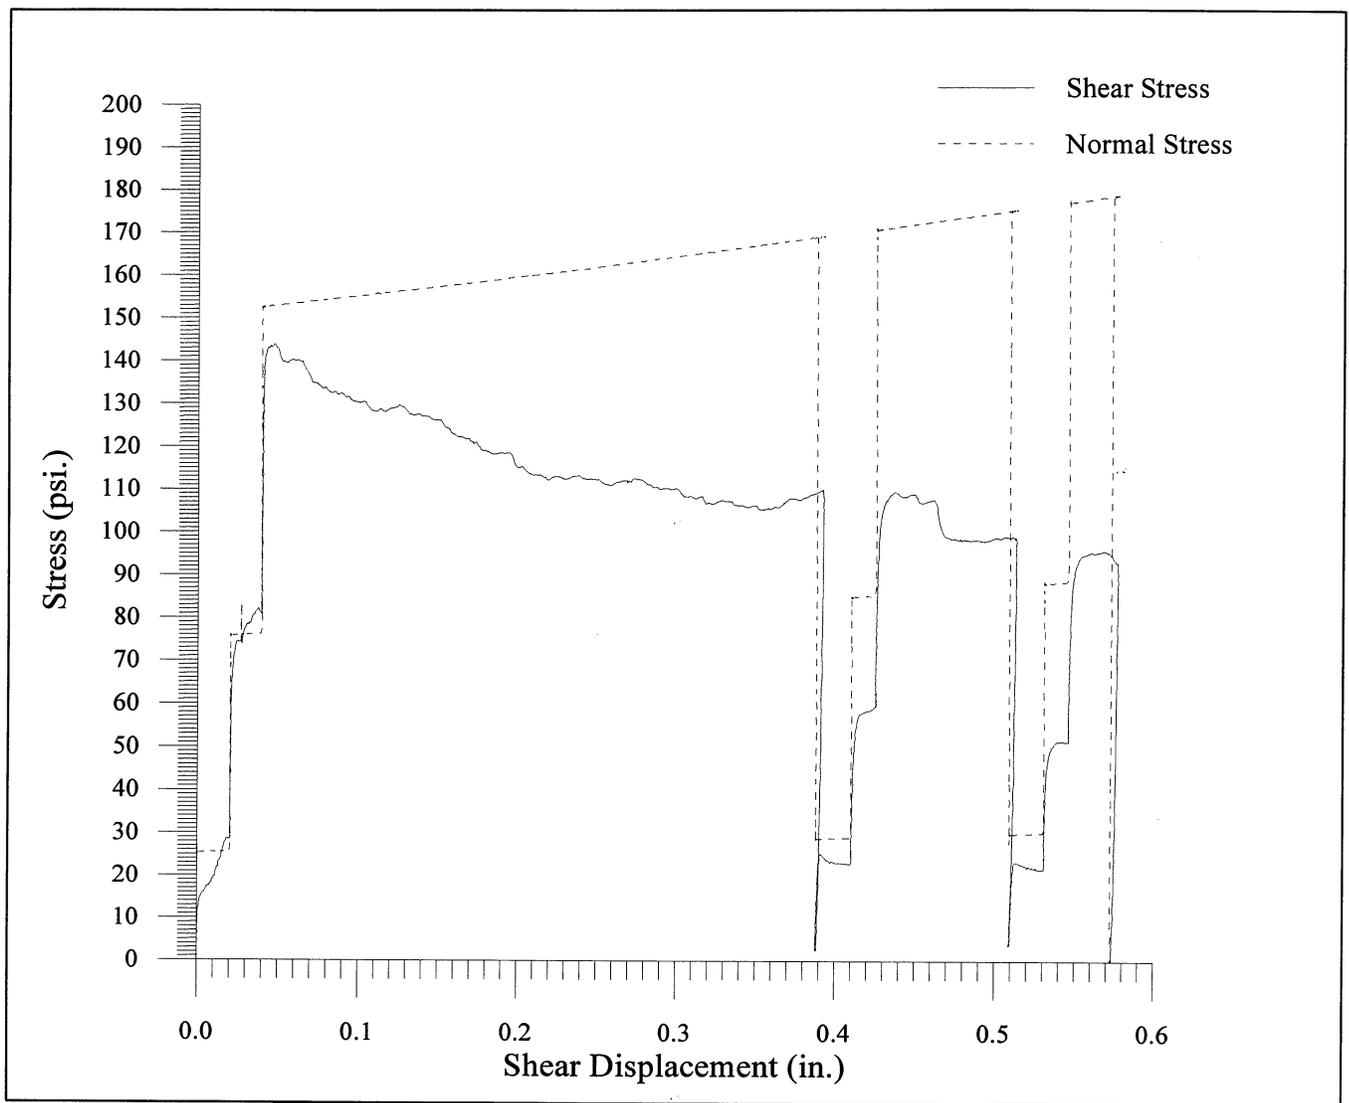
**DIRECT SHEAR TEST**  
**Shear and Normal Stress vs. Shear Displacement**

<b>SAMPLE ID:</b> Boring: 98-23 Sample: 7b Depth: 17.7'

800 Peralta Ave San Leandro, CA 94577		
<b>DESCRIPTION</b> Slightly rough joint in tan sandstone.					
	<u>Normal Stress</u>		<u>Shear Strength</u>	<b>Client:</b> Fugro West, Inc. 5855 Olivas Park Dr. Ventura, CA 93003	
Initial	25.5		28.5	<b>Project:</b> San Francisco Oakland Bay Bridge East Span Replacement Project	
	76		82	<b>Job Number:</b> 98-42-0053	
	153		144	<b>Test Date:</b> October 30, 1998	
Final	30		22		
	88.5		51		
	178		96

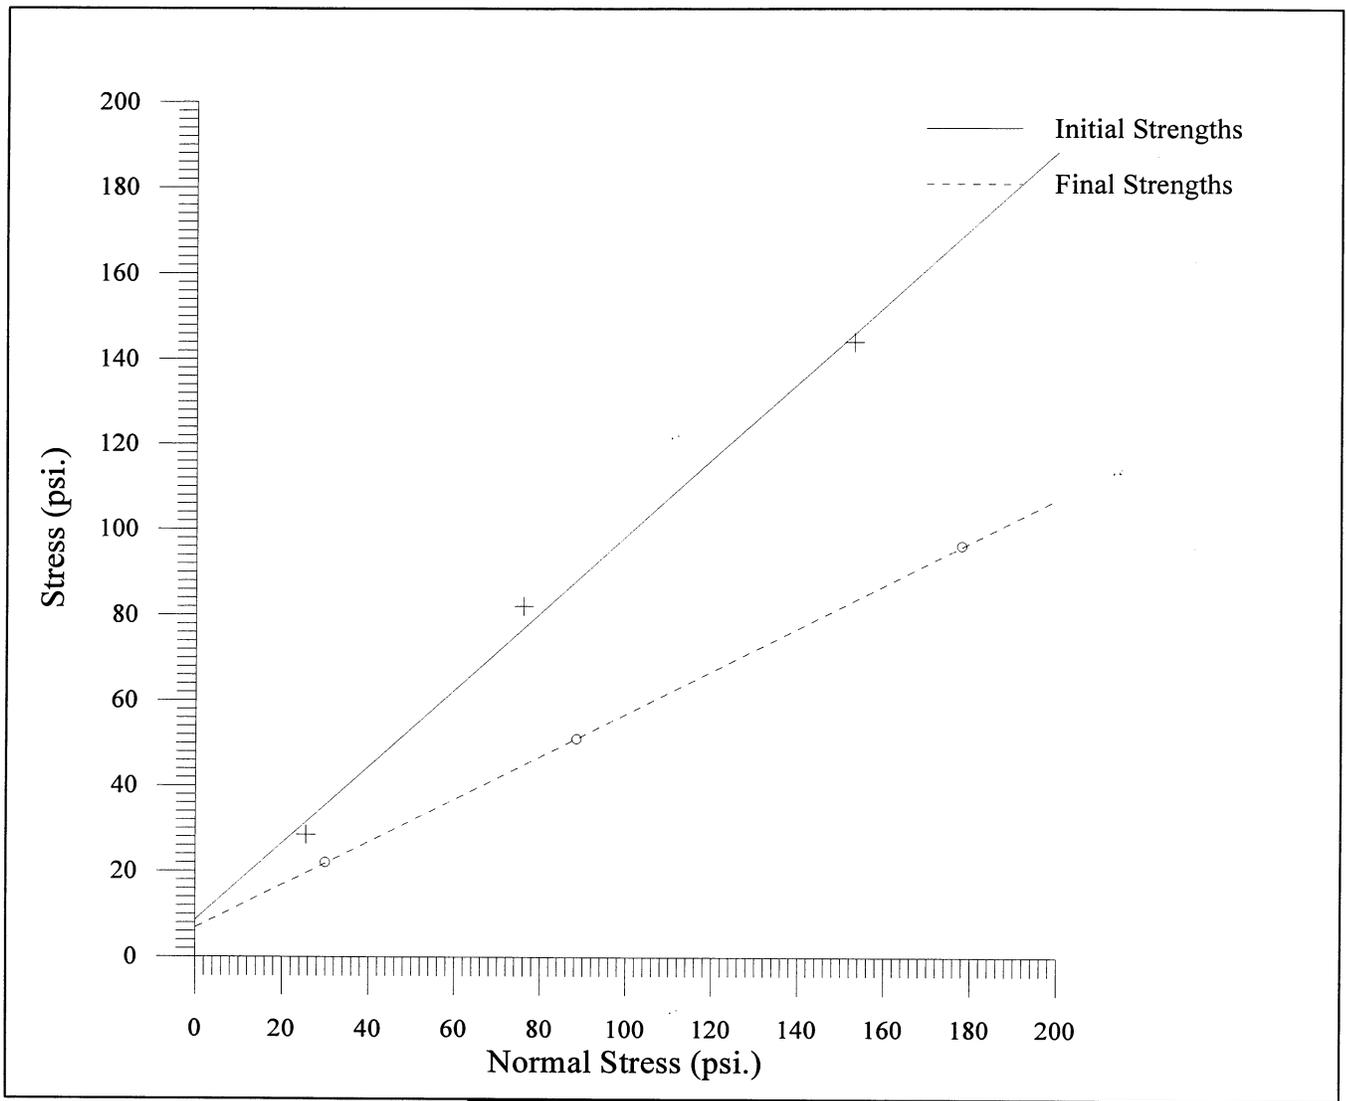
**DIRECT SHEAR TEST  
Failure Envelope**

**SAMPLE ID:** Boring: 98-23  
Sample: 7b  
Depth: 17.7'

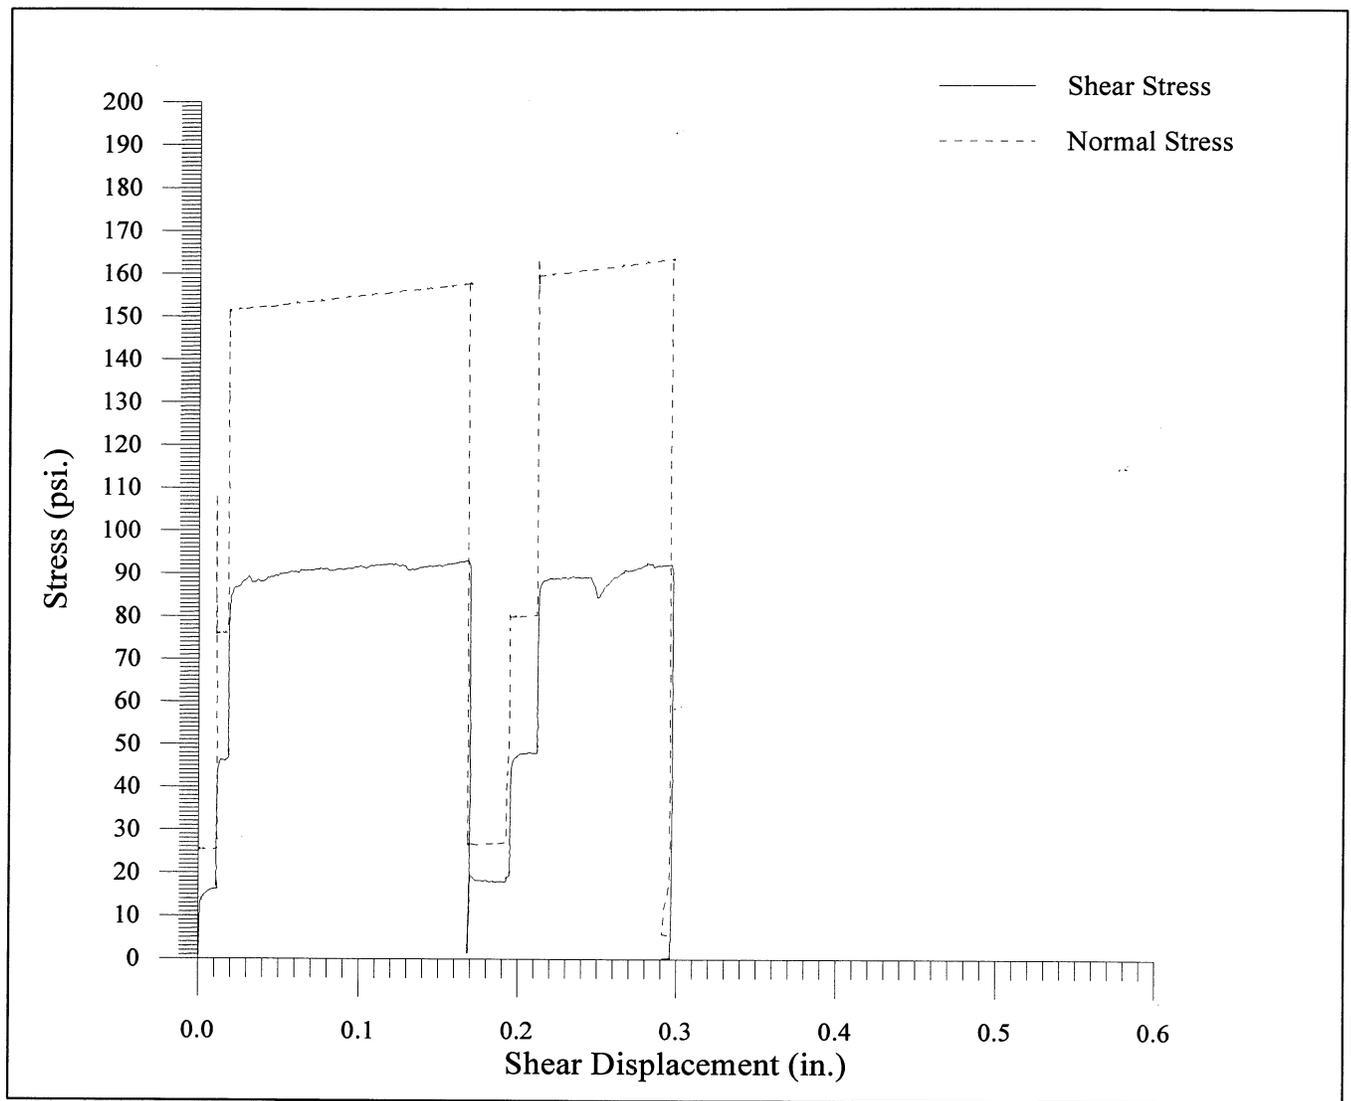
**DIRECT SHEAR TEST**  
**Shear and Normal Stress vs. Shear Displacement**

<p><b>SAMPLE ID:</b> Boring: 98-23  Sample: 17b  Depth: 58'</p> <p><b>DESCRIPTION</b>  Planar calcite coated joint in dark gray claystone.</p>	<p align="center"> <i>Geo</i>

Normal Stress	Shear Strength	Initial	25.5	16	76	46.5	152	88	Final	27	18	80	48	160.5	89	<p><b>Project:</b> San Francisco Oakland Bay Bridge  East Span Replacement Project</p>	
	Normal Stress	Shear Strength																	
Initial	25.5	16																	
	76	46.5																	
	152	88																	
Final	27	18																	
	80	48																	
	160.5	89																	
<p><b>Job Number:</b> 98-42-0053</p>																			
<p><b>Test Date:</b> October 30, 1998</p>

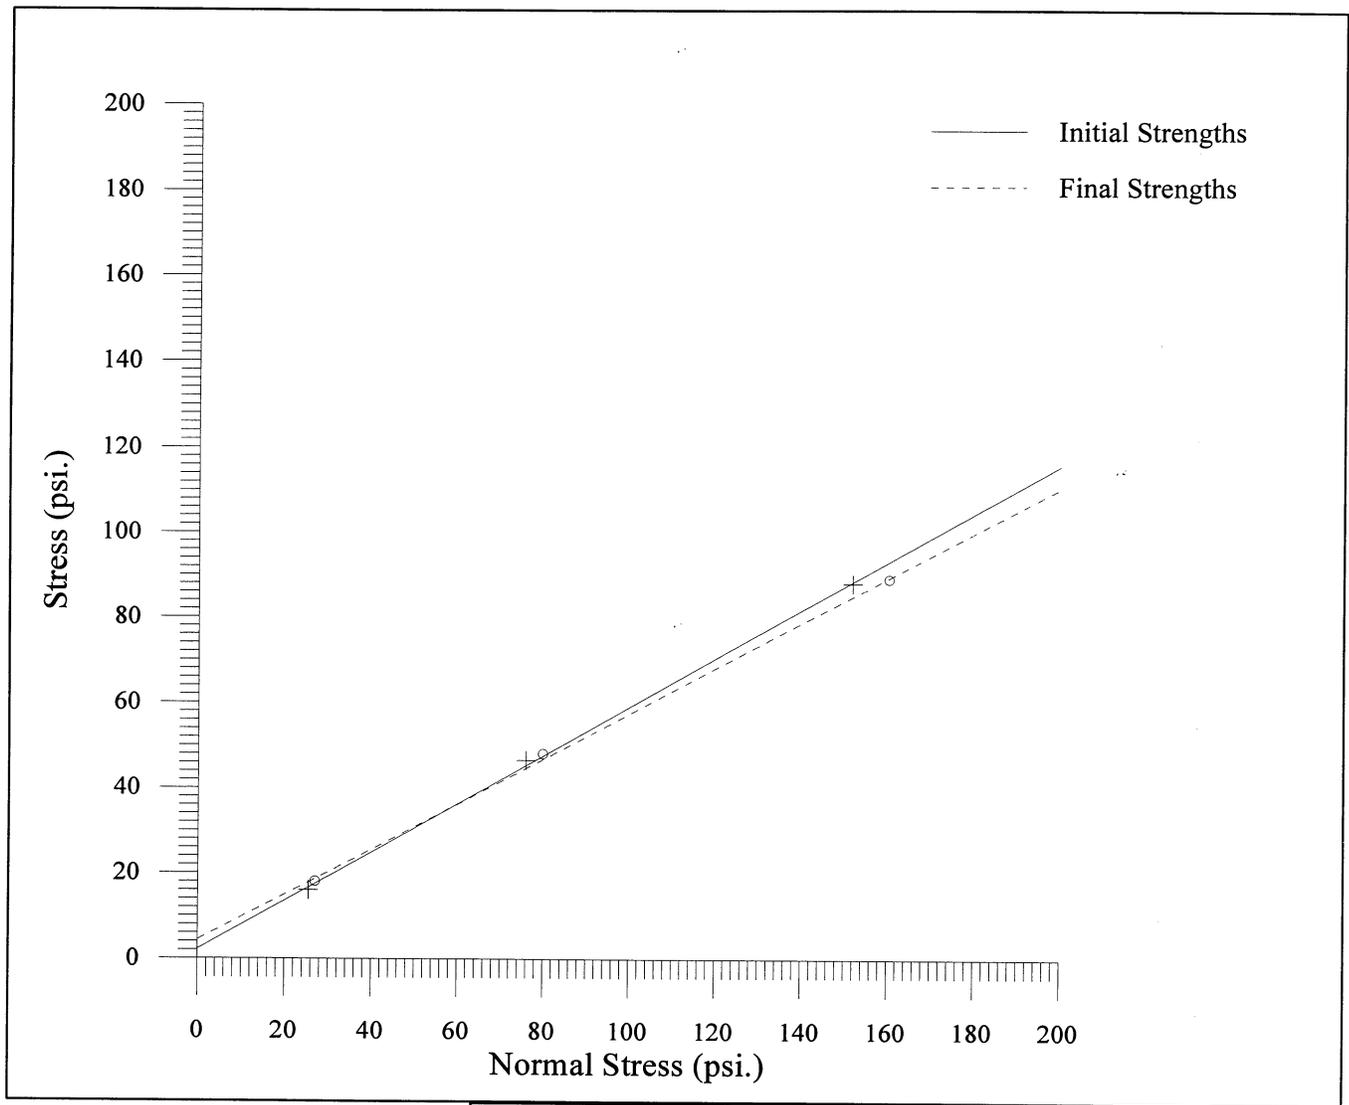
**DIRECT SHEAR TEST  
Failure Envelope**

<p><b>SAMPLE ID:</b> Boring: 98-23 Sample: 17b Depth: 58'</p> <p align="center"><b>DESCRIPTION</b></p> <p>Planar calcite coated joint in dark gray claystone.</p>	<p><b>Geo Test Unlimited</b> 800 Peralta Ave San Leandro, CA 94577</p>									
	<p><b>Client:</b> Fugro West, Inc. 5855 Olivas Park Dr. Ventura, CA 93003</p>

Shear Intercept (psi)	Friction Angle (degrees)	Initial	2.2	29.6	Final	4.4	27.9	<p><b>Project:</b> San Francisco Oakland Bay Bridge East Span Replacement Project</p>
	Shear Intercept (psi)	Friction Angle (degrees)								
Initial	2.2	29.6								
Final	4.4	27.9								
	<p><b>Job Number:</b> 98-42-0053</p>									
	<p><b>Test Date:</b> October 30, 1998</p>

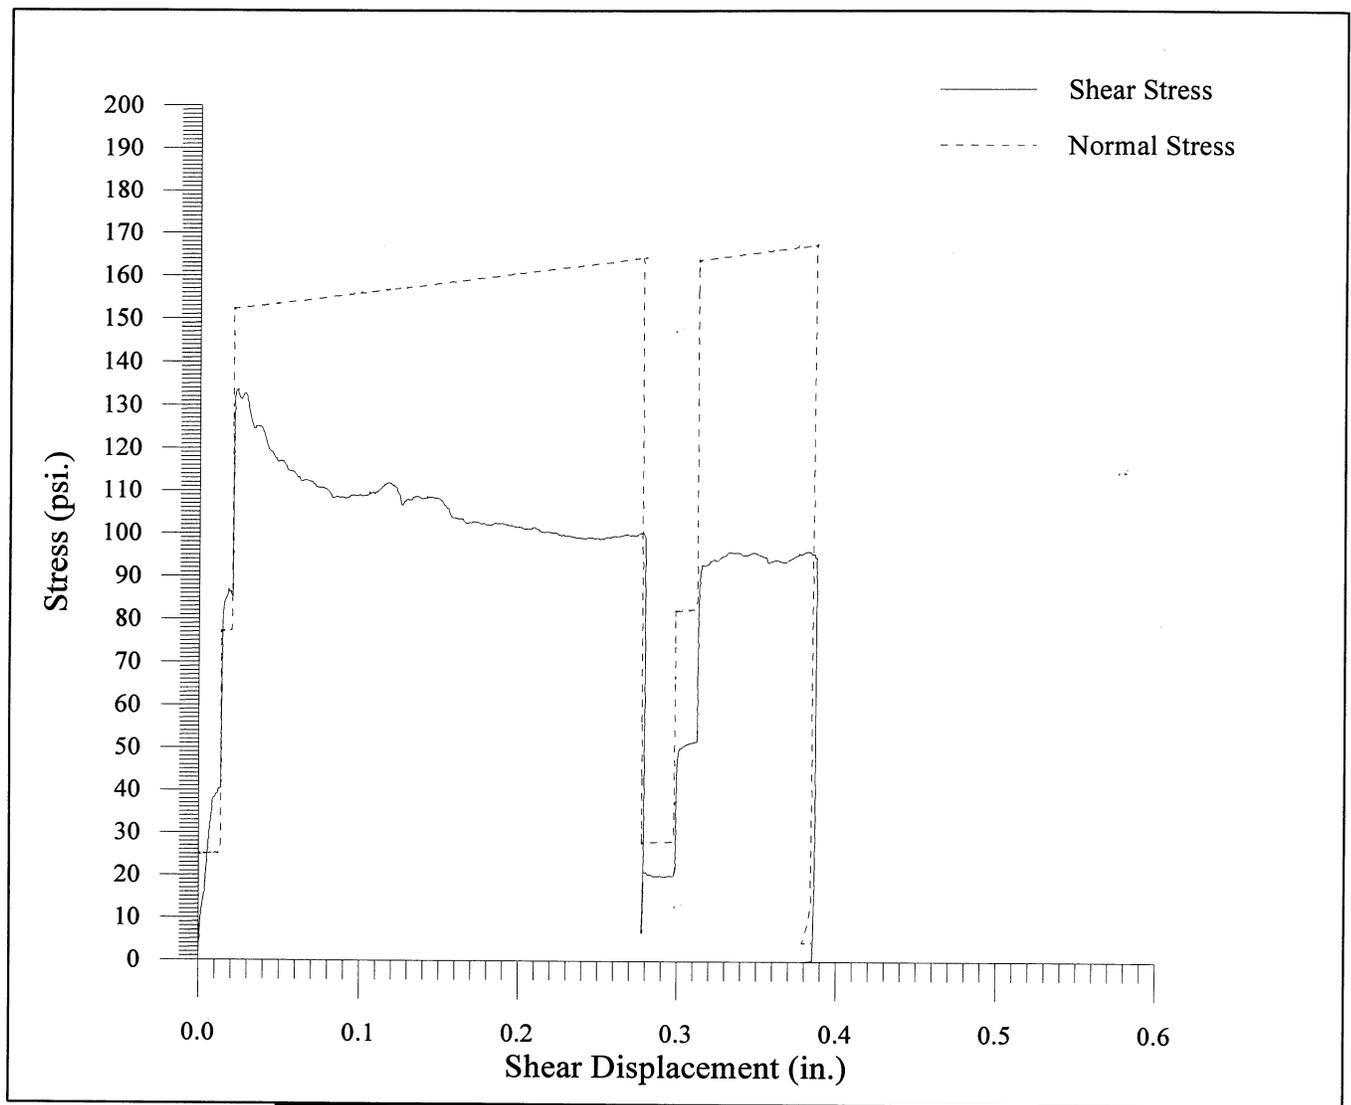
**DIRECT SHEAR TEST**  
**Shear and Normal Stress vs. Shear Displacement**

<p><b>SAMPLE ID:</b> Boring: 98-23          Sample: 24a          Depth: 96.5'</p> <p style="text-align: center;"><b>DESCRIPTION</b></p> <p>Planar calcite coated joint in dark gray claystone/siltstone.</p>

Normal Stress	Shear Strength	Initial	25	41	77	86.5	153	133	Final	28.5	20	82.5	52	165	94.5	<p><b>Client:</b> Fugro West, Inc.          5855 Olivas Park Dr.          Ventura, CA 93003</p> <p><b>Project:</b> San Francisco Oakland Bay Bridge          East Span Replacement Project</p> <p><b>Job Number:</b> 98-42-0053</p>
	Normal Stress	Shear Strength																
Initial	25	41																
	77	86.5																
	153	133																
Final	28.5	20																
	82.5	52																
	165	94.5																
<p><b>Test Date:</b> October 30, 1998</p>

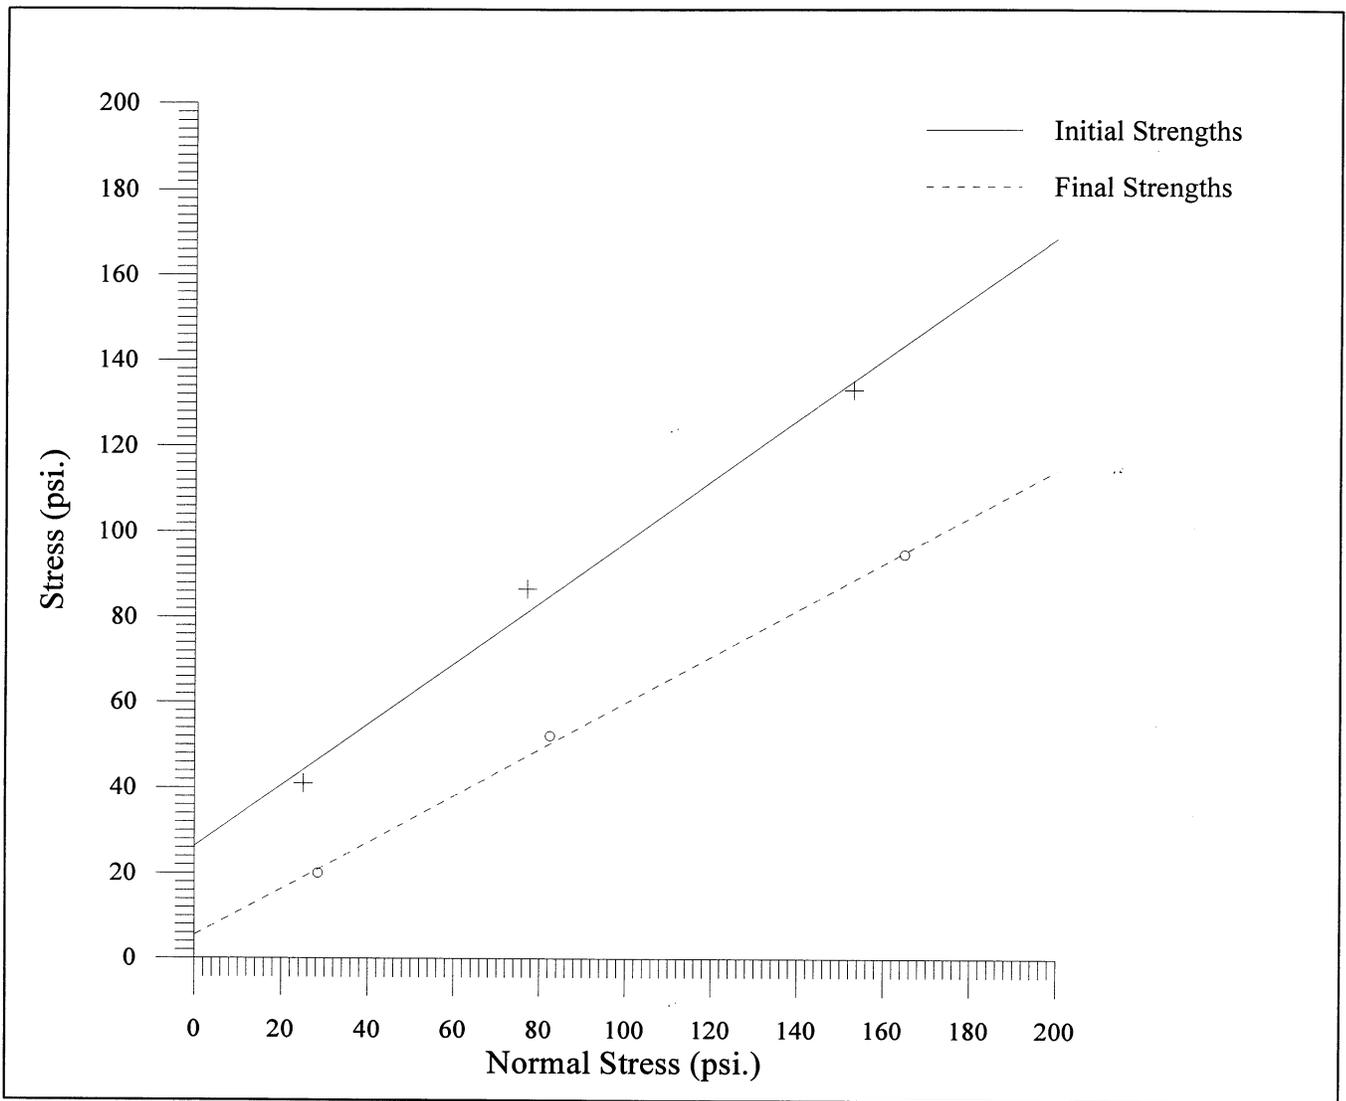
**DIRECT SHEAR TEST  
Failure Envelope**

<p><b>SAMPLE ID:</b> Boring: 98-23 Sample: 24a Depth: 96.5'</p> <p align="center"><b>DESCRIPTION</b></p> <p>Planar calcite coated joint in dark gray claystone/siltstone.</p>

<i>Test</i>  <b>Unlimited</b> 800 Peralta Ave  San Leandro, CA 94577 </p>
		Shear Intercept (psi)	Friction Angle (degrees)							
Initial	26.4	35.4								
Final	5.5	28.5								
<p><b>Client:</b> Fugro West, Inc. 5855 Olivas Park Dr. Ventura, CA 93003</p> <p><b>Project:</b> San Francisco Oakland Bay Bridge East Span Replacement Project</p> <p><b>Job Number:</b> 98-42-0053</p> <p><b>Test Date:</b> October 30, 1998</p>

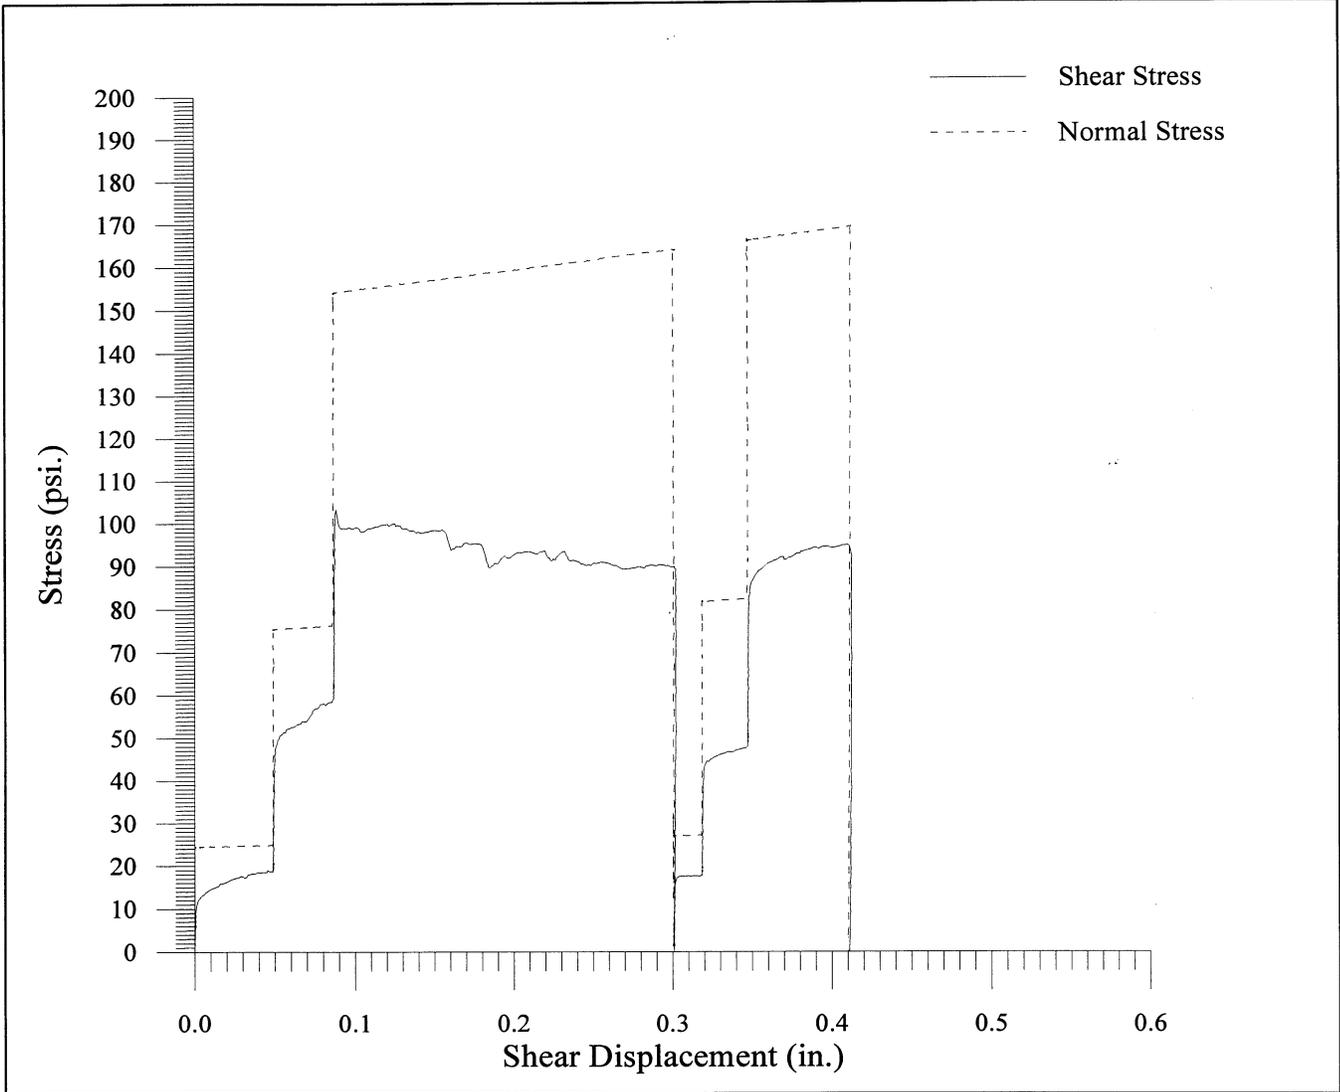
**DIRECT SHEAR TEST**  
**Shear and Normal Stress vs. Shear Displacement**

<p><b>SAMPLE ID:</b> Boring: 98-23          Sample: 26a          Depth: 103.5'</p> <p align="center"><b>DESCRIPTION</b></p> <p>Planar calcite coated bedding joint between dark gray claystone and siltstone. The joint contains a few pyrite crystals.</p>

Normal Stress	Shear Strength	Initial	25	19	76	54.5	155	99.5	Final	28	18	83	48	169.5	95	<p align="center">   <b>Geo Test Unlimited</b>          800 Peralta Ave          San Leandro, CA 94577       </p>
		Normal Stress	Shear Strength															
Initial	25	19																
	76	54.5																
	155	99.5																
Final	28	18																
	83	48																
	169.5	95																
<p><b>Client:</b> Fugro West, Inc.          5855 Olivas Park Dr.          Ventura, CA 93003</p> <p><b>Project:</b> San Francisco Oakland Bay Bridge          East Span Replacement Project</p> <p><b>Job Number:</b> 98-42-0053</p>	<p><b>Test Date:</b> October 30, 1998</p>
