**SUBCONTRACTOR REPORTS  
FINAL GEOTECHNICAL  
SITE CHARACTERIZATION**

**SAN FRANCISCO-OAKLAND BAY BRIDGE  
EAST SPAN SEISMIC SAFETY PROJECT**

**VOLUME 2 OF 3  
(GeoTest Unlimited)**

Letter Report  
San Francisco Oakland Bay Bridge  
East Span Replacement Project  
Rock Testing Program

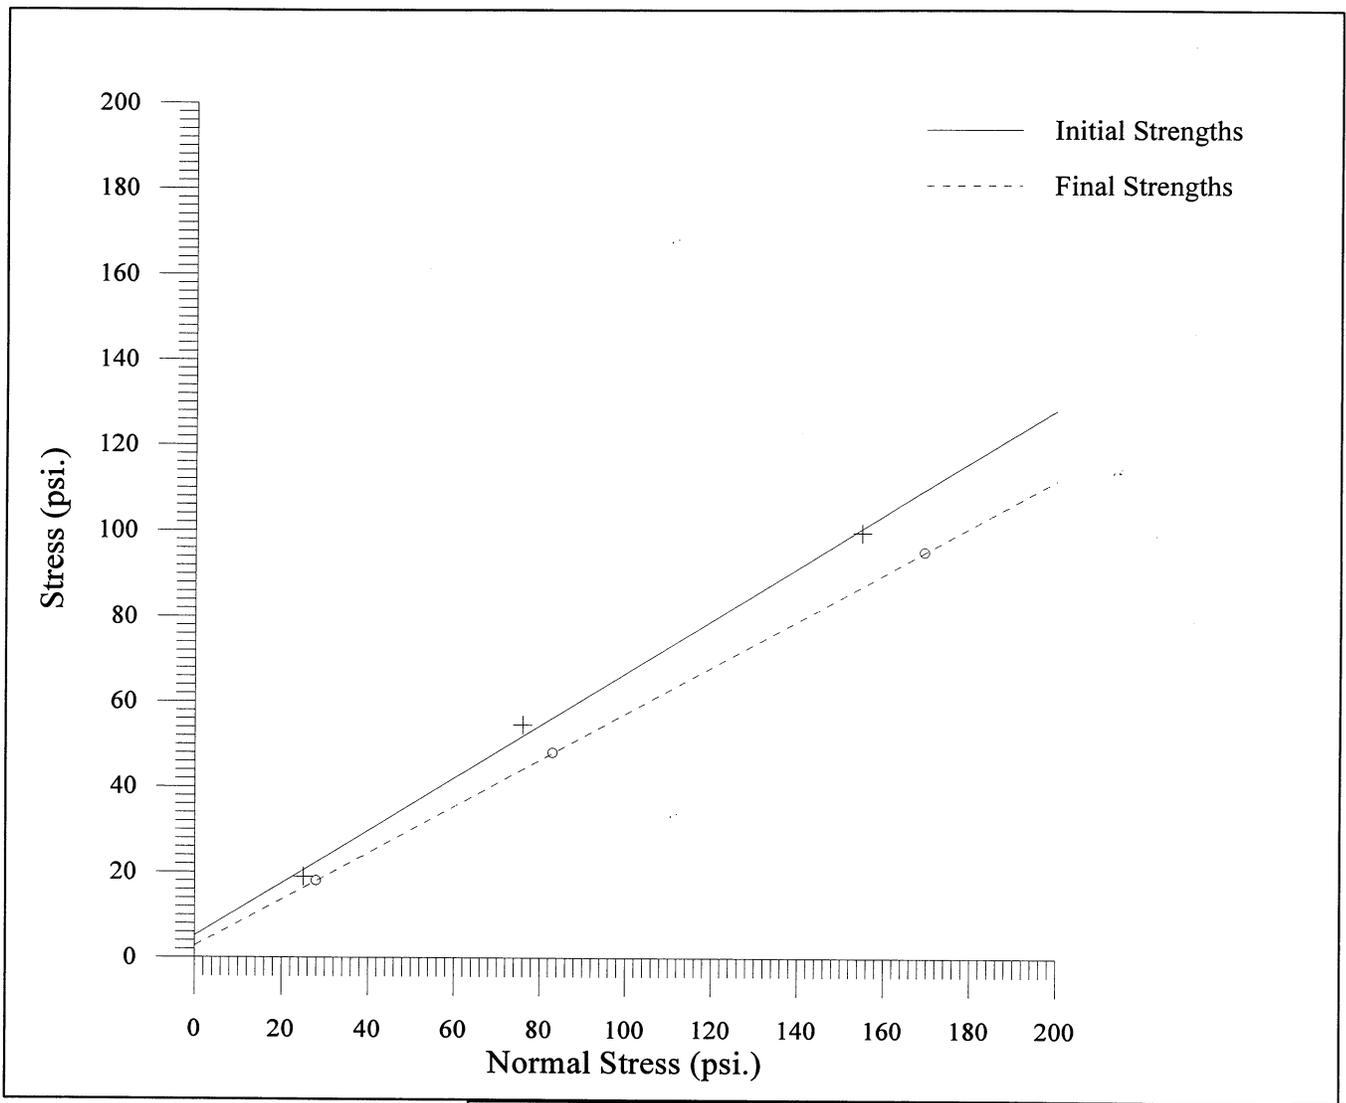
**DIRECT SHEAR TEST  
Failure Envelope**

**SAMPLE ID:** Boring: 98-23  
Sample: 26a  
Depth: 103.5'

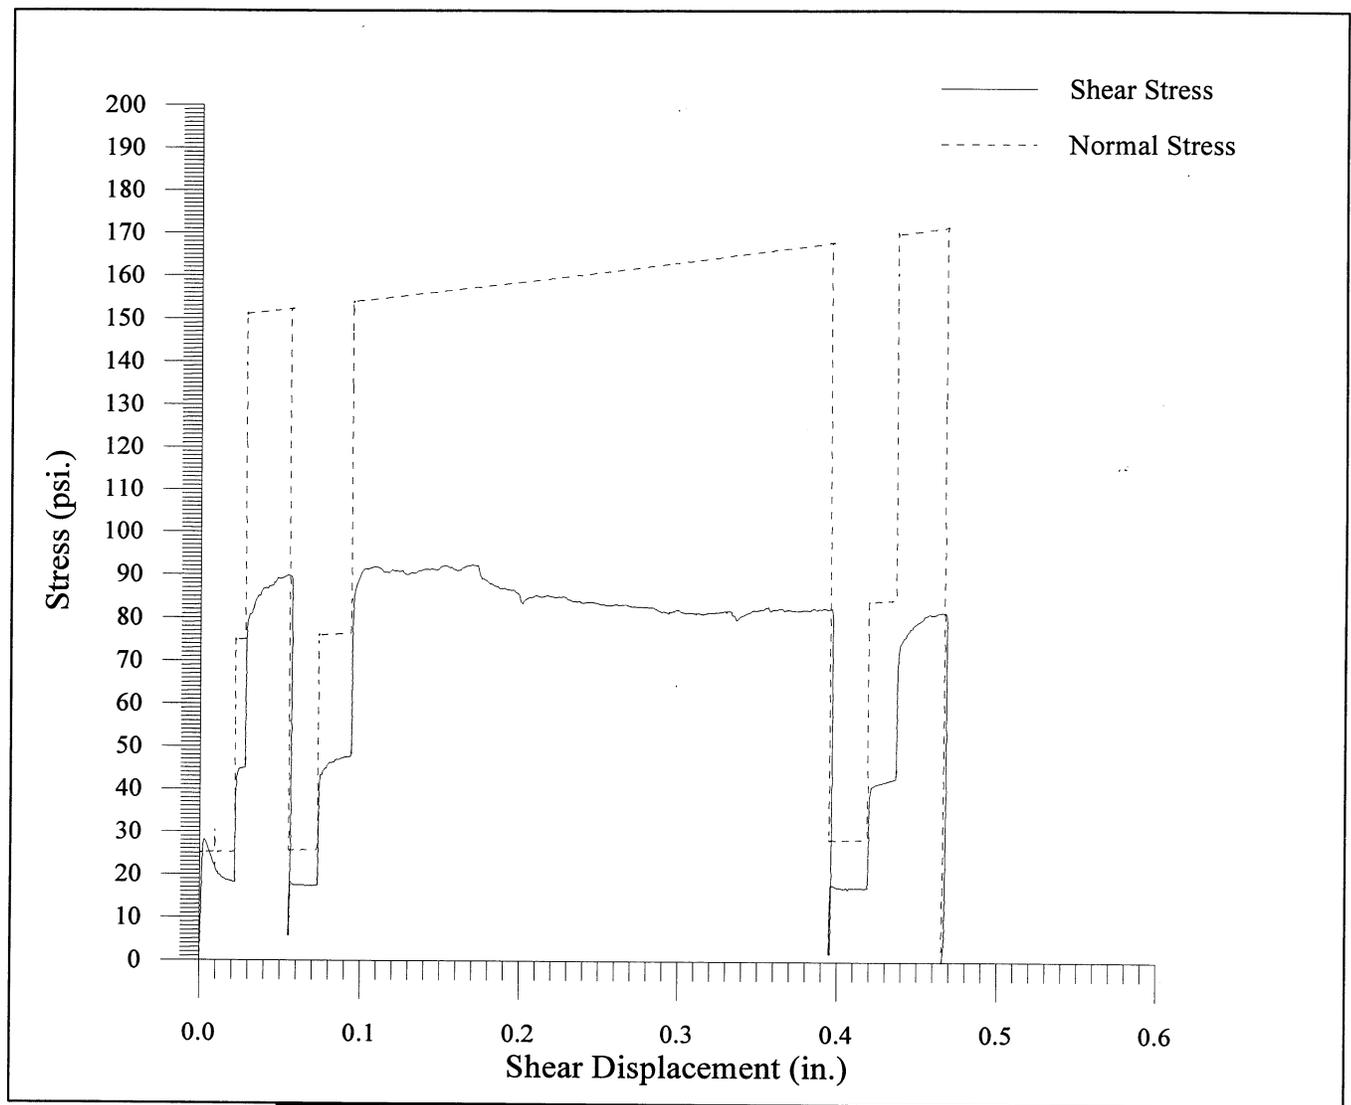
**DIRECT SHEAR TEST**  
**Shear and Normal Stress vs. Shear Displacement**

<p><b>SAMPLE ID:</b> Boring: 98-23  Sample: 26b  Depth: 104.5'</p> <p><b>DESCRIPTION</b>  Undulating calcite coated joint  in dark gray claystone.</p>

<b>U</b>  <b>Test</b>  <b>Unlimited</b> </p> <p align="right"> 800 Peralta Ave  San Leandro, CA 94577 </p>
		Normal Stress	Shear Strength															
Initial	25.5	27.5																
	76	47.5																
	154	92																
Final	28	27																
	84	42.5																
	171	81																
<p><b>Client:</b> Fugro West, Inc.  5855 Olivas Park Dr.  Ventura, CA 93003</p> <p><b>Project:</b> San Francisco Oakland Bay Bridge  East Span Replacement Project</p> <p><b>Job Number:</b> 98-42-0053</p>	<p><b>Test Date:</b> October 30, 1998</p>

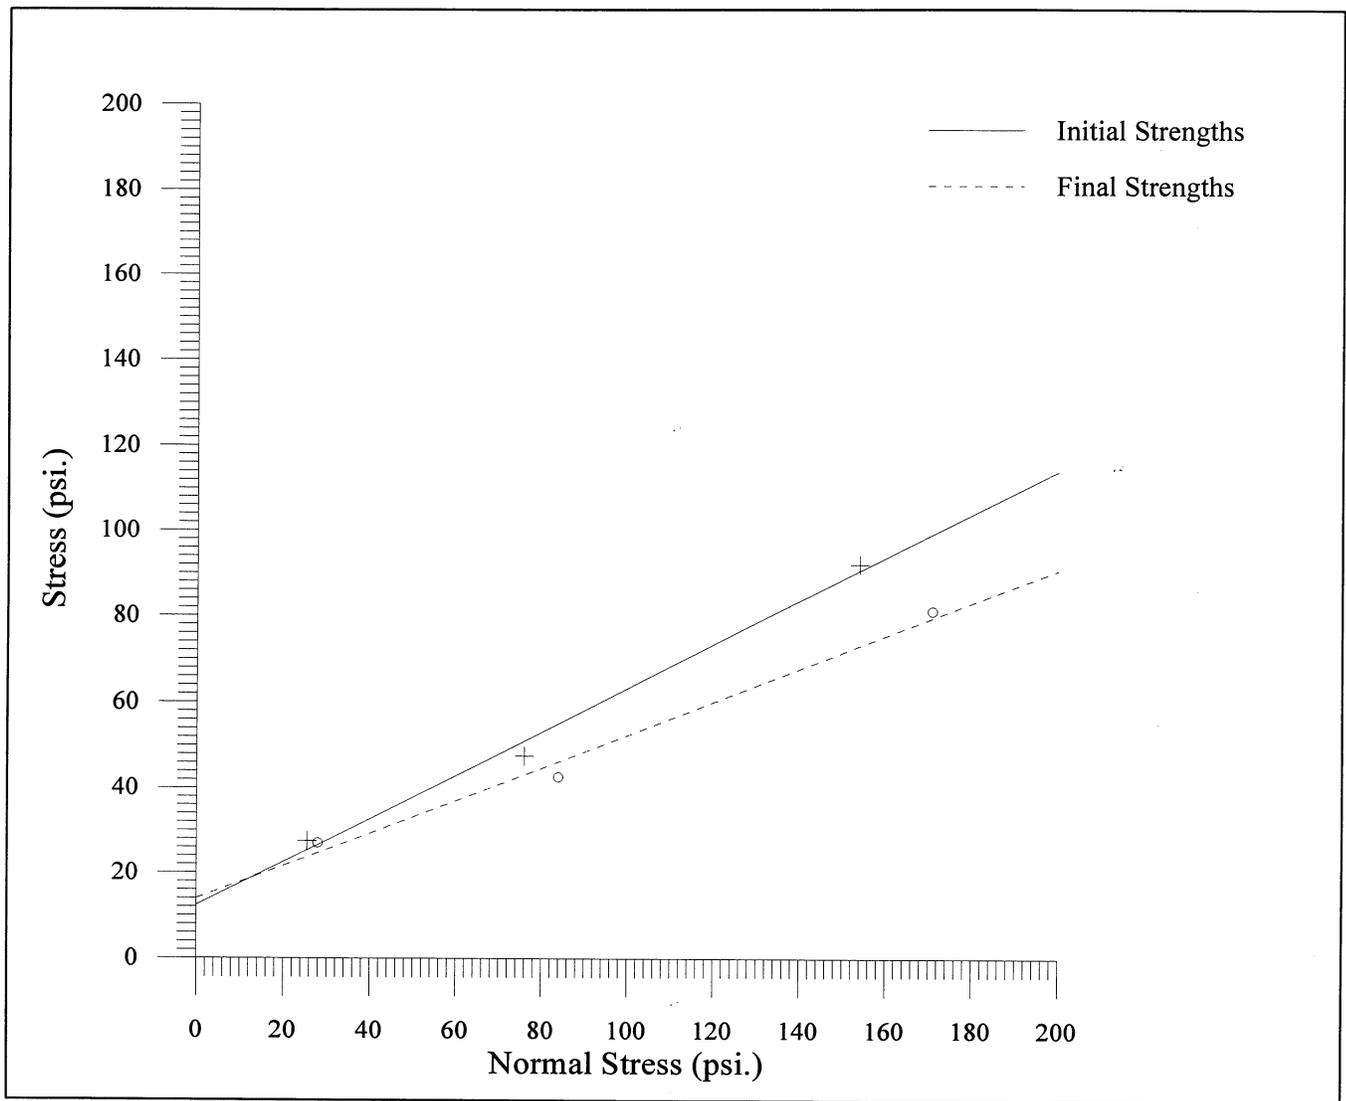
**DIRECT SHEAR TEST  
Failure Envelope**

<p><b>SAMPLE ID:</b> Boring: 98-23 Sample: 26b Depth: 104.5'</p> <p style="text-align: center;"><b>DESCRIPTION</b></p> <p style="text-align: center;">Undulating calcite coated joint in dark gray claystone.</p>

<p><b>Geo Test Unlimited</b></p> </div> <p style="text-align: right;">800 Peralta Ave San Leandro, CA 94577</p> <hr/> <p><b>Client:</b> Fugro West, Inc. 5855 Olivas Park Dr. Ventura, CA 93003</p> <p><b>Project:</b> San Francisco Oakland Bay Bridge East Span Replacement Project</p> <p><b>Job Number:</b> 98-42-0053</p> <hr/> <p><b>Test Date:</b> October 30, 1998</p>
	Shear Intercept (psi)	Friction Angle (degrees)								
Initial	12.4	26.9								
Final	14.0	21.0

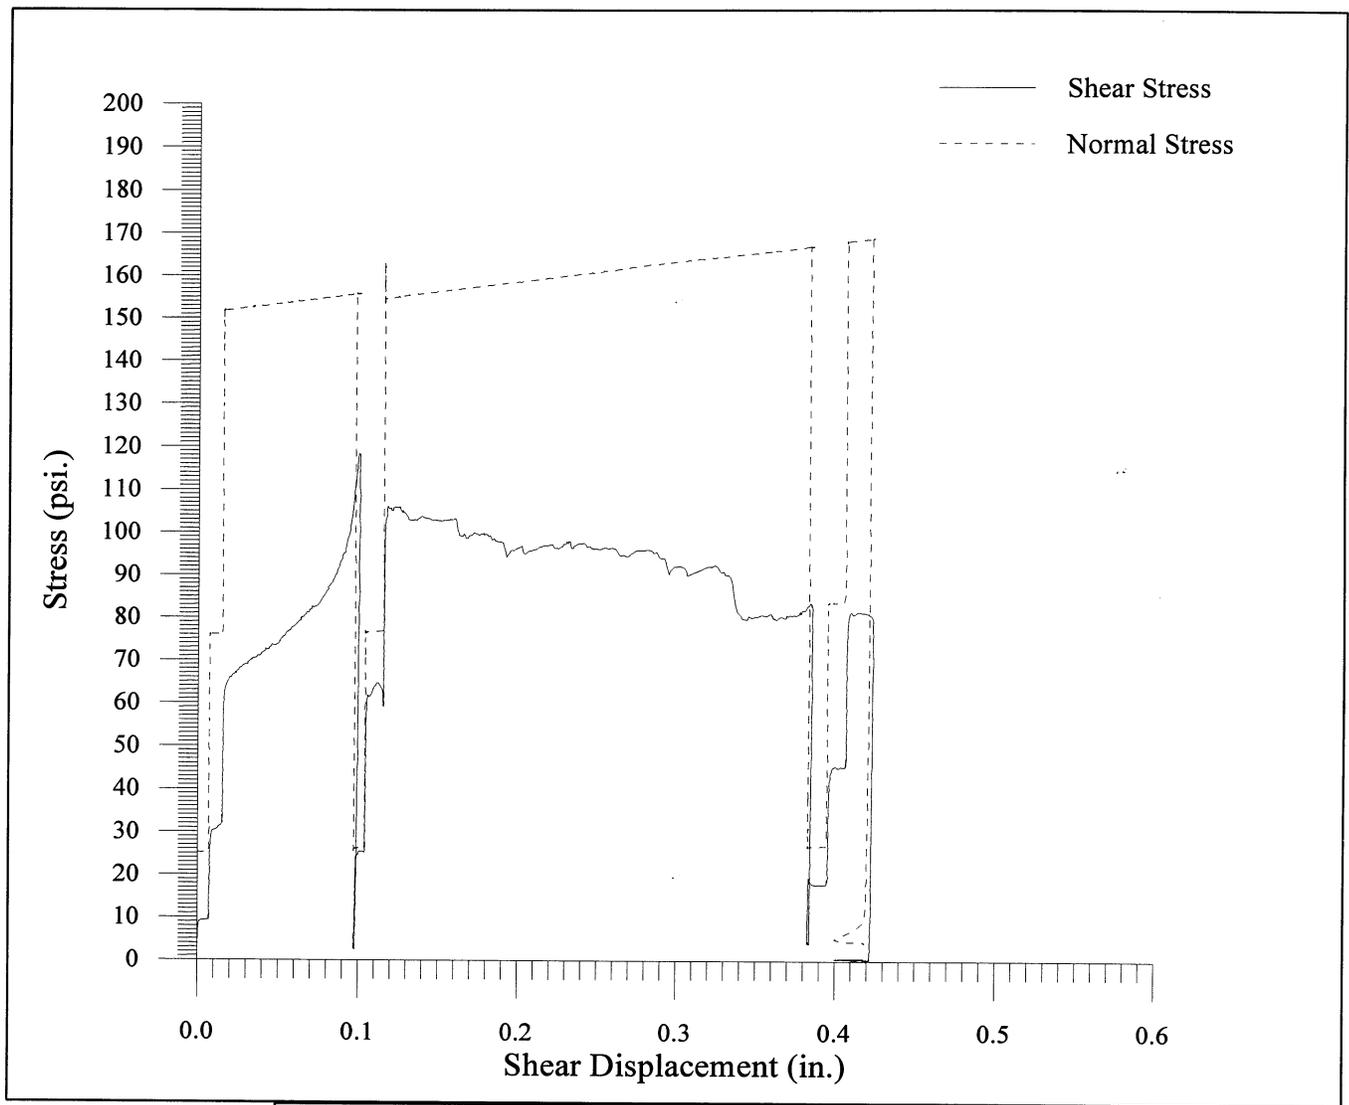
**DIRECT SHEAR TEST**  
**Shear and Normal Stress vs. Shear Displacement**

**SAMPLE ID:** Boring: 98-23  
 Sample: 30a  
 Depth: 128'

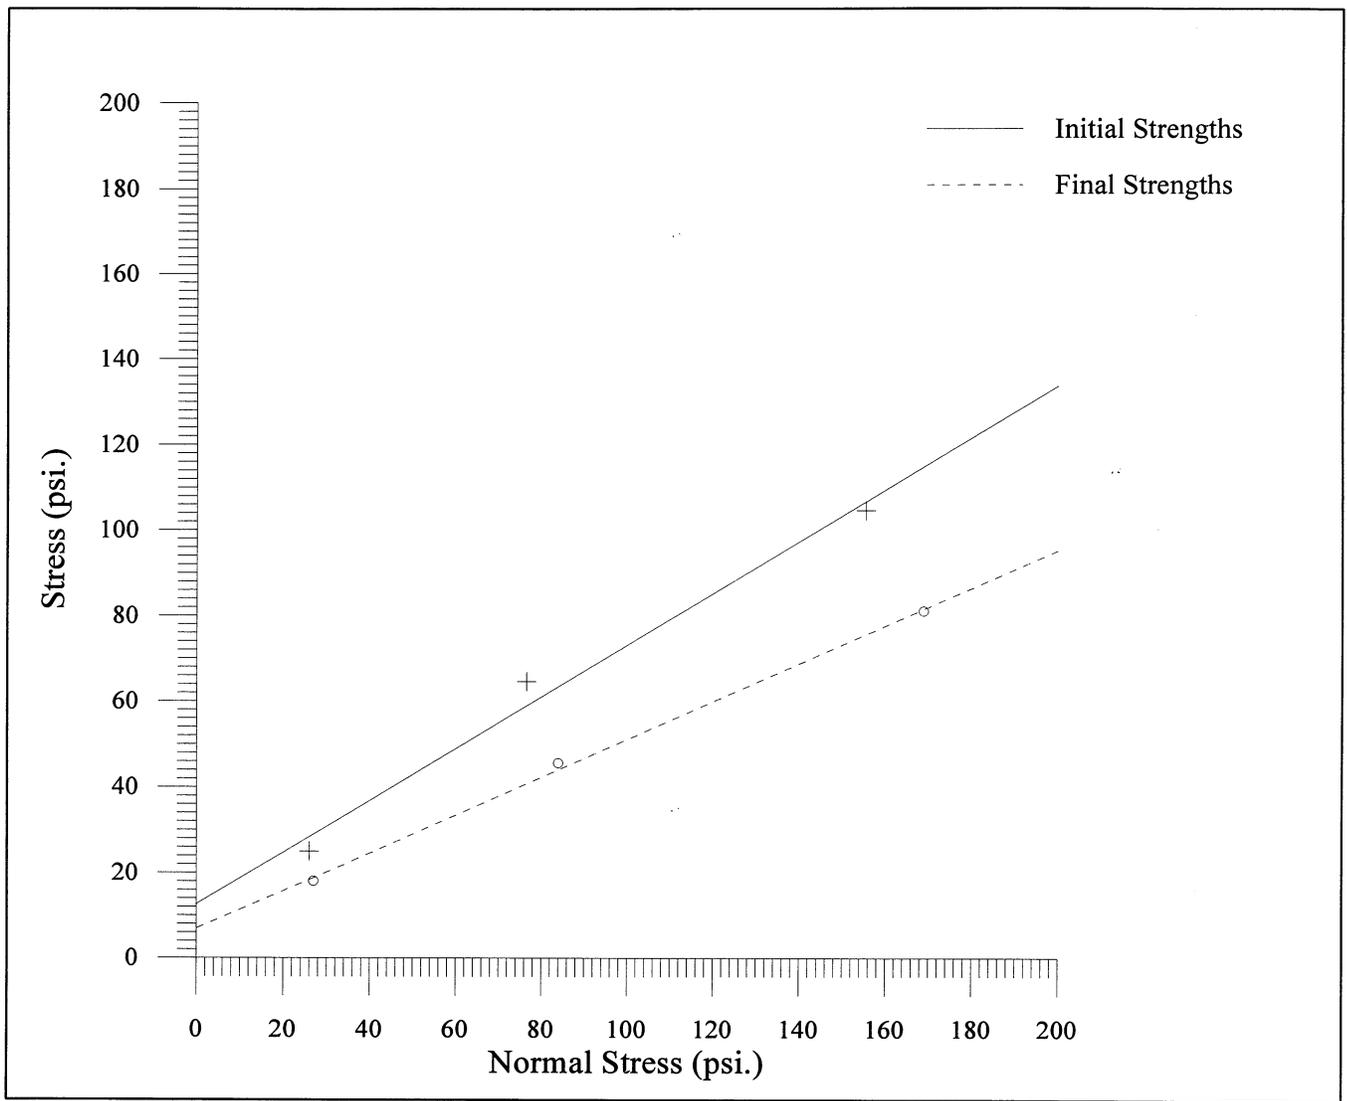
**DIRECT SHEAR TEST  
Failure Envelope**

<p><b>SAMPLE ID:</b> Boring: 98-23 Sample: 30a Depth: 128'</p> <p align="center"><b>DESCRIPTION</b></p> <p>Slightly wavy joint in medium dark gray fine sandy siltstone.</p>		<p>800 Peralta Ave San Leandro, CA 94577</p>

Shear Intercept (psi)	Friction Angle (degrees)	Initial	12.7	31.1	Final	6.9	23.8
	Shear Intercept (psi)	Friction Angle (degrees)								
Initial	12.7	31.1								
Final	6.9	23.8								
		<p><b>Test Date:</b> October 30, 1998</p>

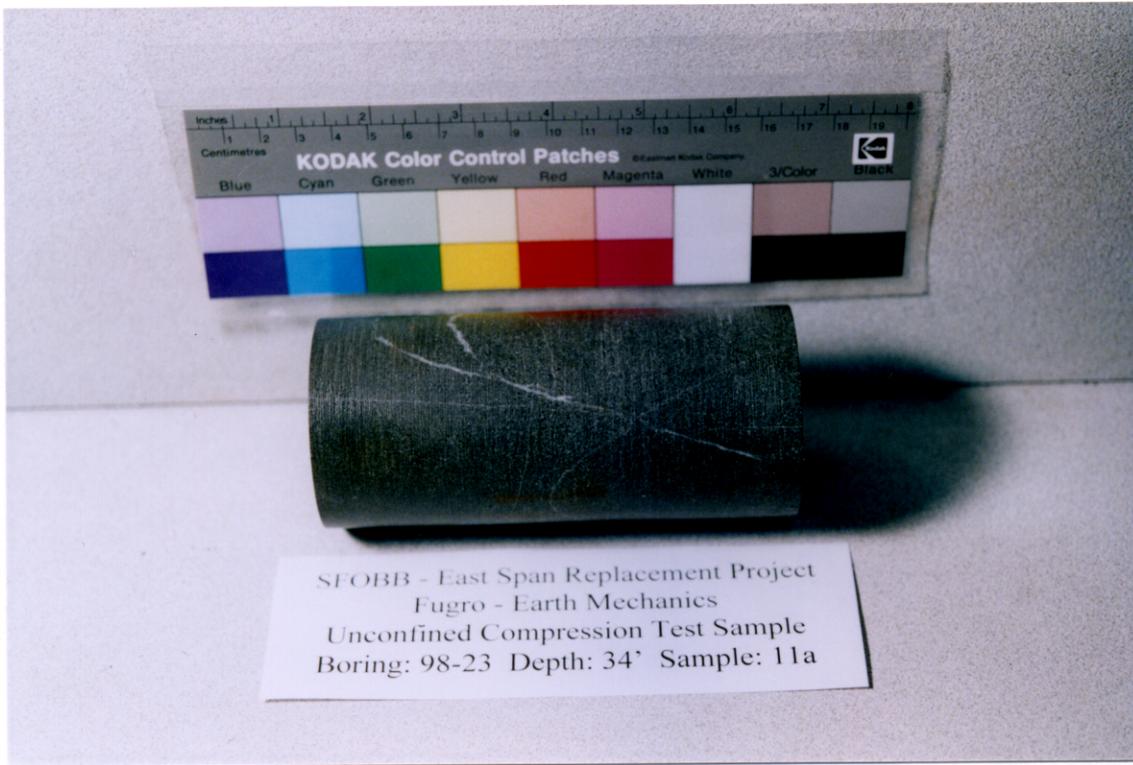
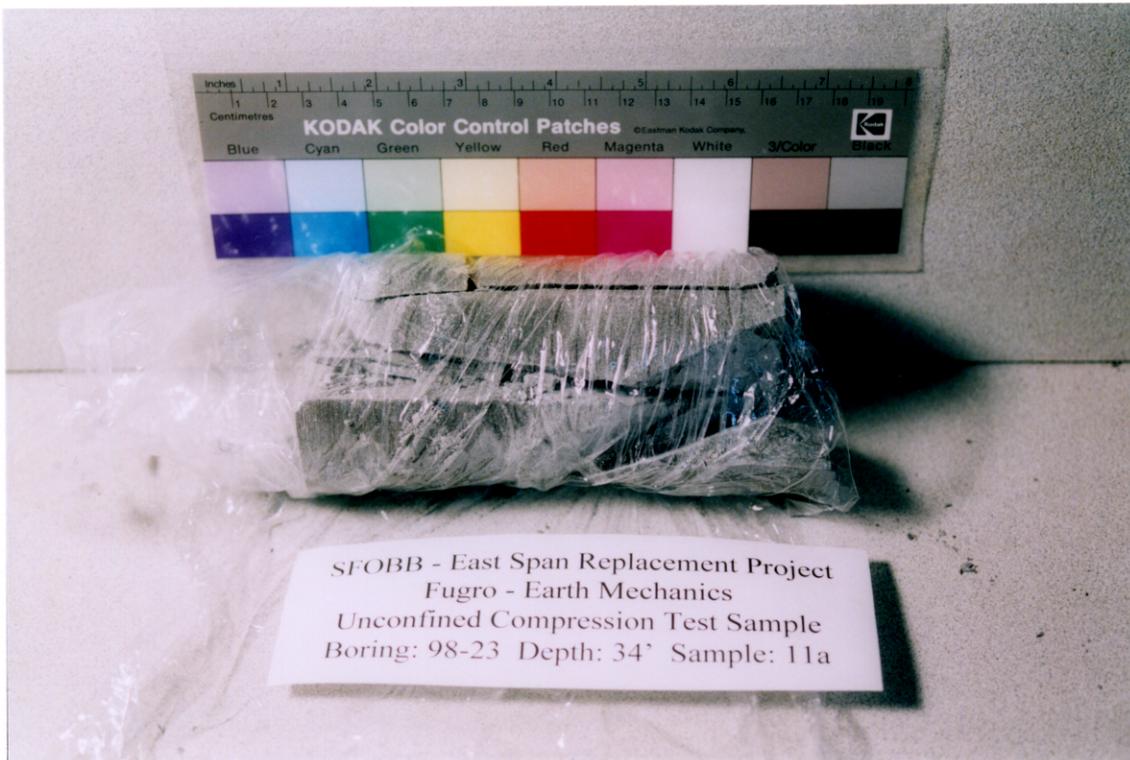
SFOBB - East Span Replacement Project  
Fugro - Earth Mechanics  
Unconfined Compression Test Sample  
Boring: 98-23 Depth: 34' Sample: 11a

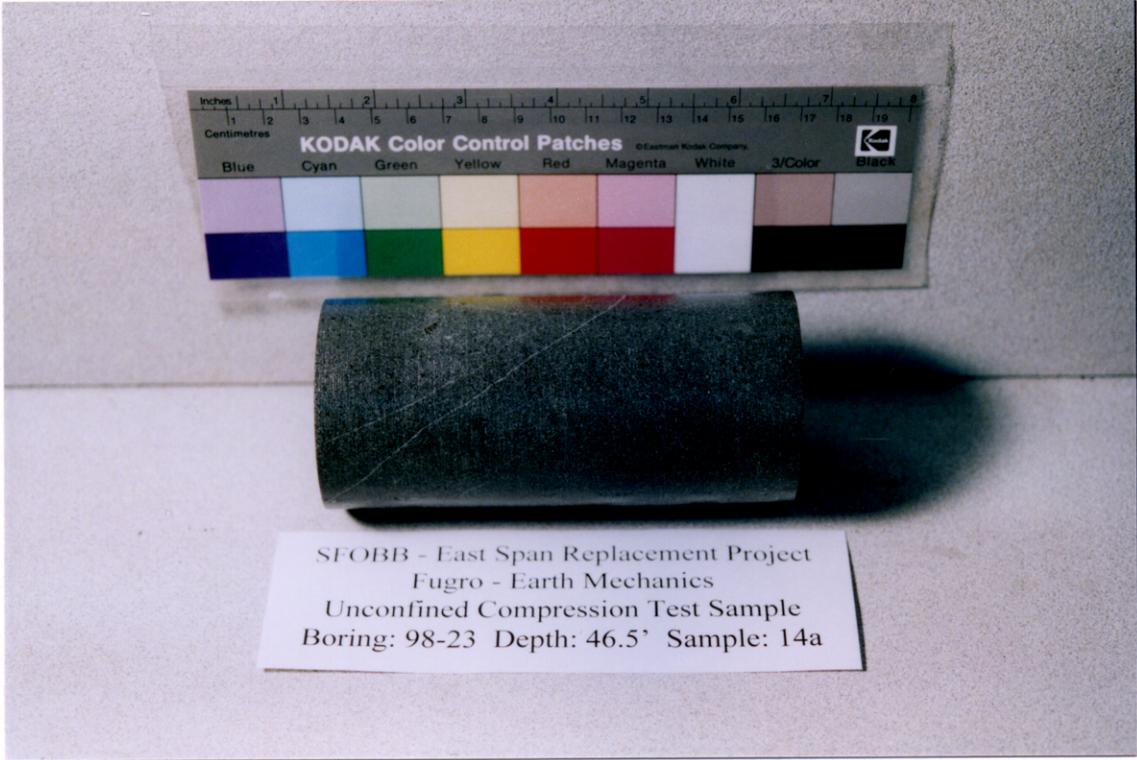
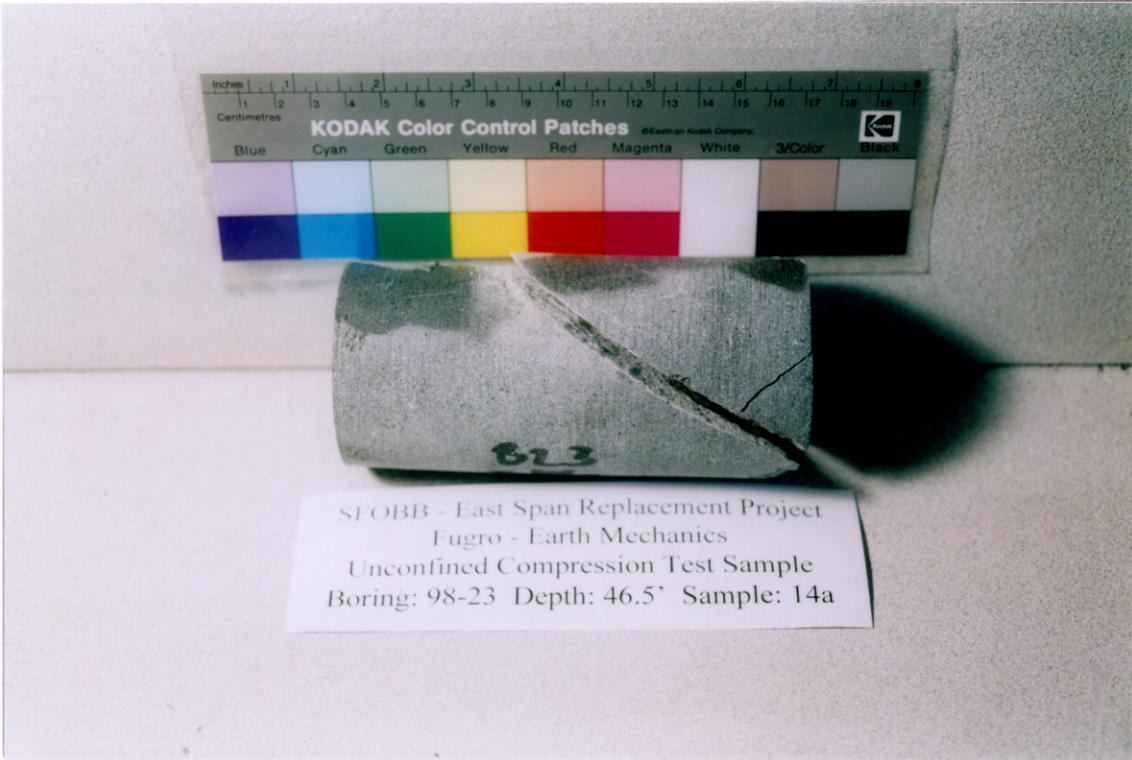
SFOBB - East Span Replacement Project  
Fugro - Earth Mechanics  
Unconfined Compression Test Sample  
Boring: 98-23 Depth: 46.5' Sample: 14a

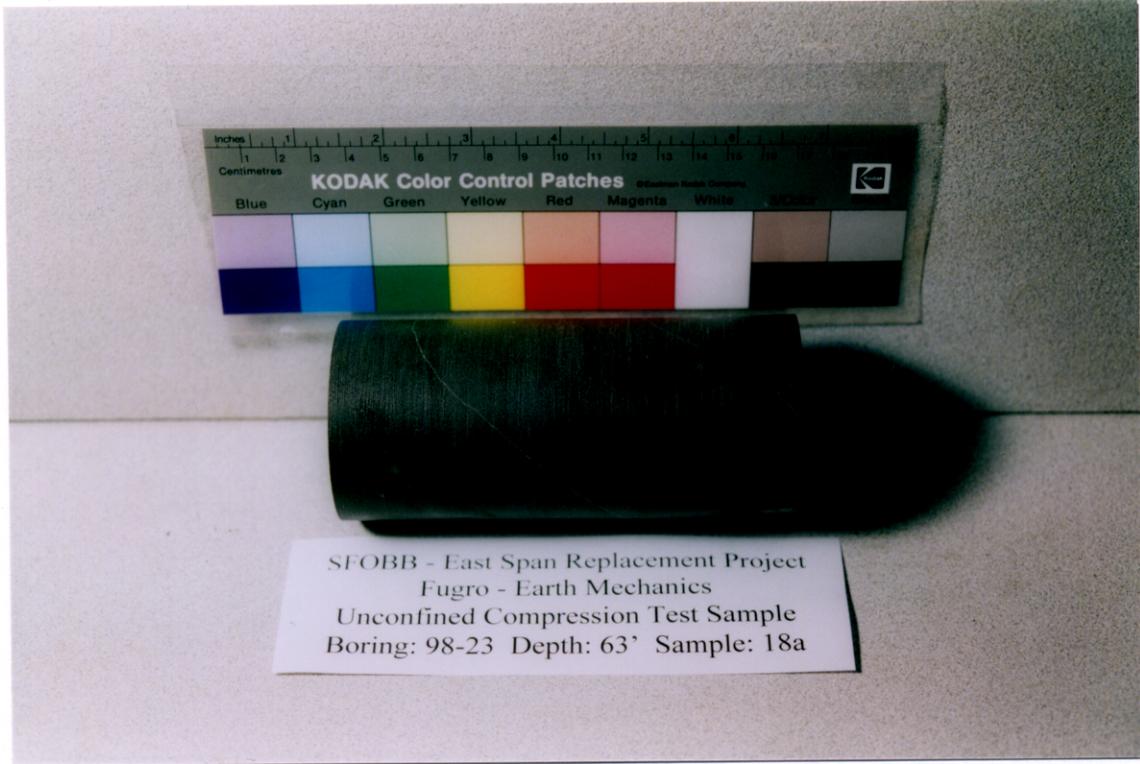
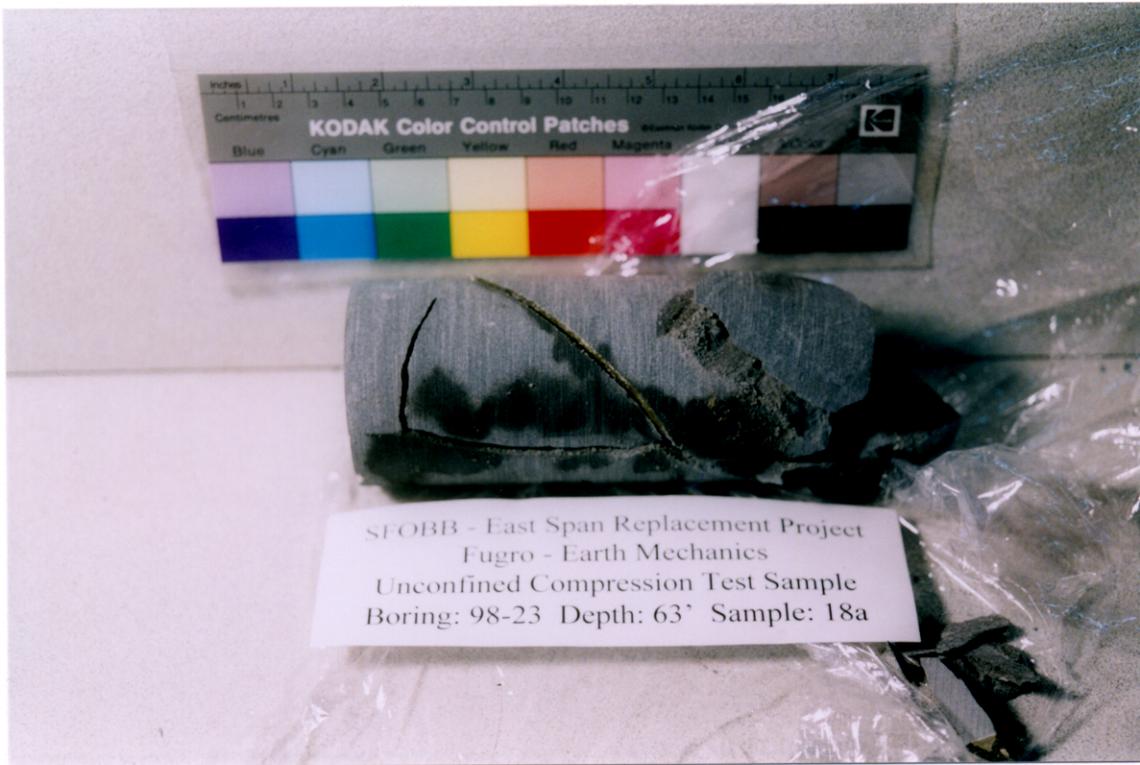
SFOBB - East Span Replacement Project  
Fugro - Earth Mechanics  
Unconfined Compression Test Sample  
Boring: 98-23 Depth: 63' Sample: 18a

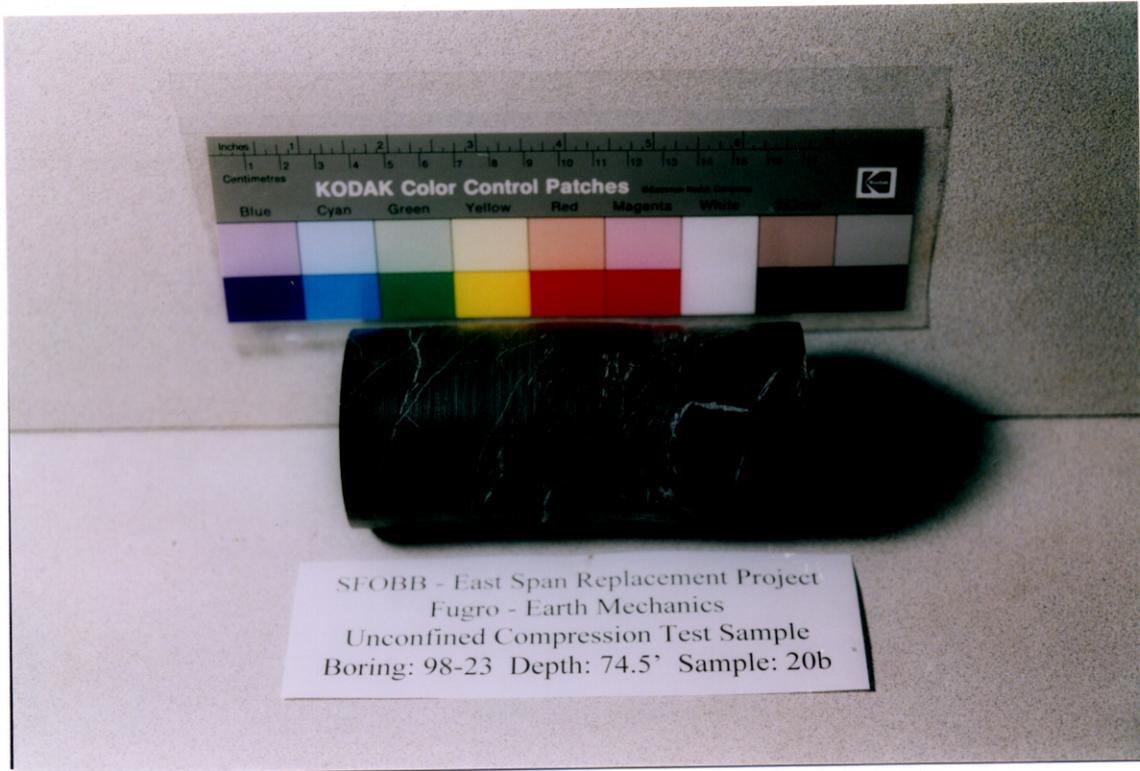
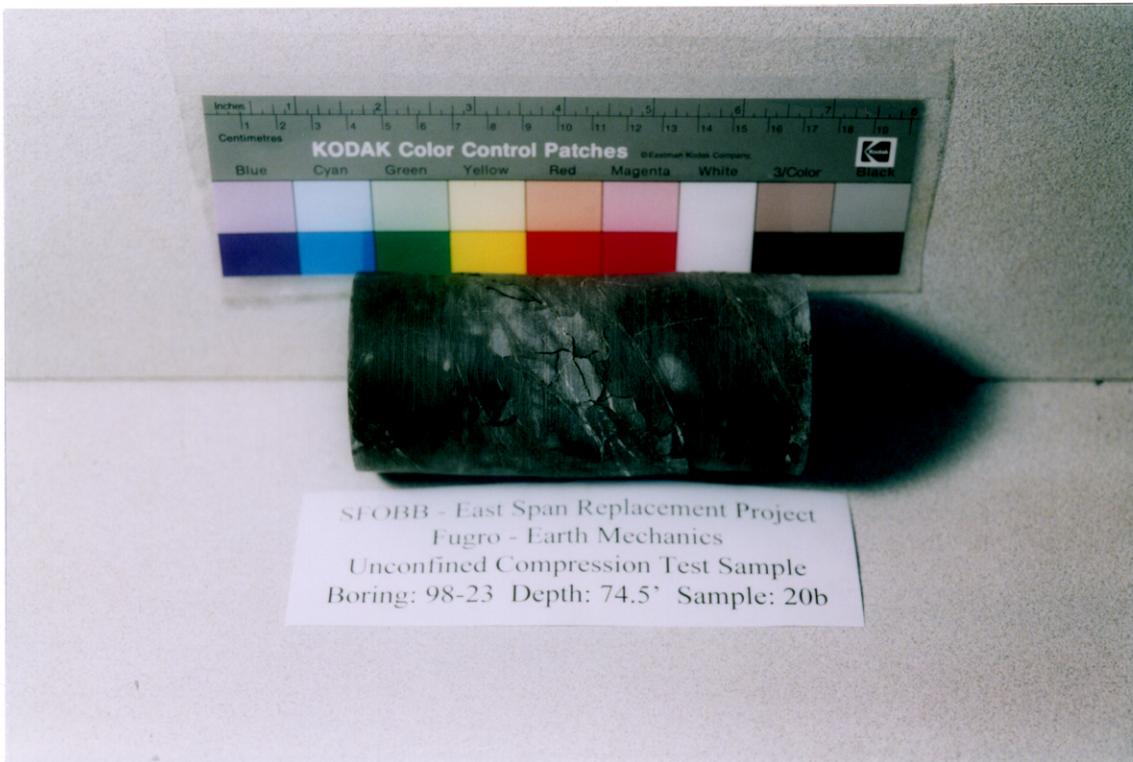
SFOBB - East Span Replacement Project  
Fugro - Earth Mechanics  
Unconfined Compression Test Sample  
Boring: 98-23 Depth: 74.5' Sample: 20b

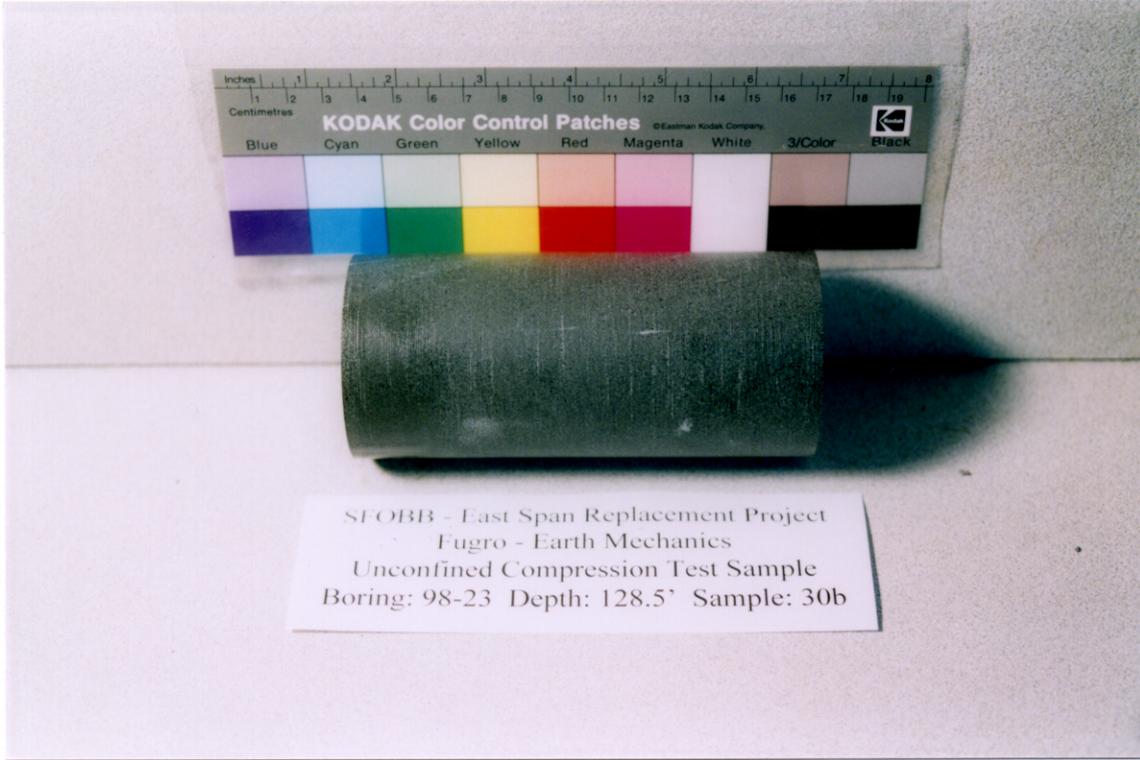
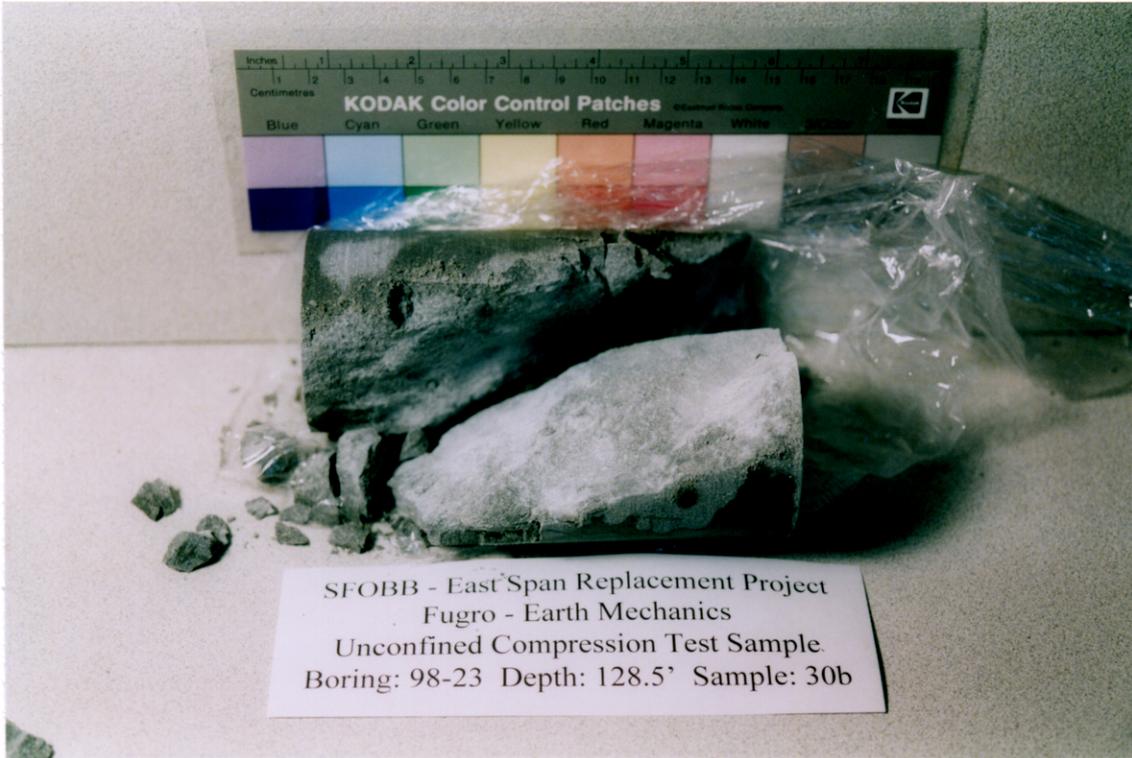
SFOBB - East Span Replacement Project  
Fugro - Earth Mechanics  
Unconfined Compression Test Sample  
Boring: 98-23 Depth: 128.5' Sample: 30b

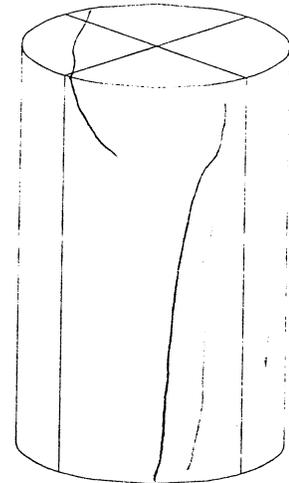
Sample Description: Medium gray sandstone with a small amount of calcite veiled axial fractures

Sample Depth: 11.7m (38.5') Sample Condition: received & tested moist

Comments: Failed by shear and mainly axial splitting along existing joints.

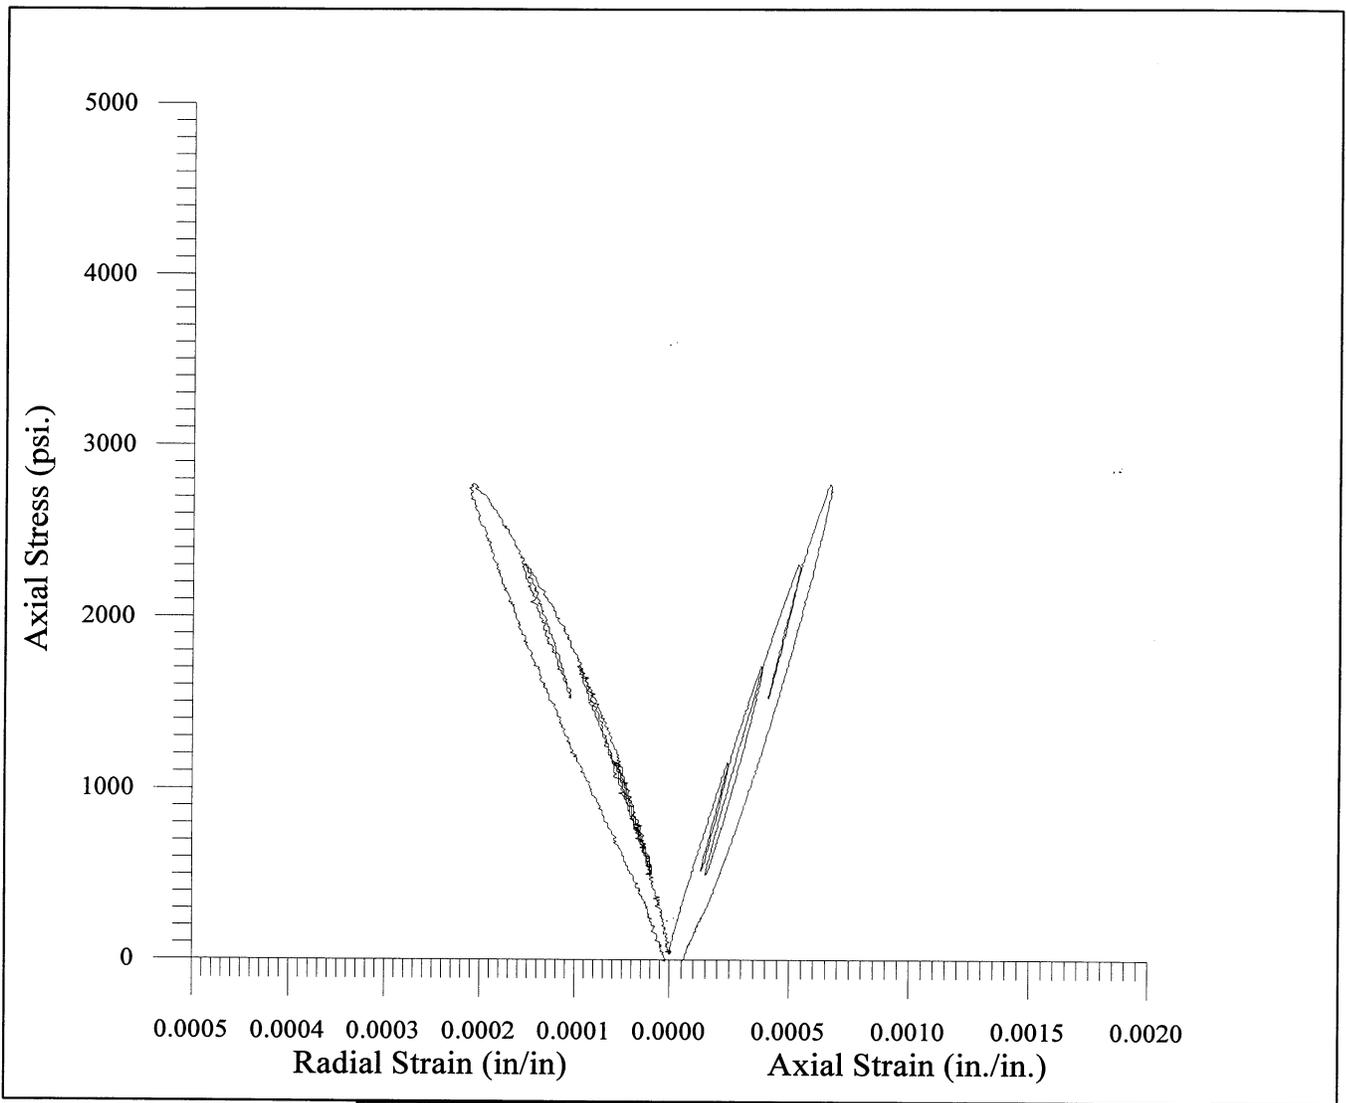
**ELASTIC MODULUS TEST**  
**Axial Stress vs. Axial & Radial Strain**

**SAMPLE ID:** Boring: 98-24  
 Sample: 12a  
 Depth: 38.5'

**DESCRIPTION**  
 Medium gray sandstone with a small swarm of calcite healed axial fractures.

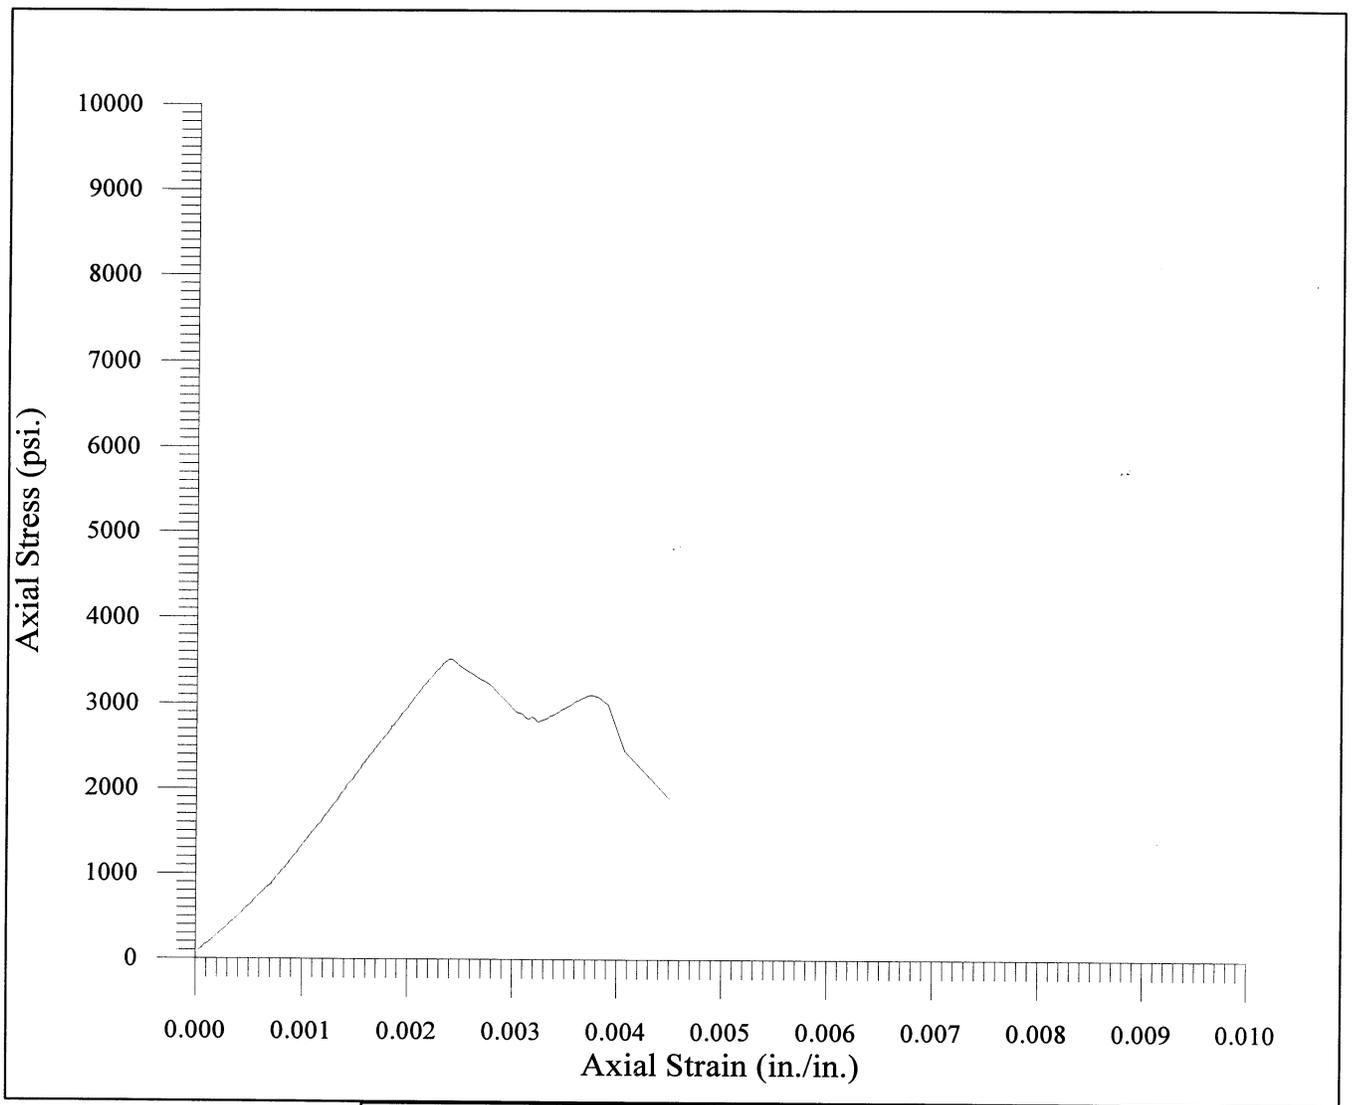
**UNCONFINED COMPRESSION TEST**  
**Axial Stress vs. Axial Strain**

<p><b>SAMPLE ID:</b> Boring : 98-24  Sample: 12a  Depth: 38.5'</p> <p align="center"><b>DESCRIPTION</b></p> <p>Medium gray sandstone with a small swarm of calcite healed axial fractures.</p> <p><b>STRENGTH:</b> 3521 psi</p>	<p><i>Geo</i>

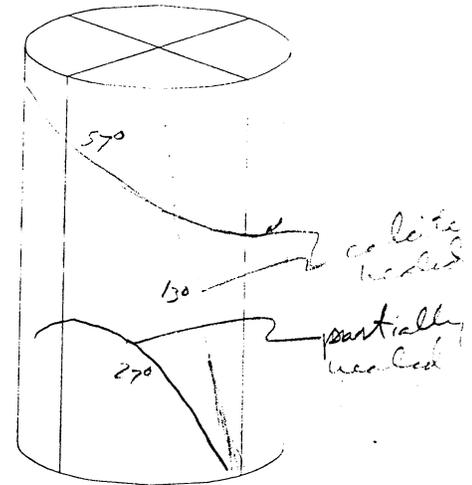
Sample Description: Medium gray sandstone, with partially healed calcite healed fractures 27, 13°, & 57° to core axis

Sample Depth: 13.7m (45') Sample Condition: received & tested moist

Comments: Failed by splitting on steeply inclined joint -

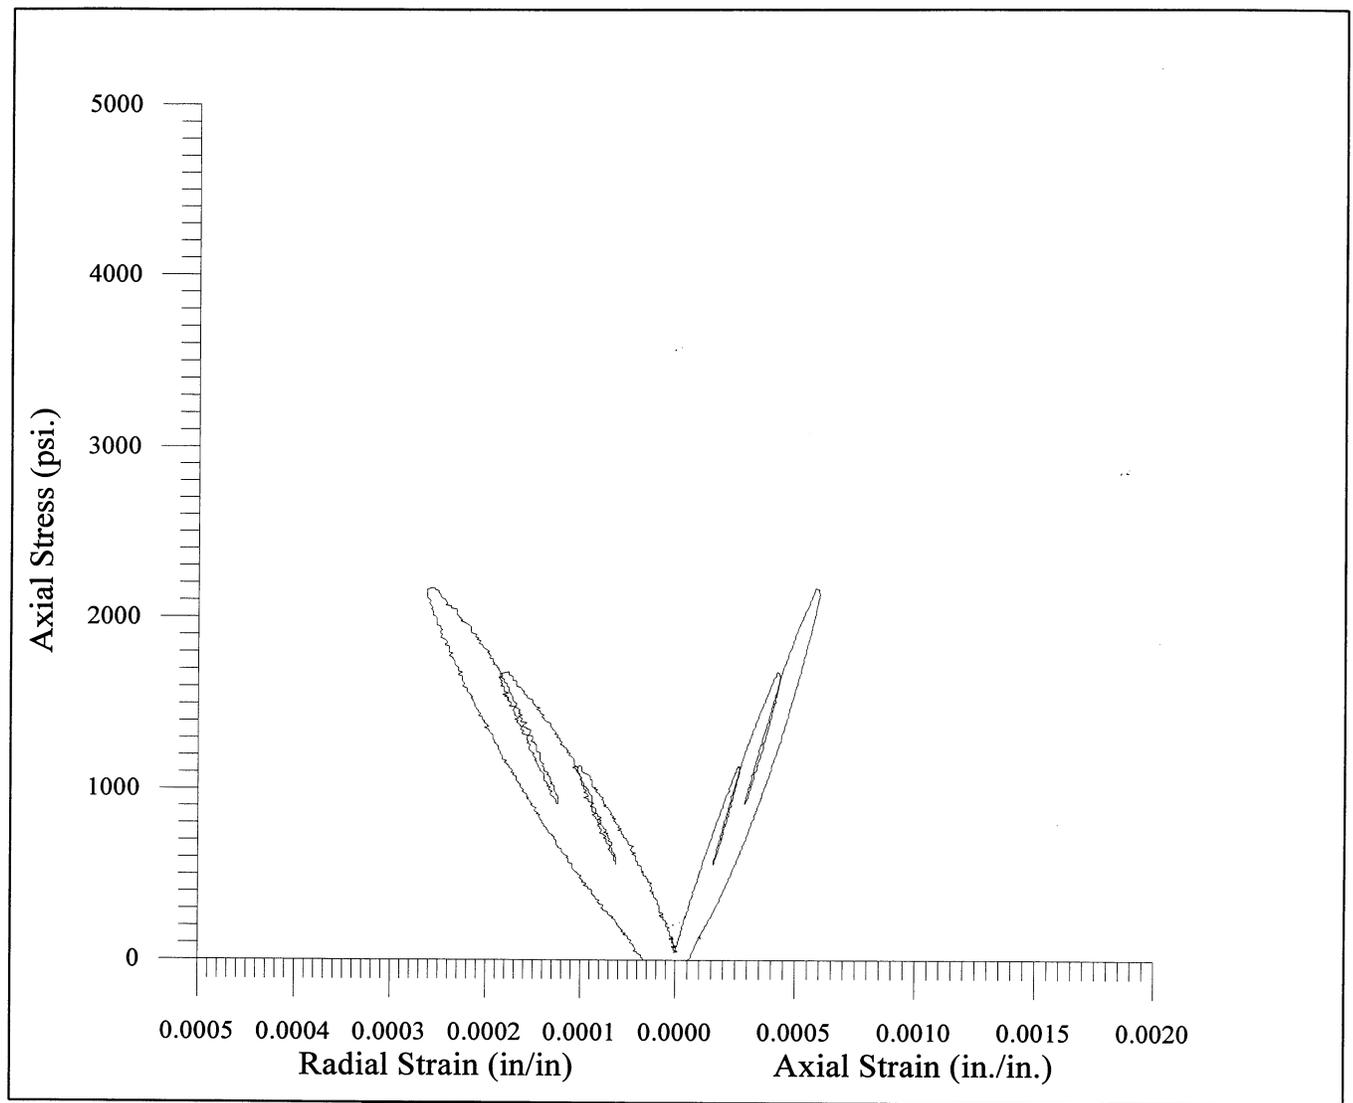
**ELASTIC MODULUS TEST**  
**Axial Stress vs. Axial & Radial Strain**

**SAMPLE ID:** Boring: 98-24  
 Sample: 13a  
 Depth: 45'

Medium gray sandstone with partially healed and calcite healed fractures, 13, 27, and 57 degrees to the core axis.
