**SUBCONTRACTOR REPORTS  
FINAL GEOTECHNICAL  
SITE CHARACTERIZATION**

**SAN FRANCISCO-OAKLAND BAY BRIDGE  
EAST SPAN SEISMIC SAFETY PROJECT**

**VOLUME 2 OF 3  
(GeoTest Unlimited)**

Letter Report  
San Francisco Oakland Bay Bridge  
East Span Replacement Project  
Rock Testing Program

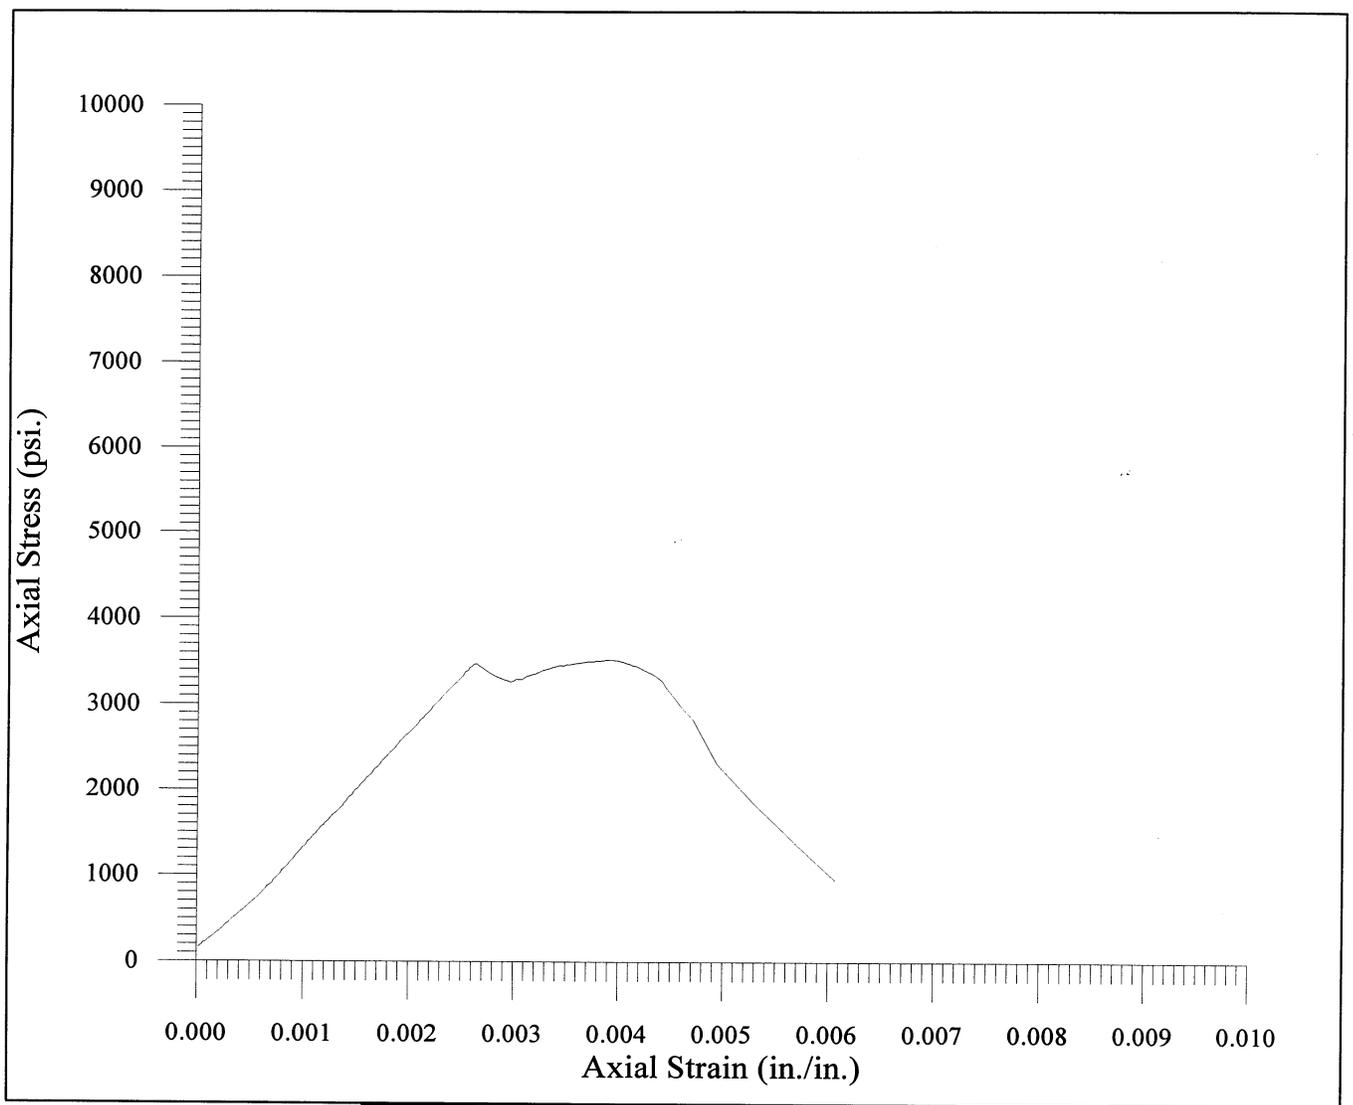
**UNCONFINED COMPRESSION TEST**  
**Axial Stress vs. Axial Strain**

**SAMPLE ID:** Boring : 98-24  
 Sample: 13a  
 Depth: 45'

Medium gray sandstone with partially healed and calcite healed fractures, 13, 27, and 57 degrees to the core axis.

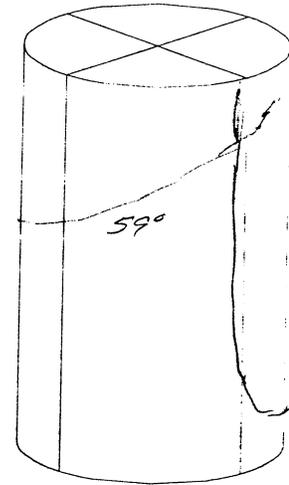
Sample Description: Dark gray siltstone with many hairline fractures and two calcite healed fractures 59° and 0° to core axis.

Sample Depth: 15.9 m (52') Sample Condition: received & tested moist

Comments: \*End needed to be capped w/ hydrostone  
This is NOT ASTM!

In modulus test, 1 axial & 1 radial gauge registered failure at low axial loads. Nice demonstration of behavior non-homogeneity.

Failed along existing joints, generally splitting w/a little shear on suitably oriented joints.

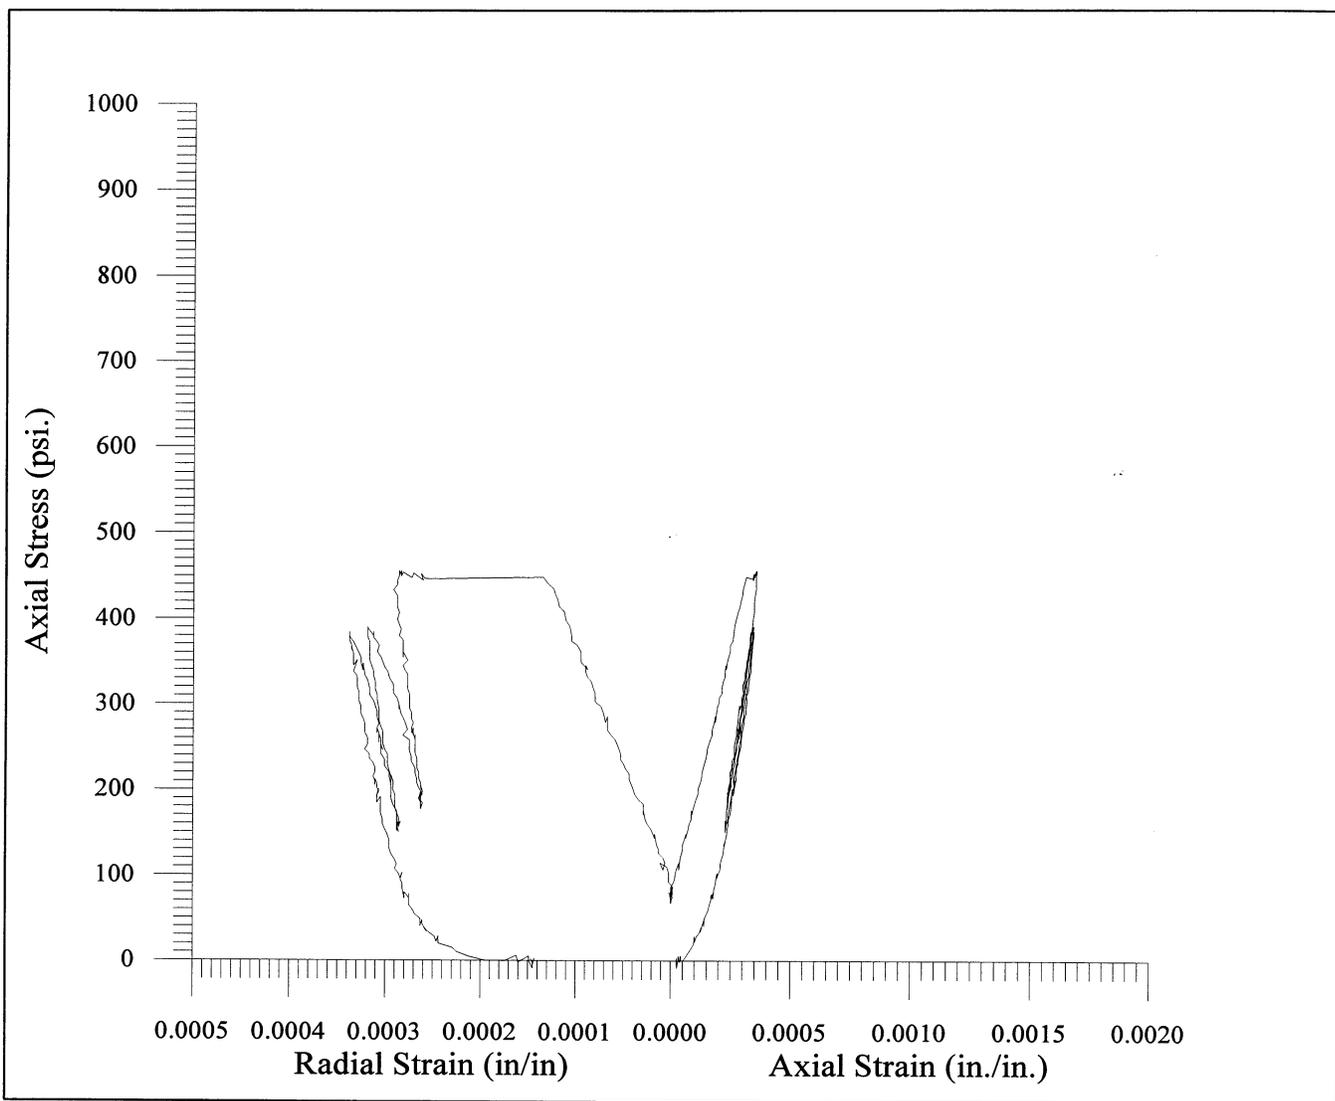
**ELASTIC MODULUS TEST**  
**Axial Stress vs. Axial & Radial Strain**

**SAMPLE ID:** Boring: 98-24  
 Sample: 14a  
 Depth: 52'

**DESCRIPTION**  
 Dark gray siltstone and claystone with many hairline fractures and two calcite healed fractures 0 and 59 degrees to the core axis.

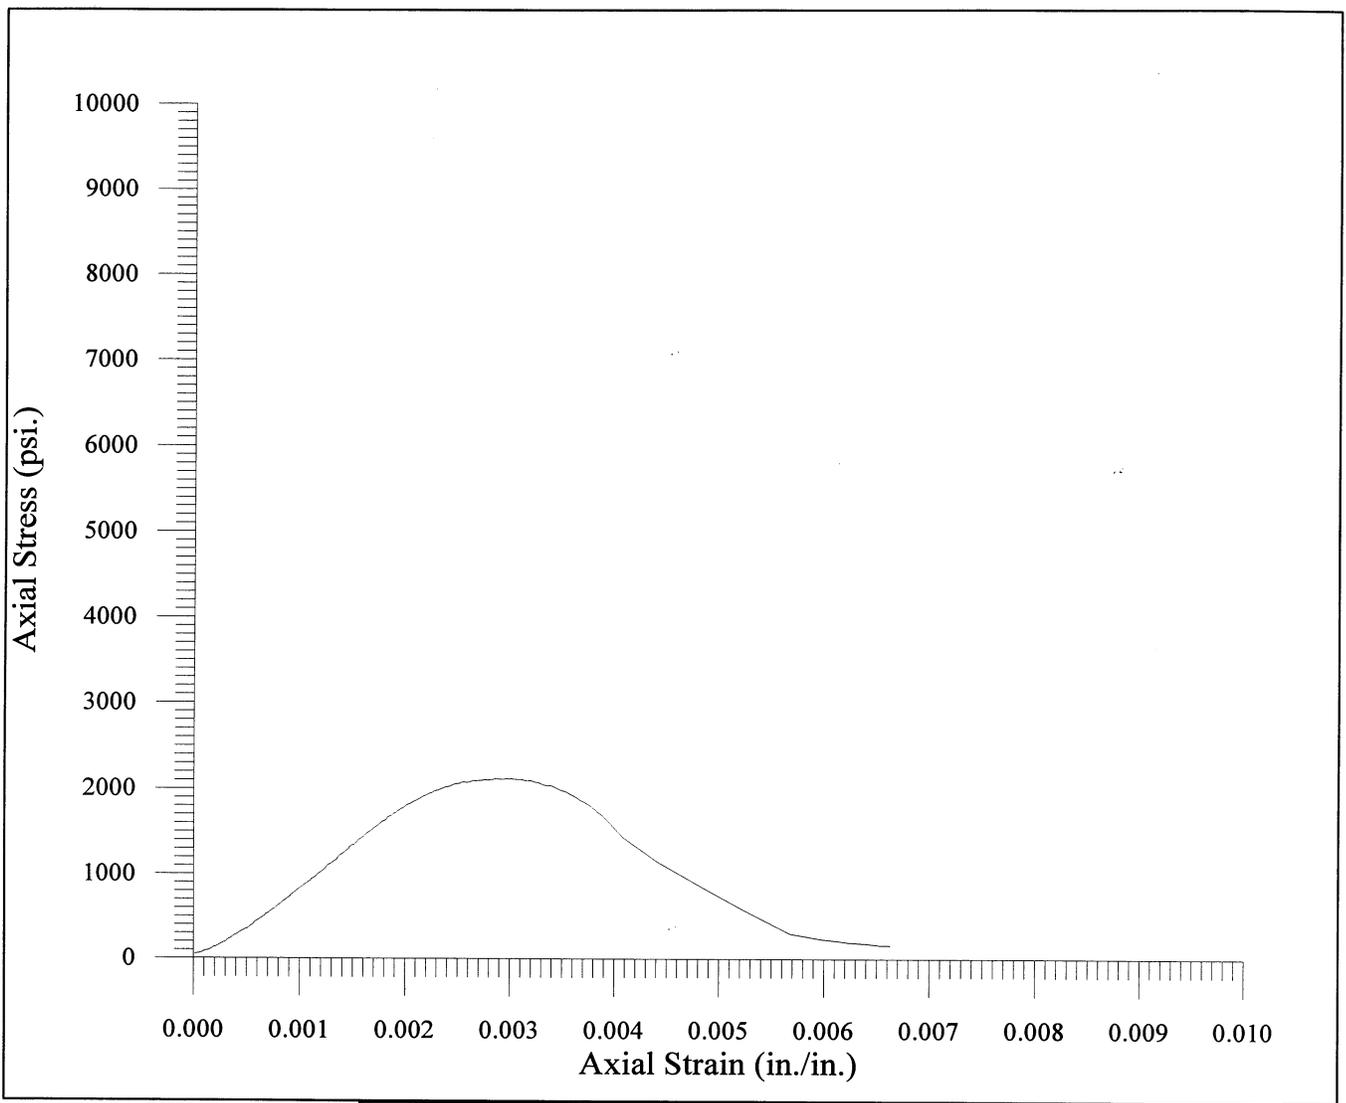
**UNCONFINED COMPRESSION TEST**  
**Axial Stress vs. Axial Strain**

**SAMPLE ID:** Boring : 98-24  
 Sample: 14a  
 Depth: 52'

Dark gray siltstone and claystone with many hairline fractures and two calcite healed fractures 0 and 59 degrees to the core axis.

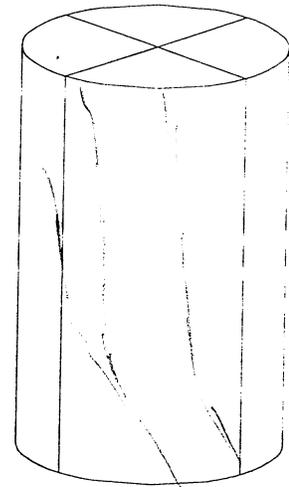
Sample Description: Medium gray sandstone with many calcite healed fractures (hairline to 3/16" wide) 45° to parallel the core axis

Sample Depth: 16.5m (54') Sample Condition: received & tested moist

Comments: failed by wedge shear on existing joints (steeply inclined)

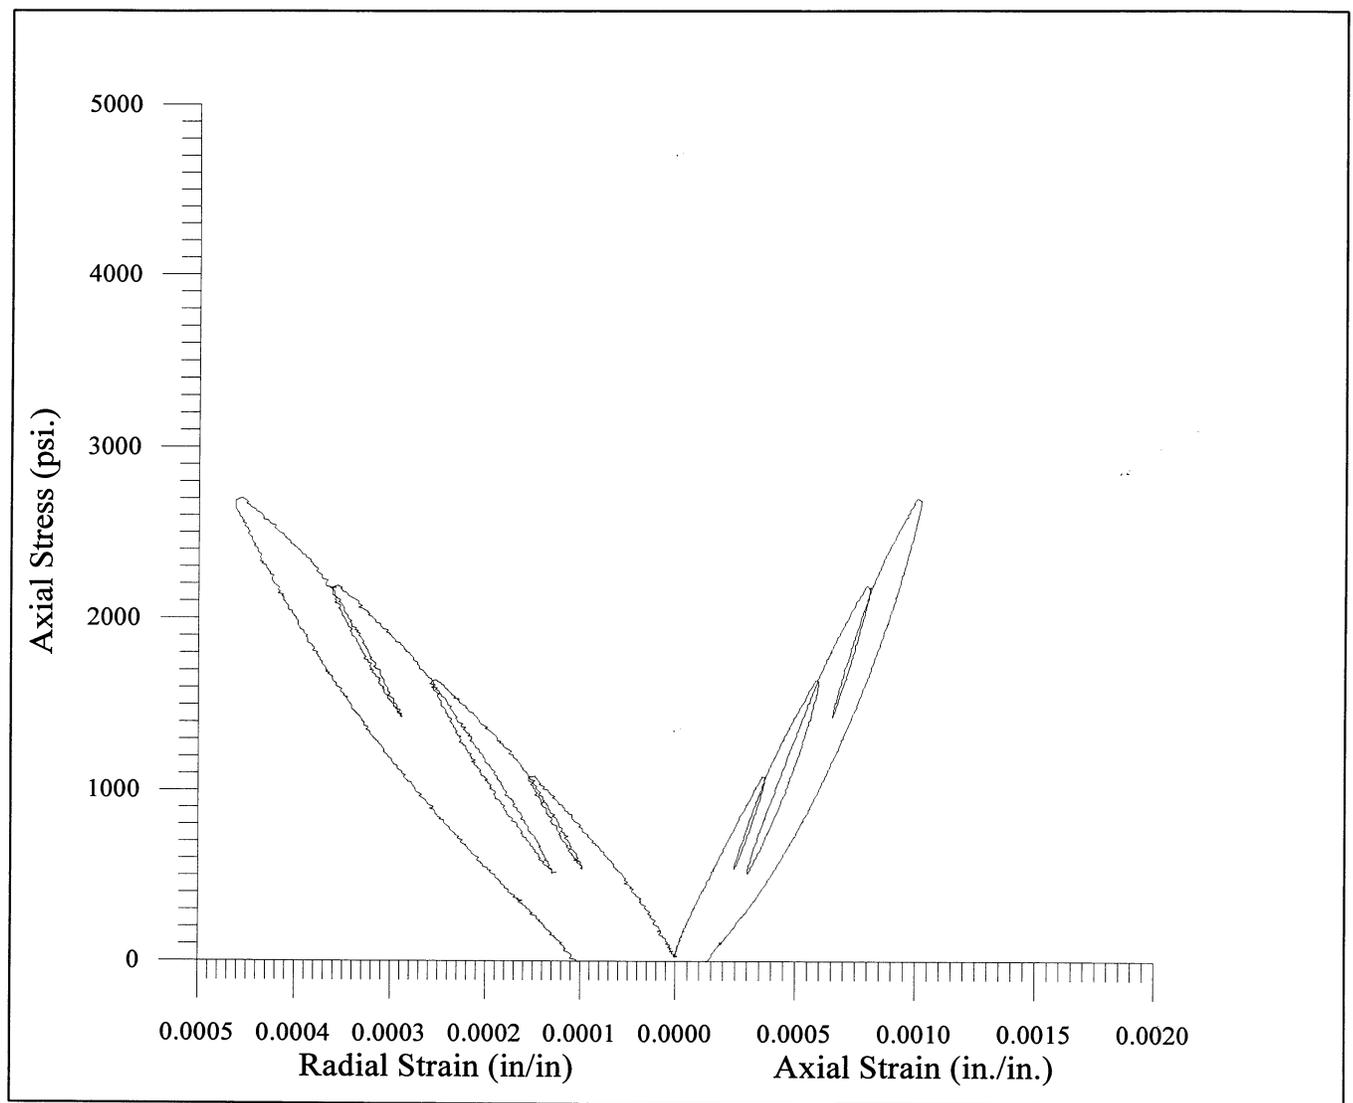
**ELASTIC MODULUS TEST**  
**Axial Stress vs. Axial & Radial Strain**

**SAMPLE ID:** Boring: 98-24  
 Sample: 15a  
 Depth: 54'

**DESCRIPTION**  
 Medium gray sandstone with with many calcite healed fractures (hairline to 3/16 inch wide) 0 to 45 degrees to the core axis.

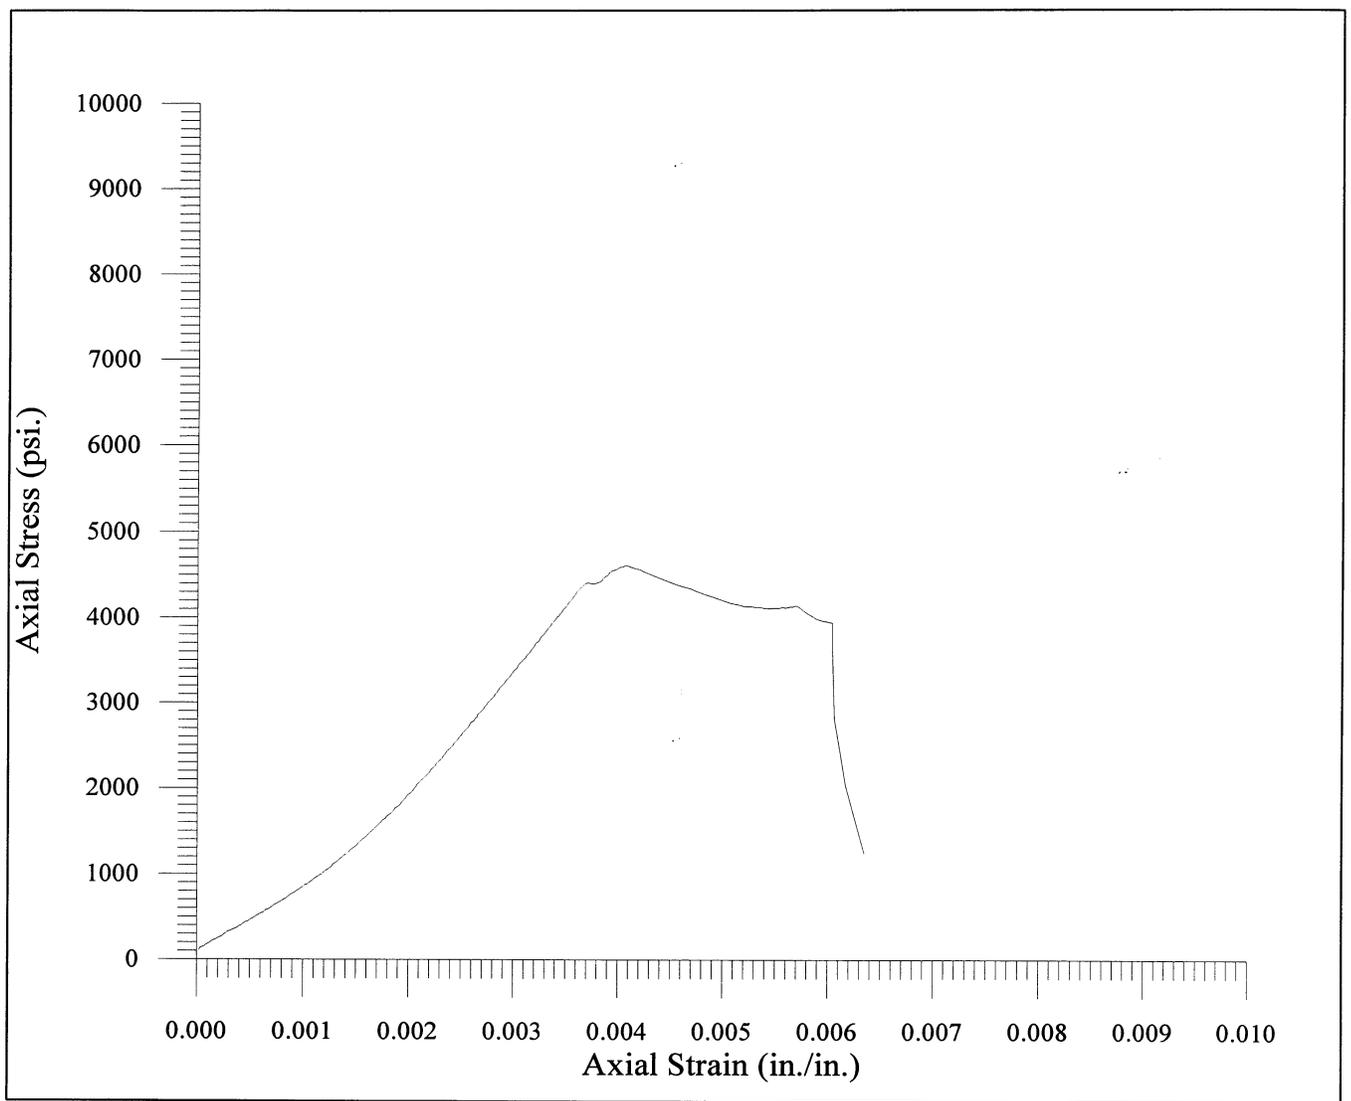
**UNCONFINED COMPRESSION TEST**  
**Axial Stress vs. Axial Strain**

<p><b>SAMPLE ID:</b> Boring : 98-24  Sample: 15a  Depth: 54'</p> <p align="center"><b>DESCRIPTION</b></p> <p>Medium gray sandstone with many calcite healed fractures (hairline to 3/6 inch wide) 0 to 45 degrees to the core axis.</p> <p><b>STRENGTH:</b> 4610 psi</p>	<p align="center"> <i>Geo</i>

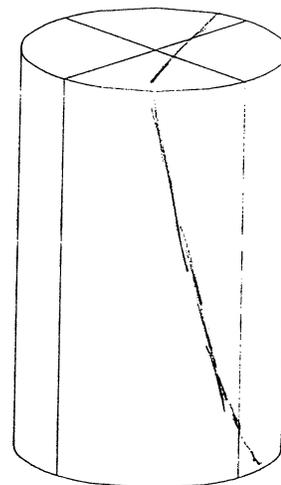
Sample Description: medium gray sandstone with a small claystone inclusion and a calcite healed hairline fracture ~10° to core axis

Sample Depth: 18.1m (59.5') Sample Condition: received & tested moist

Comments: shear failure along existing healed joint.

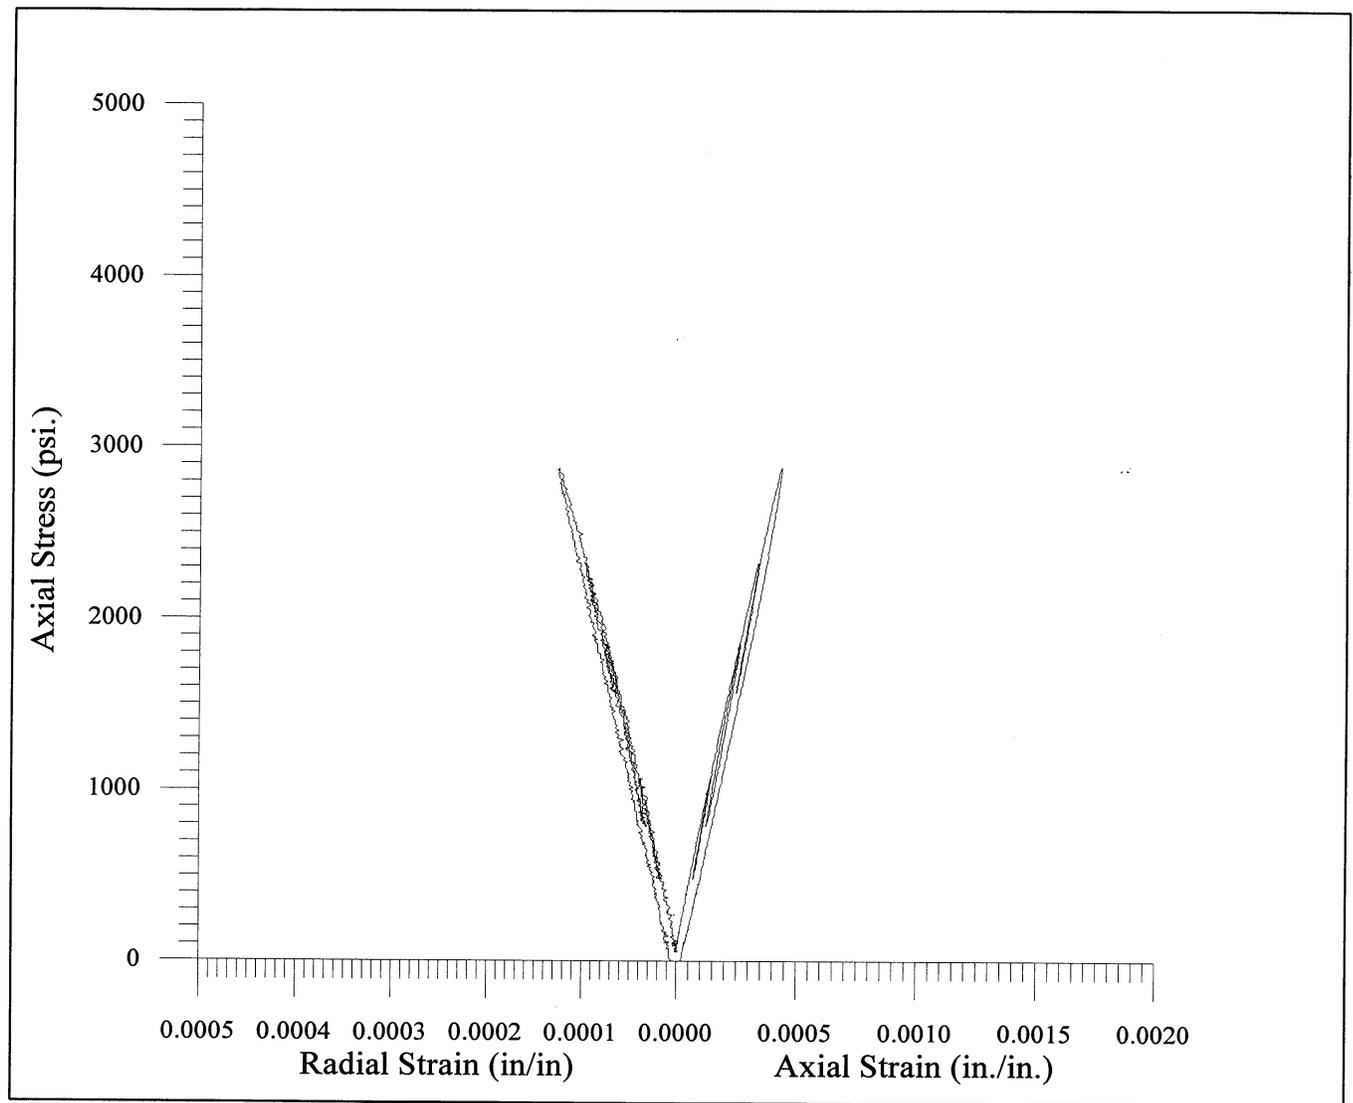
**ELASTIC MODULUS TEST**  
**Axial Stress vs. Axial & Radial Strain**

<p><b>SAMPLE ID:</b> Boring: 98-24  Sample: 16a  Depth: 59.5'</p> <p style="text-align: center;"><b>DESCRIPTION</b></p> <p>Medium gray sandstone with a small claystone inclusion and a calcite healed hairline fracture about 10 degrees to the core axis.</p> <p><b>MODULUS:</b> 8,060,000 psi  <b>POISSON'S RATIO:</b> .32</p>	<div style="text-align: center;">

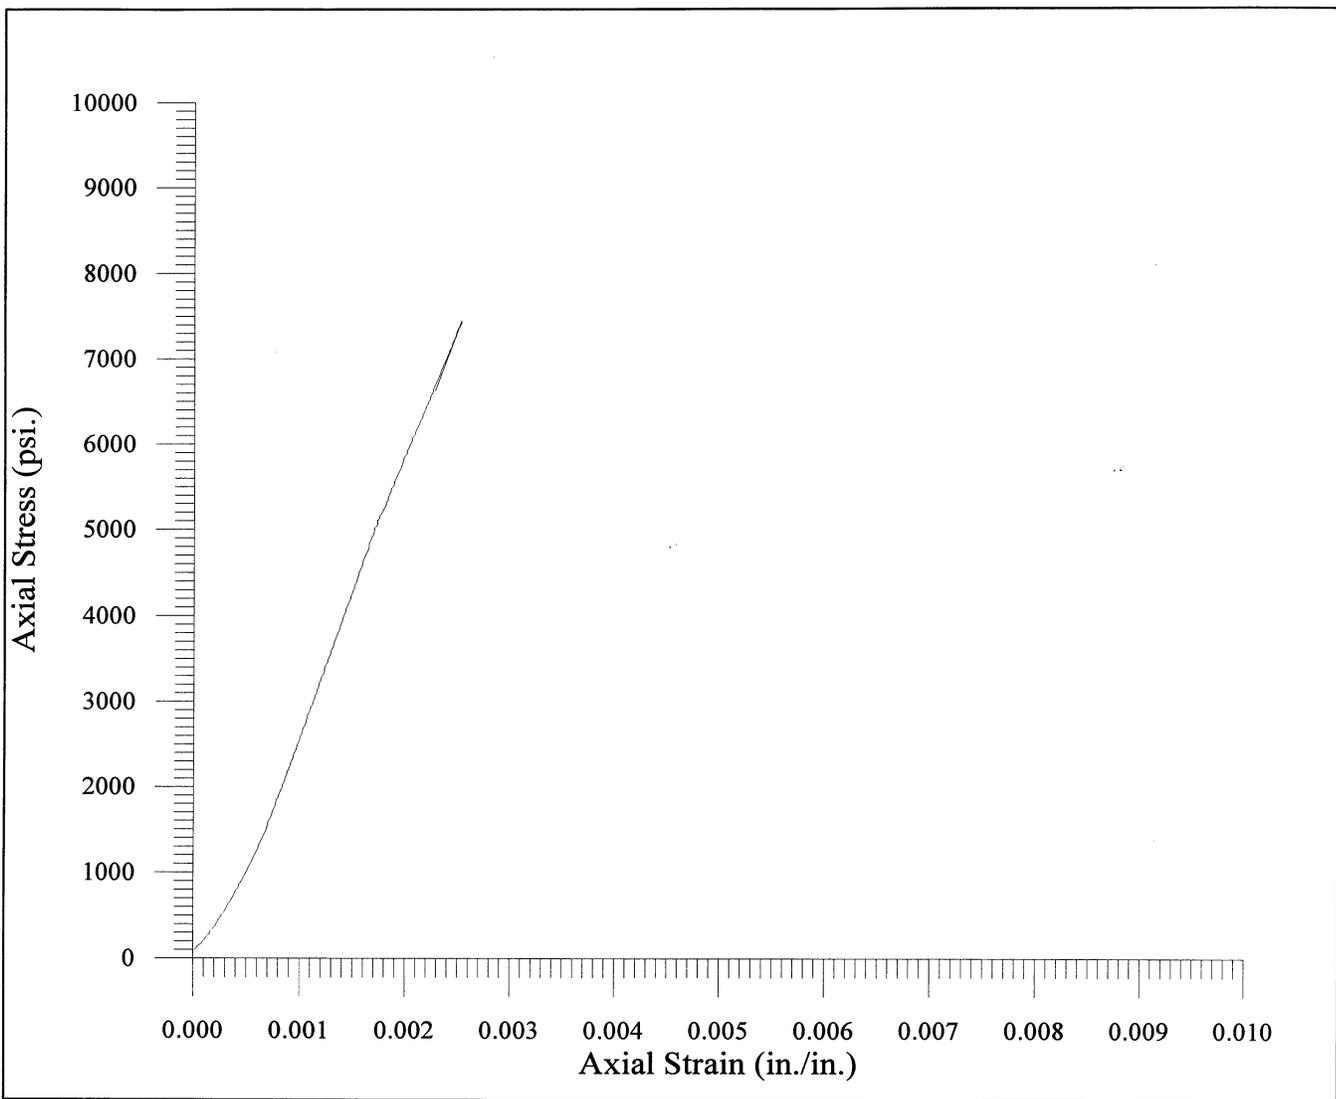
**UNCONFINED COMPRESSION TEST**  
**Axial Stress vs. Axial Strain**

**SAMPLE ID:** Boring : 98-24  
 Sample: 16a  
 Depth: 59.5'

Medium gray sandstone with a small claystone inclusion and a calcite healed hairline fracture about 10 degrees to the core axis.

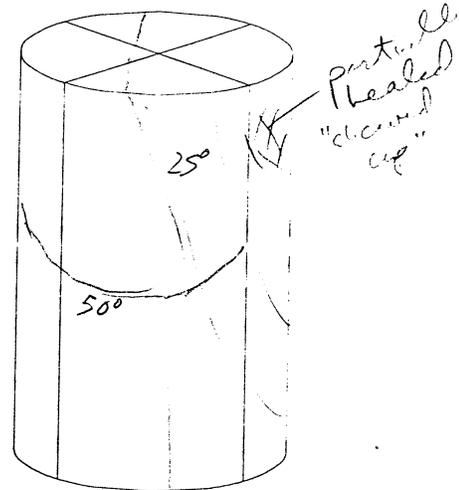
Sample Description: medium gray sandstone with partially healed and calcite healed fractures generally 25° to core axis. (1-50° to core axis.)

Sample Depth: 23.0m (75.5') Sample Condition: received & tested moist

Comments: due to joints, quite unequal E<sub>o1</sub> & E<sub>o2</sub> E<sub>o1</sub> ≈ 2 × E<sub>o2</sub> may be starting to fail at end of mod. test.

Failed by shear in partially healed zone along 25° joints.

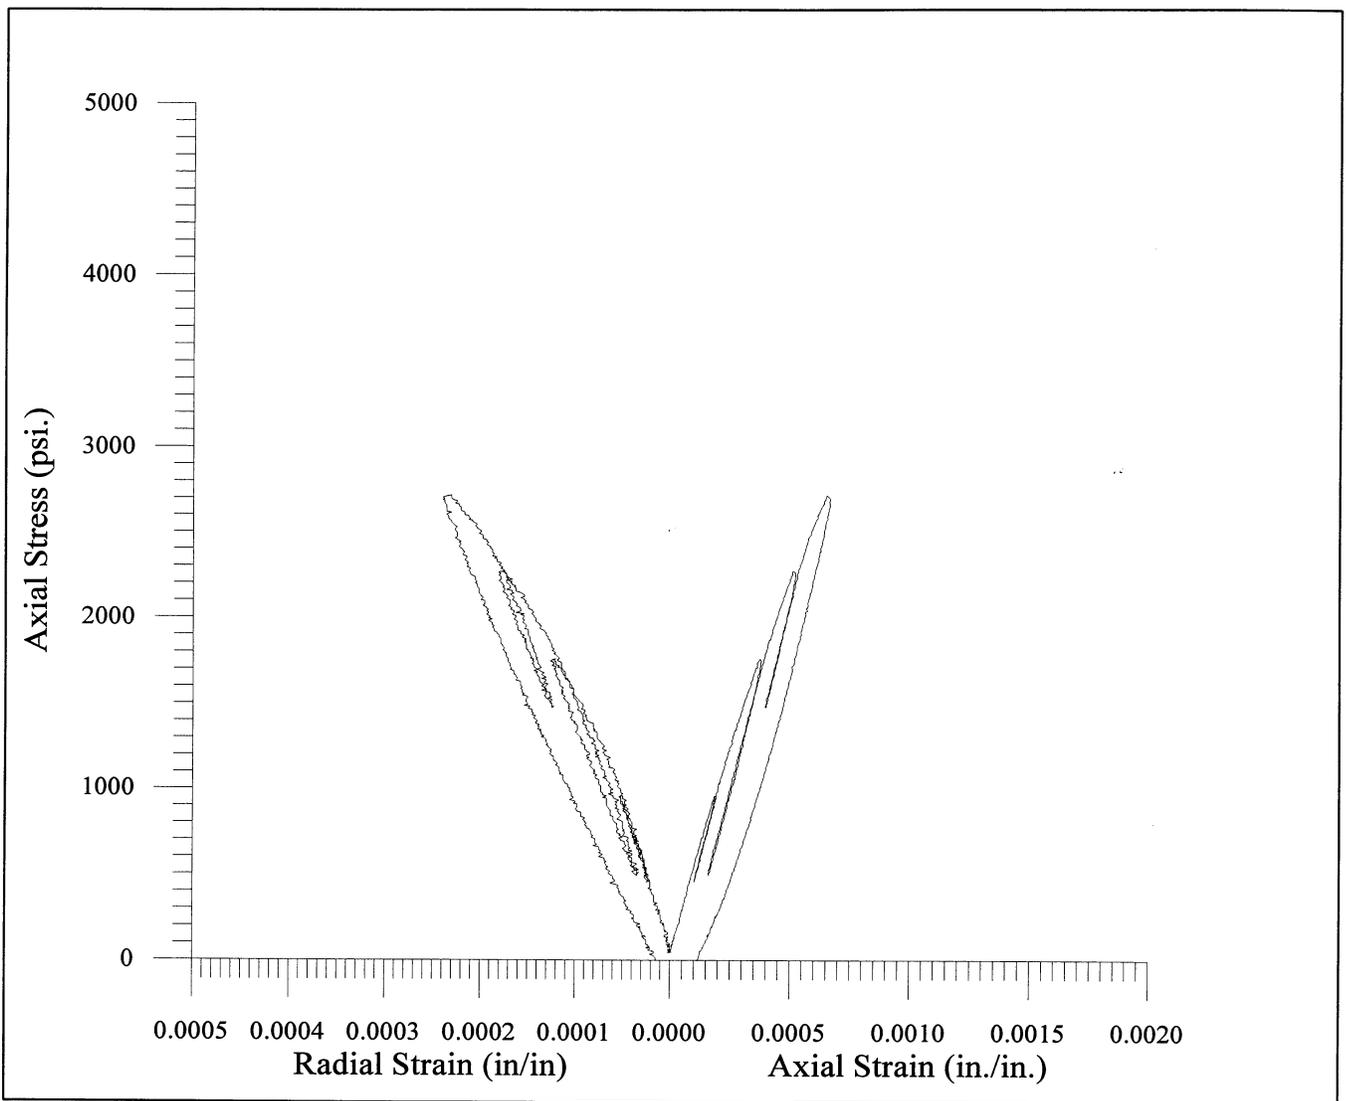
**ELASTIC MODULUS TEST**  
**Axial Stress vs. Axial & Radial Strain**

**SAMPLE ID:** Boring: 98-24  
 Sample: 20a  
 Depth: 75.5'

**DESCRIPTION**  
 Medium gray sandstone with partially healed and calcite healed fractures, generally 25 degrees to the core axis and one 50 degrees to the core axis.

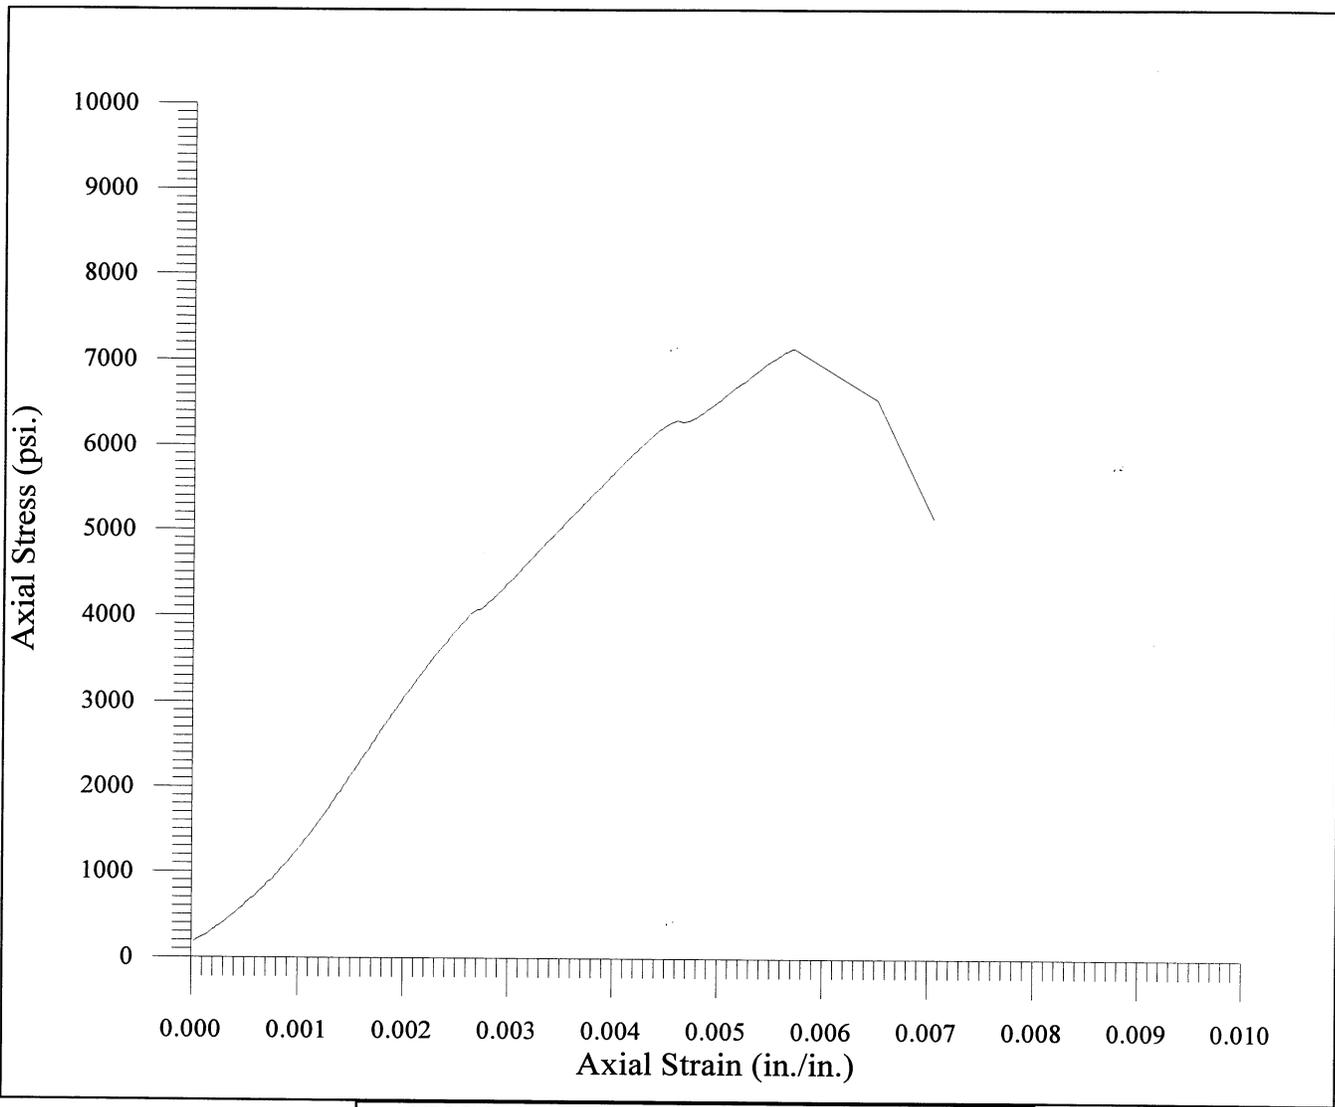
**UNCONFINED COMPRESSION TEST**  
**Axial Stress vs. Axial Strain**

<p><b>SAMPLE ID:</b> Boring : 98-24  Sample: 20a  Depth: 75.5'</p> <p align="center"><b>DESCRIPTION</b></p> <p>Medium gray sandstone with partially healed and calcite healed fractures, generally 25 degrees to the core axis and one 50 degrees to the axis.</p> <p><b>STRENGTH:</b> 7134 psi</p>	<p align="center"> <i>Geo</i>

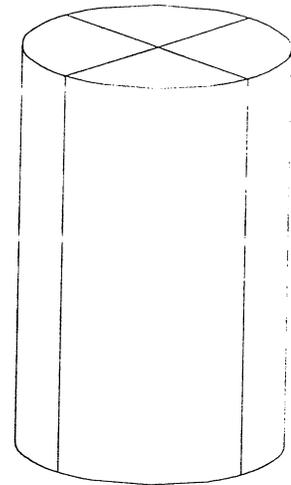
Sample Description: Dark gray siltstone with some beds of sandstone. Numerous horizontal fractures in the siltstone parallel to bedding at 65° to core axis.

Comments: failed by shear and axial splitting

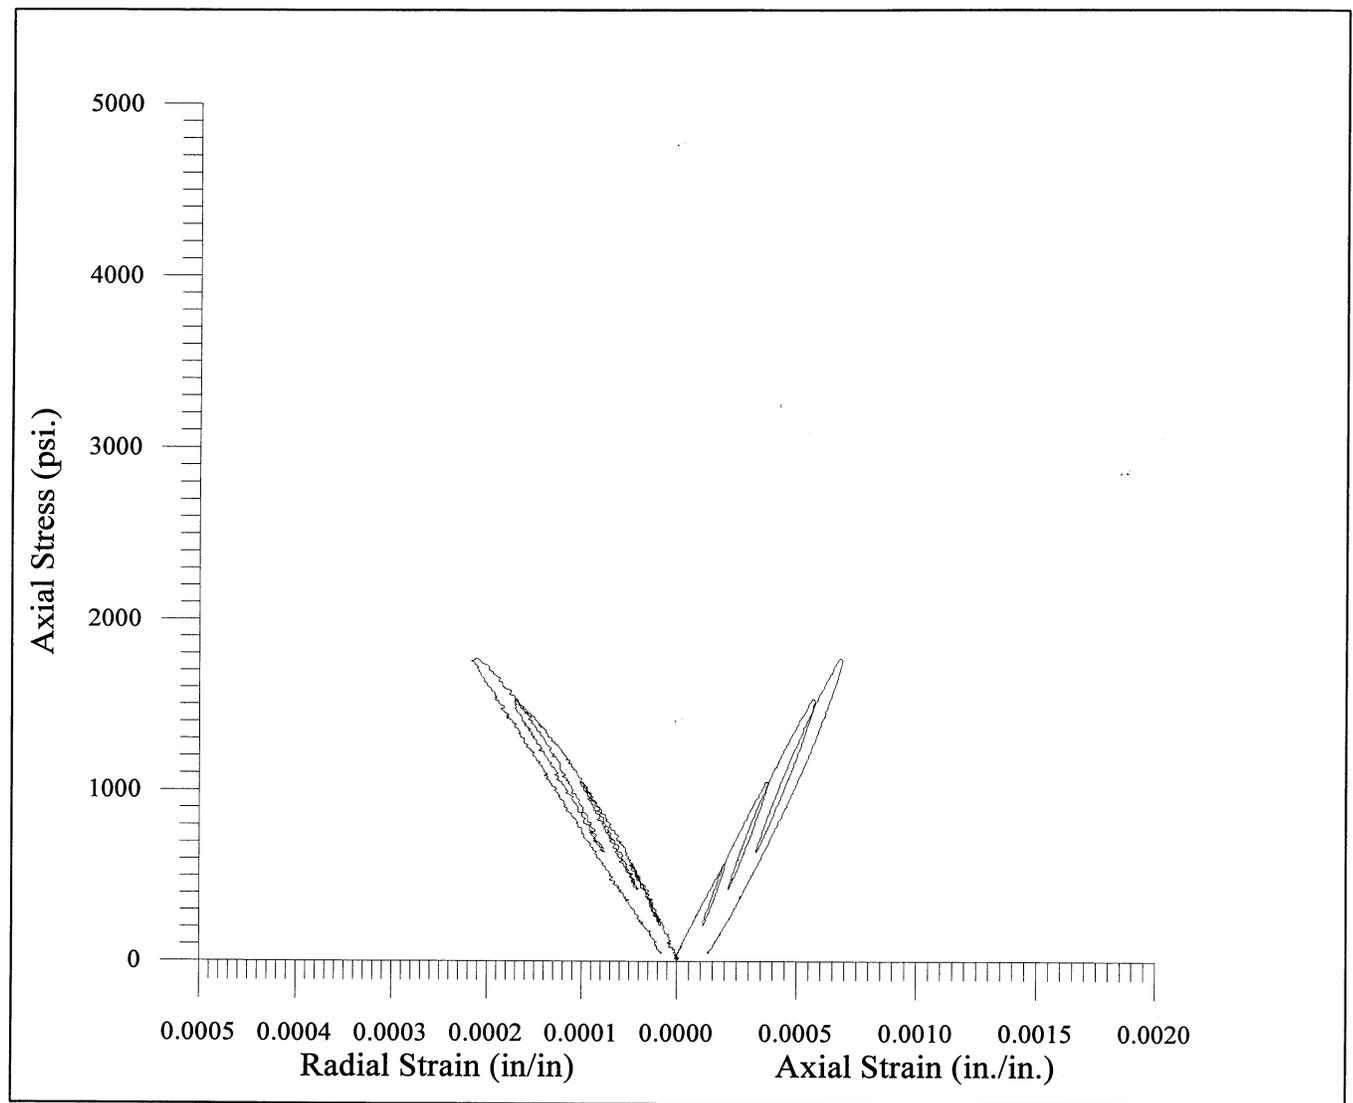
**ELASTIC MODULUS TEST**  
**Axial Stress vs. Axial & Radial Strain**

**SAMPLE ID:** Boring: 98-24  
 Sample: 21a  
 Depth: 79'

**DESCRIPTION**  
 Dark gray siltstone with sandstone layers. The siltstone contains many hairline fractures parallel to the bedding, about 65 degrees to the core axis.

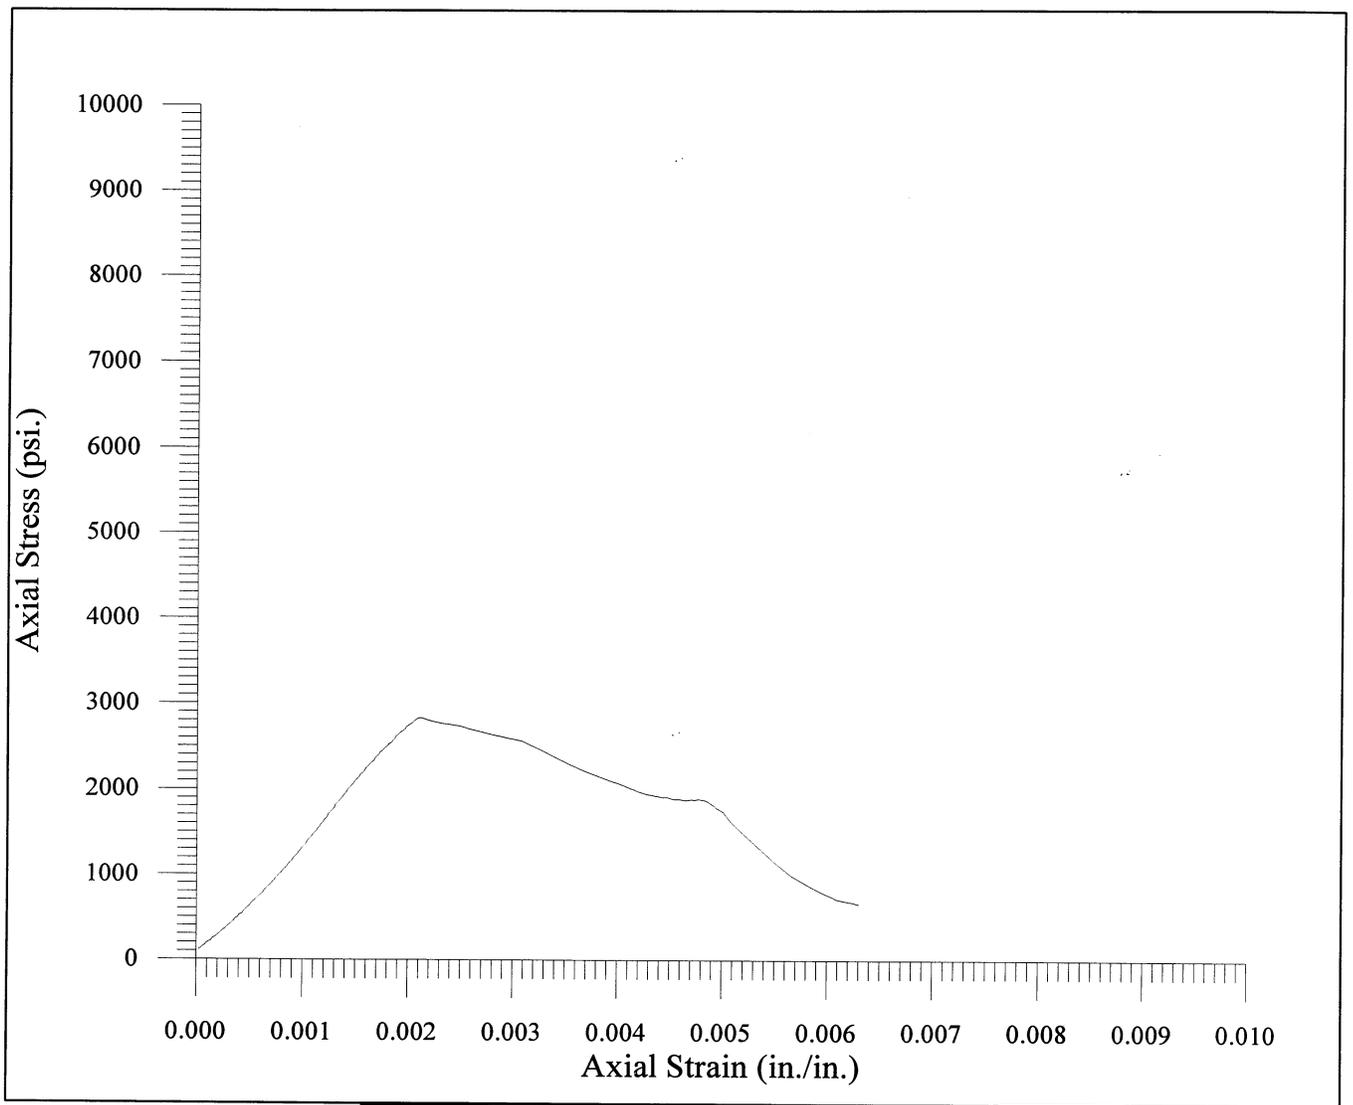
**UNCONFINED COMPRESSION TEST**  
**Axial Stress vs. Axial Strain**

**SAMPLE ID:** Boring : 98-24  
 Sample: 21a  
 Depth: 79'

Dark gray siltstone with sandstone layers. The siltstone contains many hairline fractures parallel to the bedding, about 65 degrees to the core axis.

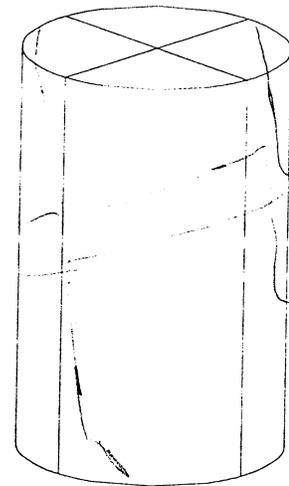
Sample Description: medium gray sandstone with several thin calcite healed fractures 62° & 12° to core axis

Sample Depth: 26.7m (87.5') Sample Condition: received & tested moist

Comments: Failed by axial splitting

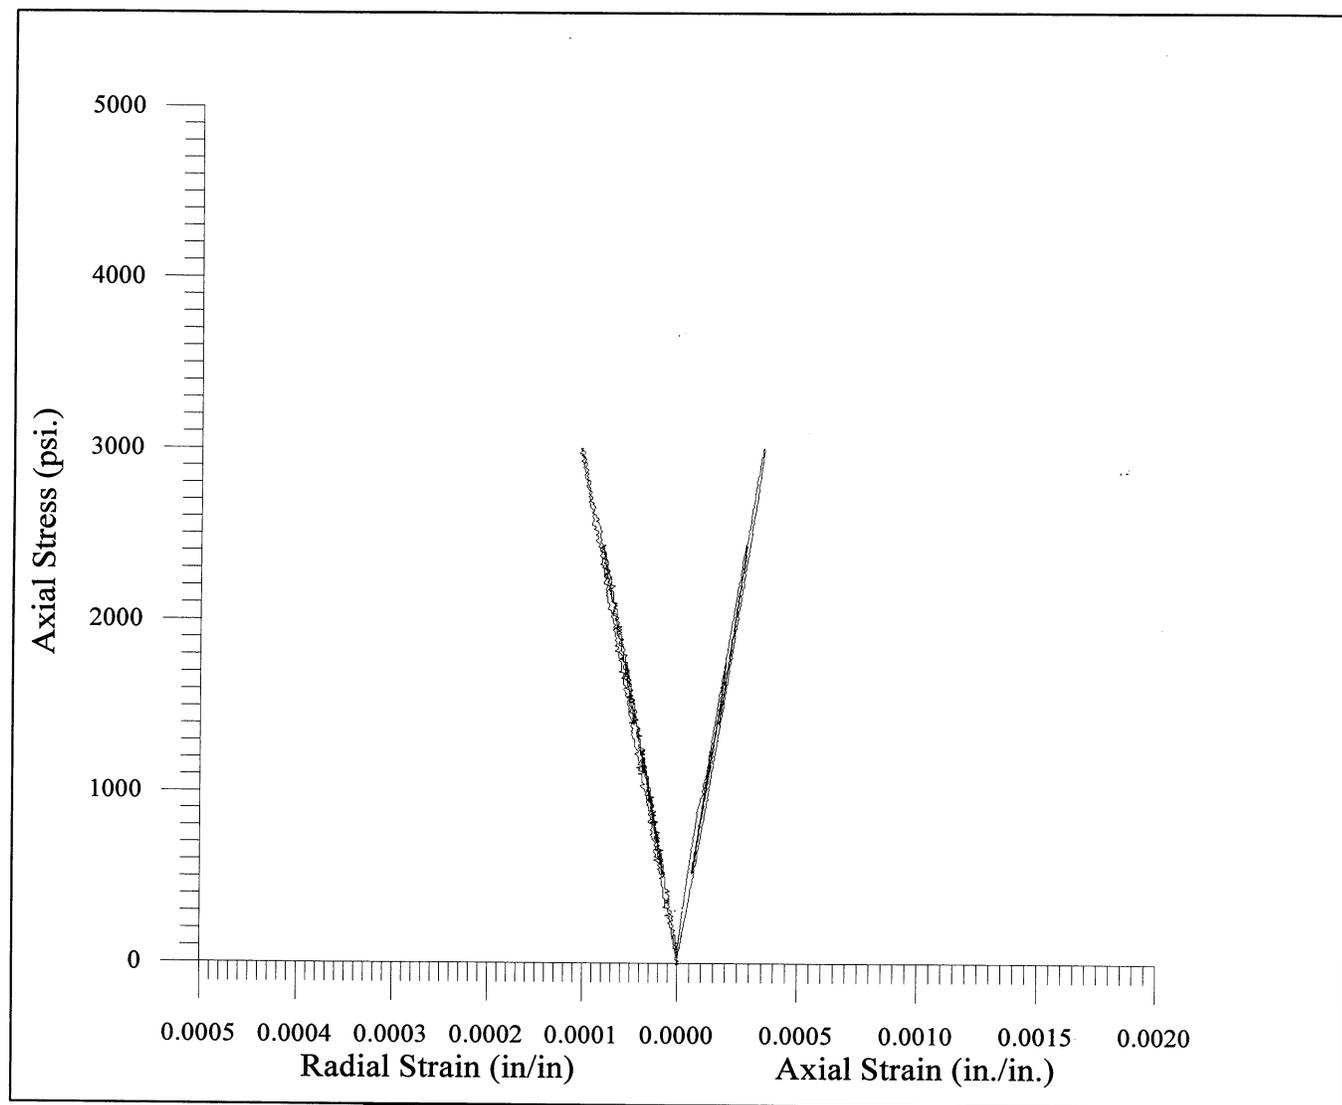
**ELASTIC MODULUS TEST**  
**Axial Stress vs. Axial & Radial Strain**

**SAMPLE ID:** Boring: 98-24  
 Sample: 22a  
 Depth: 87.5'

**DESCRIPTION**  
 Medium gray sandstone with several calcite healed hairline fractures, 12 and 62 degrees to the core axis.

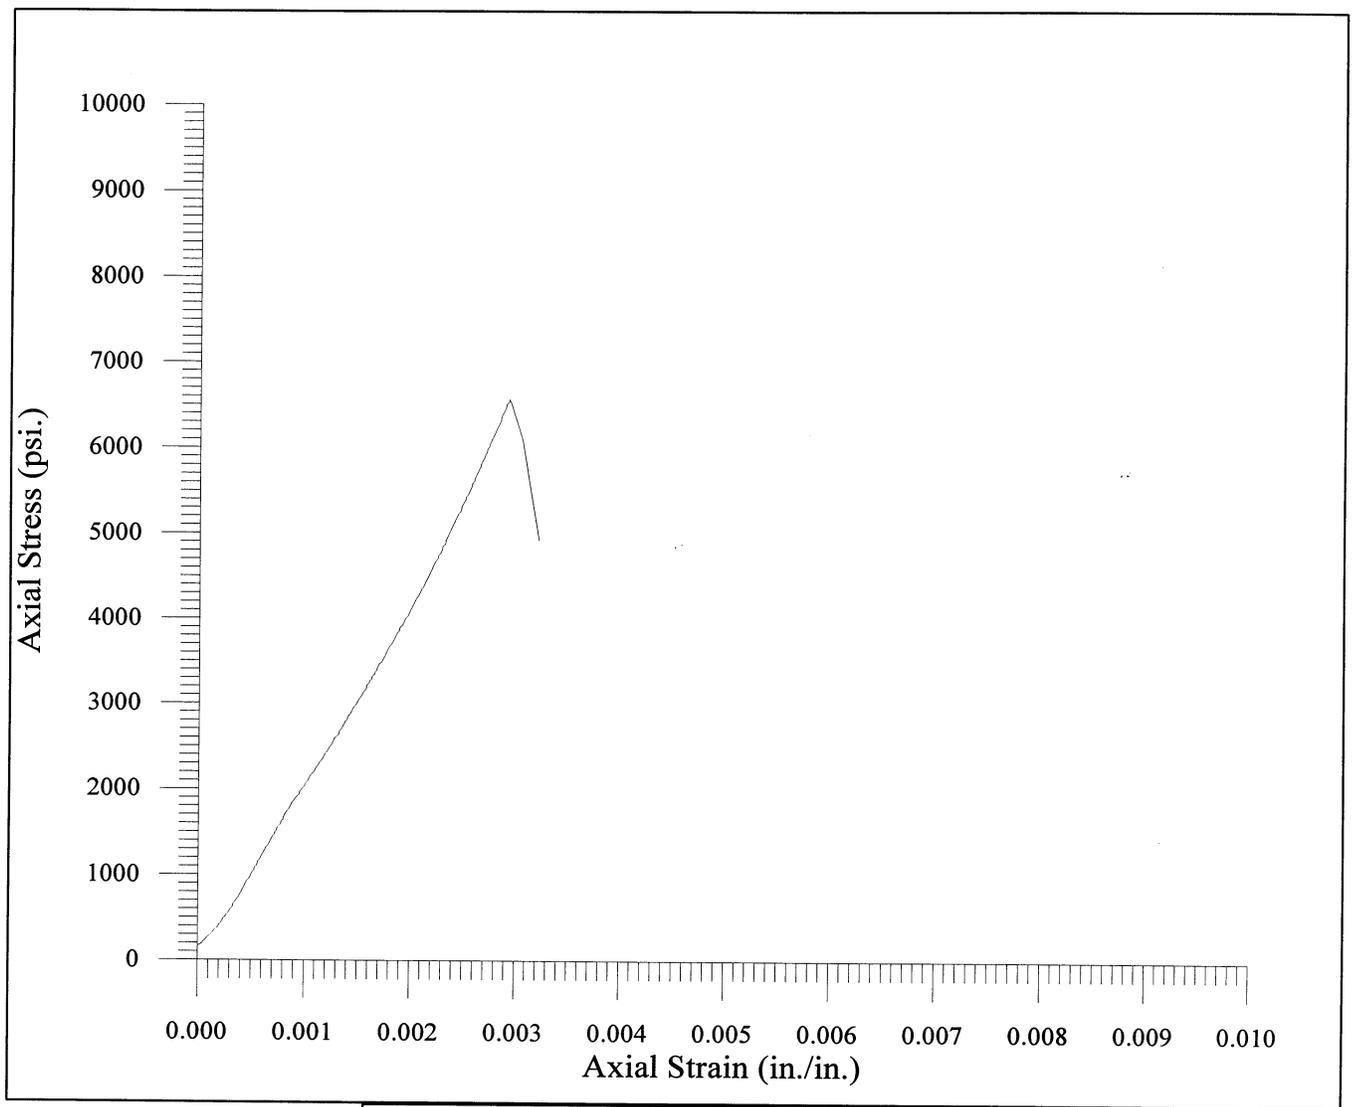
**UNCONFINED COMPRESSION TEST**  
**Axial Stress vs. Axial Strain**

<p><b>SAMPLE ID:</b> Boring : 98-24          Sample: 22a          Depth: 87.5'</p> <p align="center"><b>DESCRIPTION</b></p> <p>Medium gray sandstone with several calcite healed hairline fractures, 12 and 62 degrees to the core axis.</p> <p><b>STRENGTH:</b> 6562 psi</p>	<p><i>Geo</i>

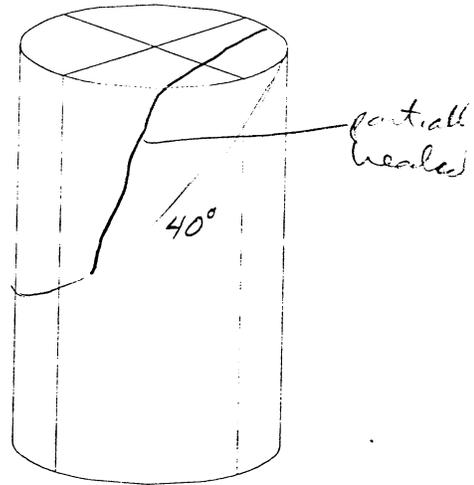
Sample Description: medium gray sandstone with partially healed and calcite healed fractures.

Sample Depth: 29.9m (98') Sample Condition: received & tested moist

Comments: Failed by shear on 40° healed joint
