**SUBCONTRACTOR REPORTS  
FINAL GEOTECHNICAL  
SITE CHARACTERIZATION**

**SAN FRANCISCO-OAKLAND BAY BRIDGE  
EAST SPAN SEISMIC SAFETY PROJECT**

**VOLUME 2 OF 3  
(GeoTest Unlimited)**

Letter Report  
San Francisco Oakland Bay Bridge  
East Span Replacement Project  
Rock Testing Program

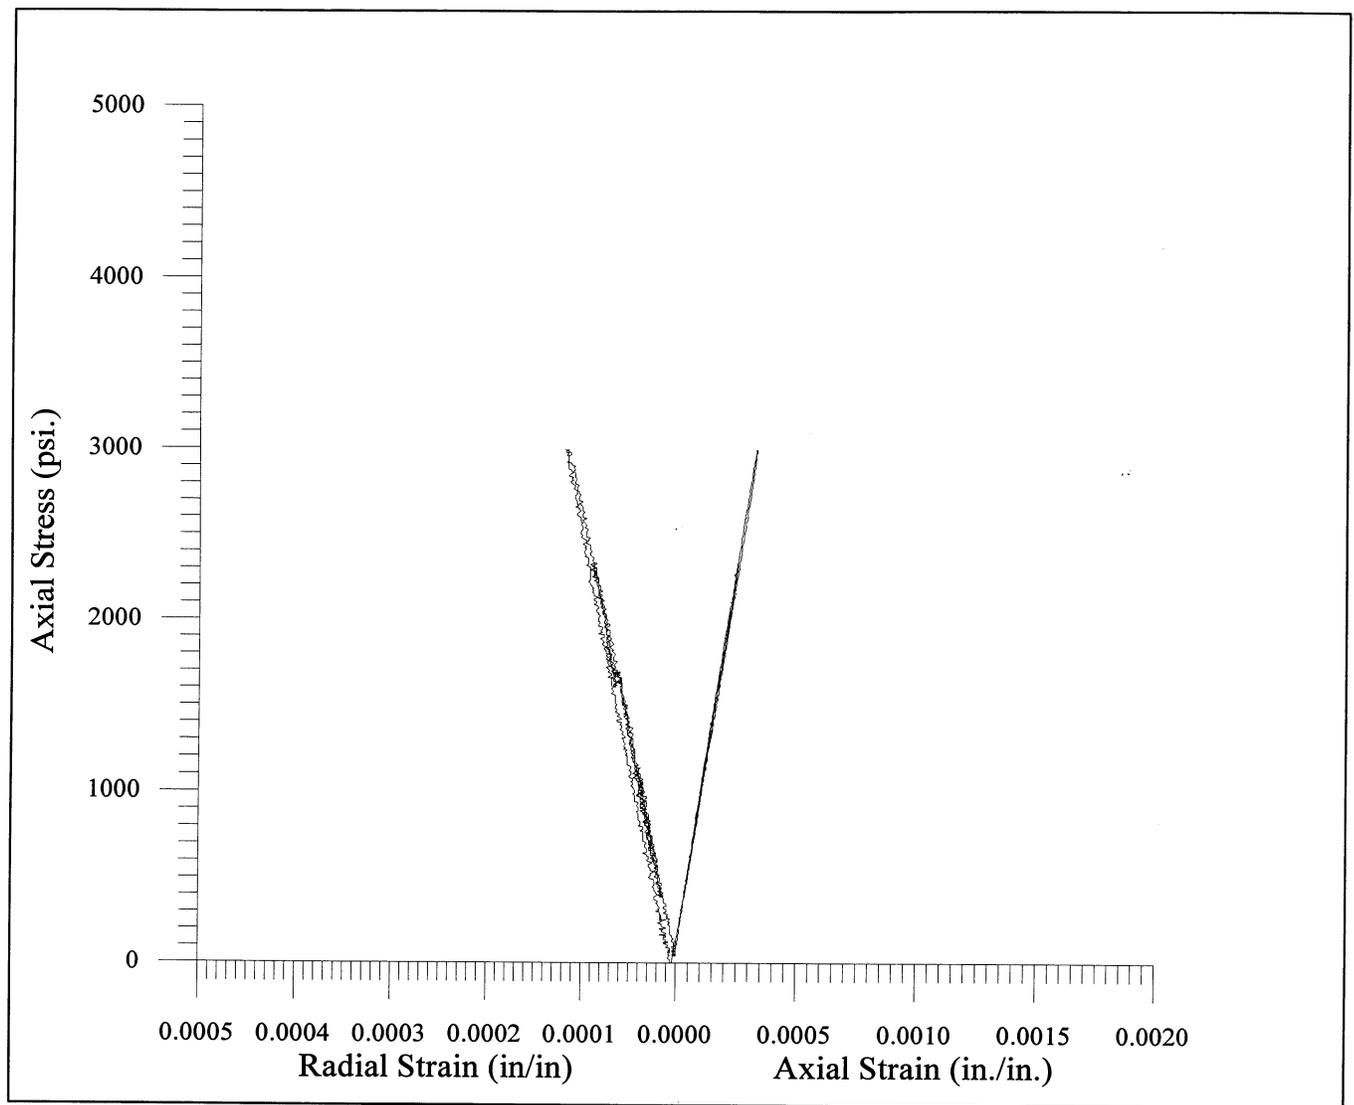
**ELASTIC MODULUS TEST**  
**Axial Stress vs. Axial & Radial Strain**

<p><b>SAMPLE ID:</b> Boring: 98-24  Sample: 24a  Depth: 98'</p> <p><b>DESCRIPTION</b>  Medium gray sandstone with partially healed and calcite healed fractures about 40 degrees to the core axis.</p> <p><b>MODULUS:</b> 9,620,000 psi  <b>POISSON'S RATIO:</b> .30</p>	<p align="center"> <i>Geo</i>

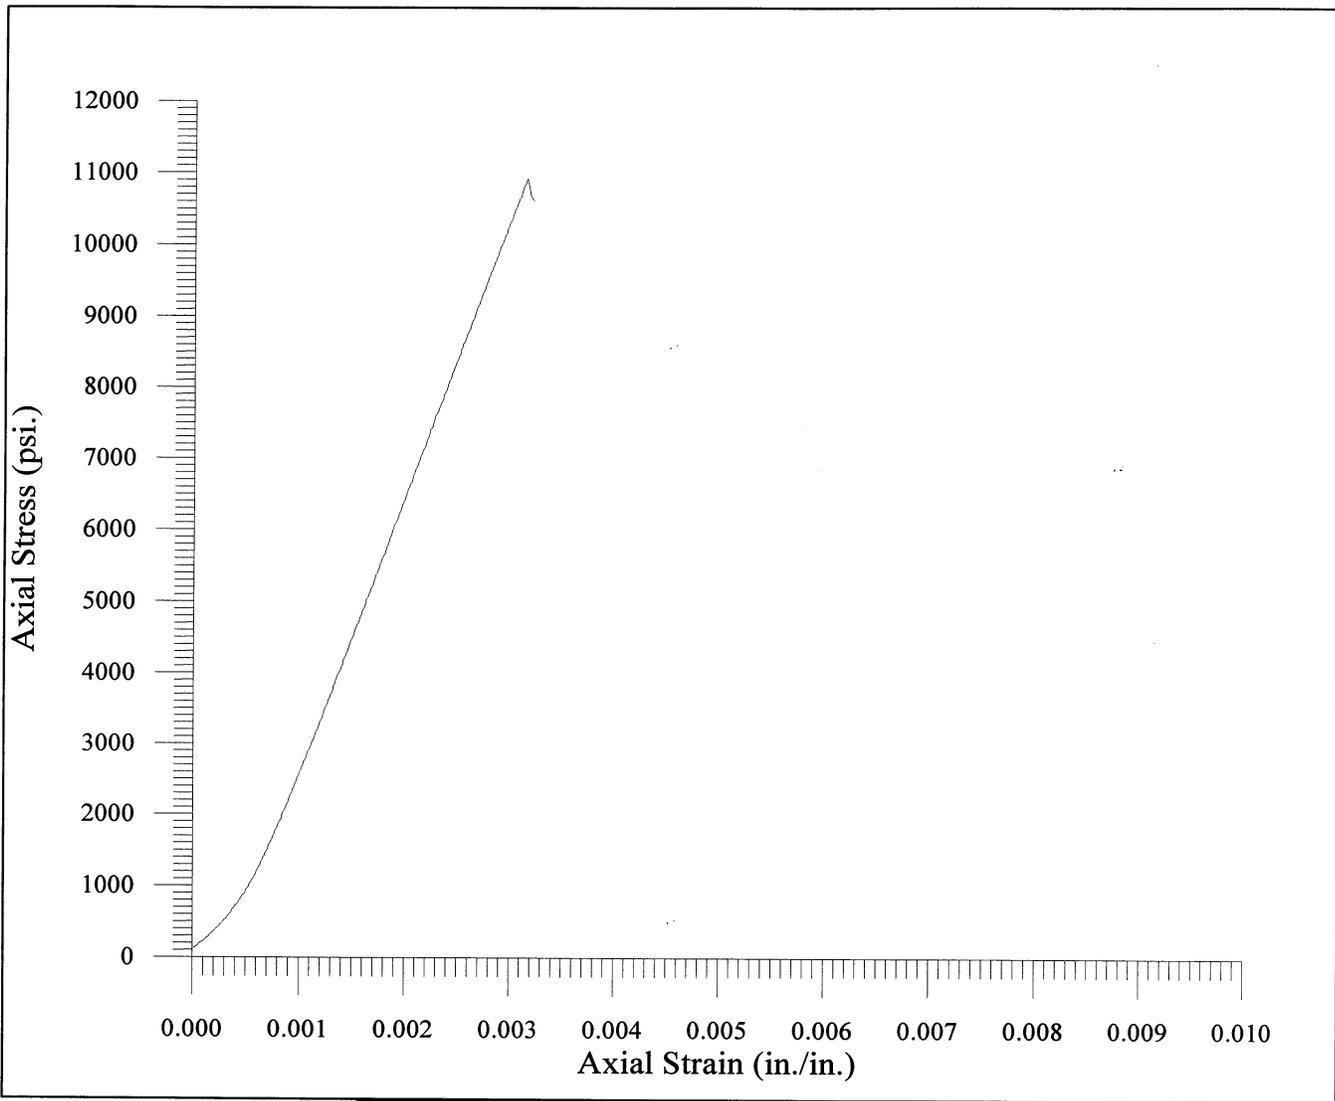
**UNCONFINED COMPRESSION TEST**  
**Axial Stress vs. Axial Strain**

<p><b>SAMPLE ID:</b> Boring : 98-24  Sample: 24a  Depth: 98'</p> <p align="center"><b>DESCRIPTION</b></p> <p>Medium gray sandstone with partially healed and calcite healed fractures about 40 degrees to the core axis.</p> <p><b>STRENGTH:</b> 10,912 psi</p>	<p align="center"> <i>Geo</i>

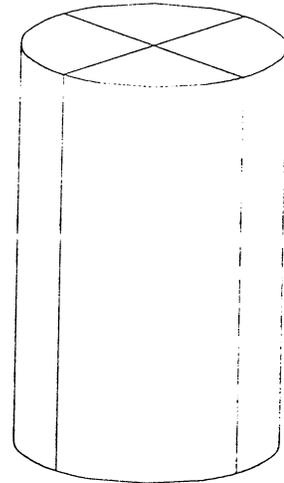
Sample Depth: 32.0m (105') Sample Condition: received & tested moist

Comments: hard strong rock  $E_{1a} = E_{2a}$ ! implies that for the  
weaker/fractured rock, that  $E$  is very non uniform.

probably axial split @ ~70kips (slight change in  $\sigma$ - $\epsilon$  slope)  
heard a cracking sound.

Failed by shear and splitting

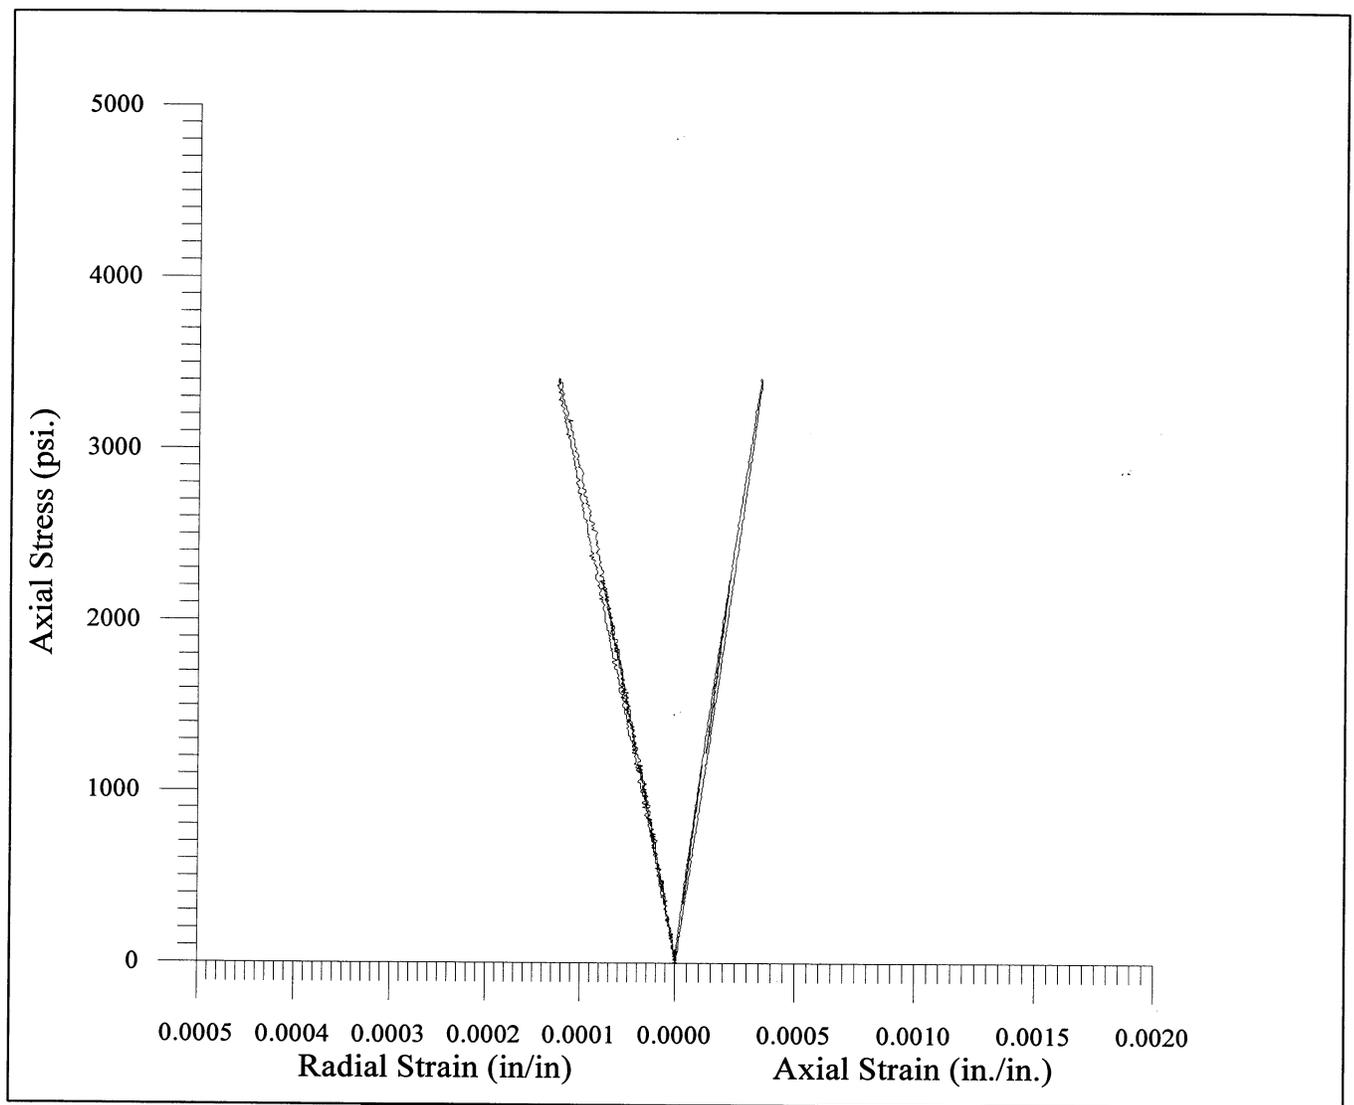
**ELASTIC MODULUS TEST**  
**Axial Stress vs. Axial & Radial Strain**

<p><b>SAMPLE ID:</b> Boring: 98-24  Sample: 25a  Depth: 105'</p> <p align="center"><b>DESCRIPTION</b></p> <p align="center">Medium gray massive sandstone.</p> <p><b>MODULUS:</b> 10,000,000 psi</p> <p><b>POISSON'S RATIO:</b> .35</p>	<p align="center"> <i>Geo</i>

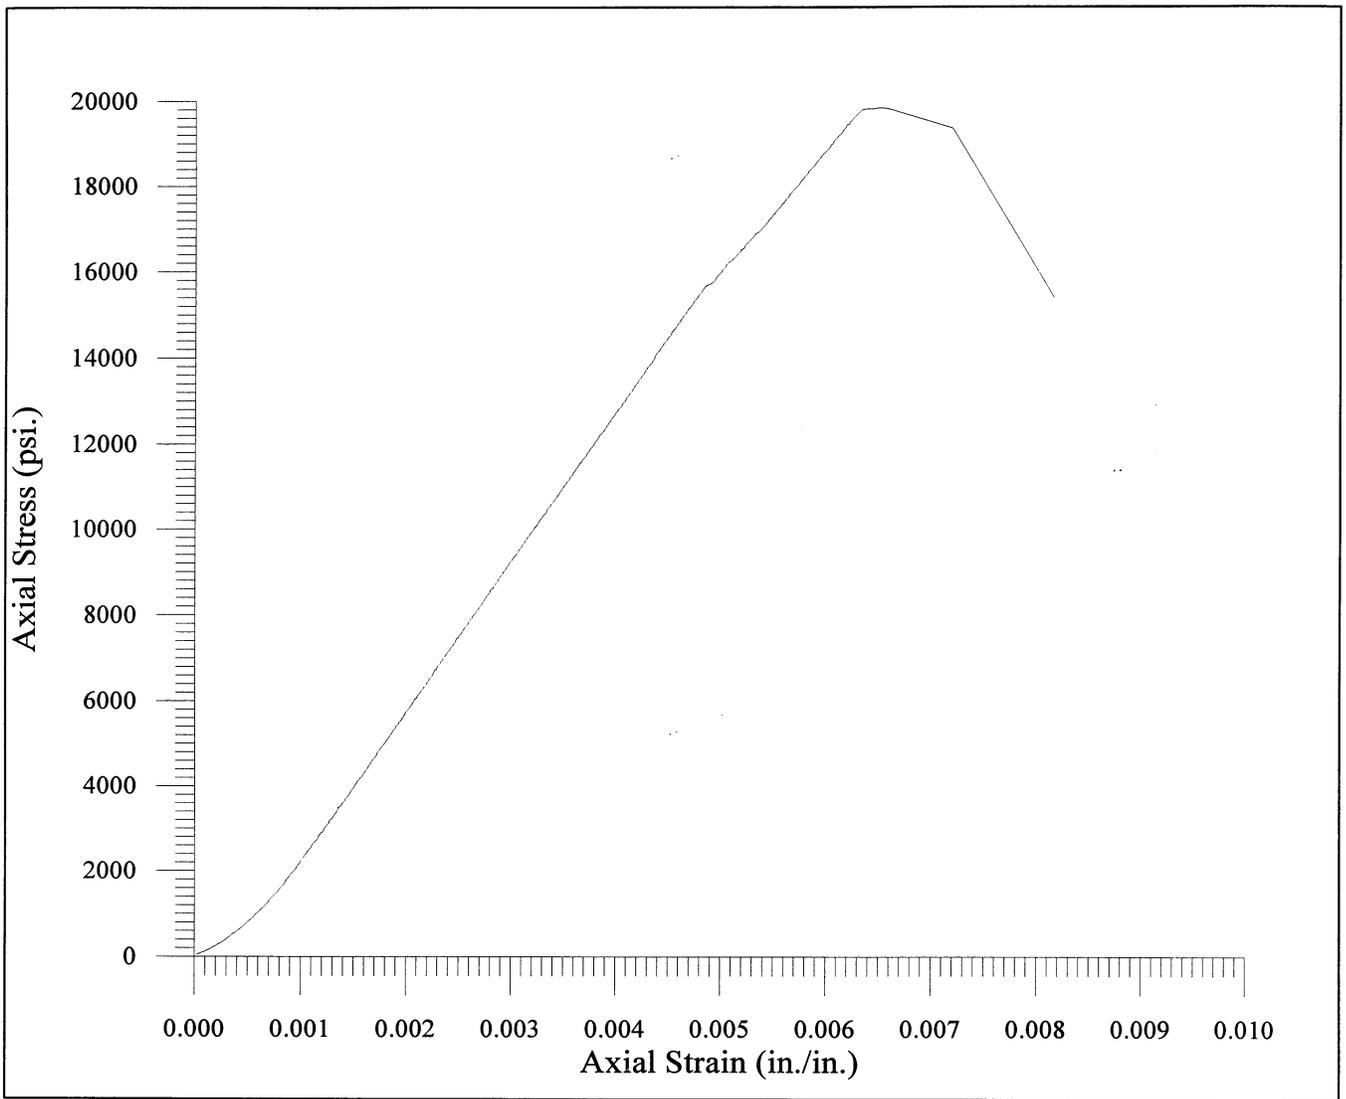
**UNCONFINED COMPRESSION TEST**  
**Axial Stress vs. Axial Strain**

<p><b>SAMPLE ID:</b> Boring : 98-24          Sample: 25a          Depth: 105'</p> <p align="center"><b>DESCRIPTION</b></p> <p align="center">Medium gray massive sandstone.</p> <p><b>STRENGTH:</b> 19,835 psi</p>	<p align="center"> <i>Geo</i>

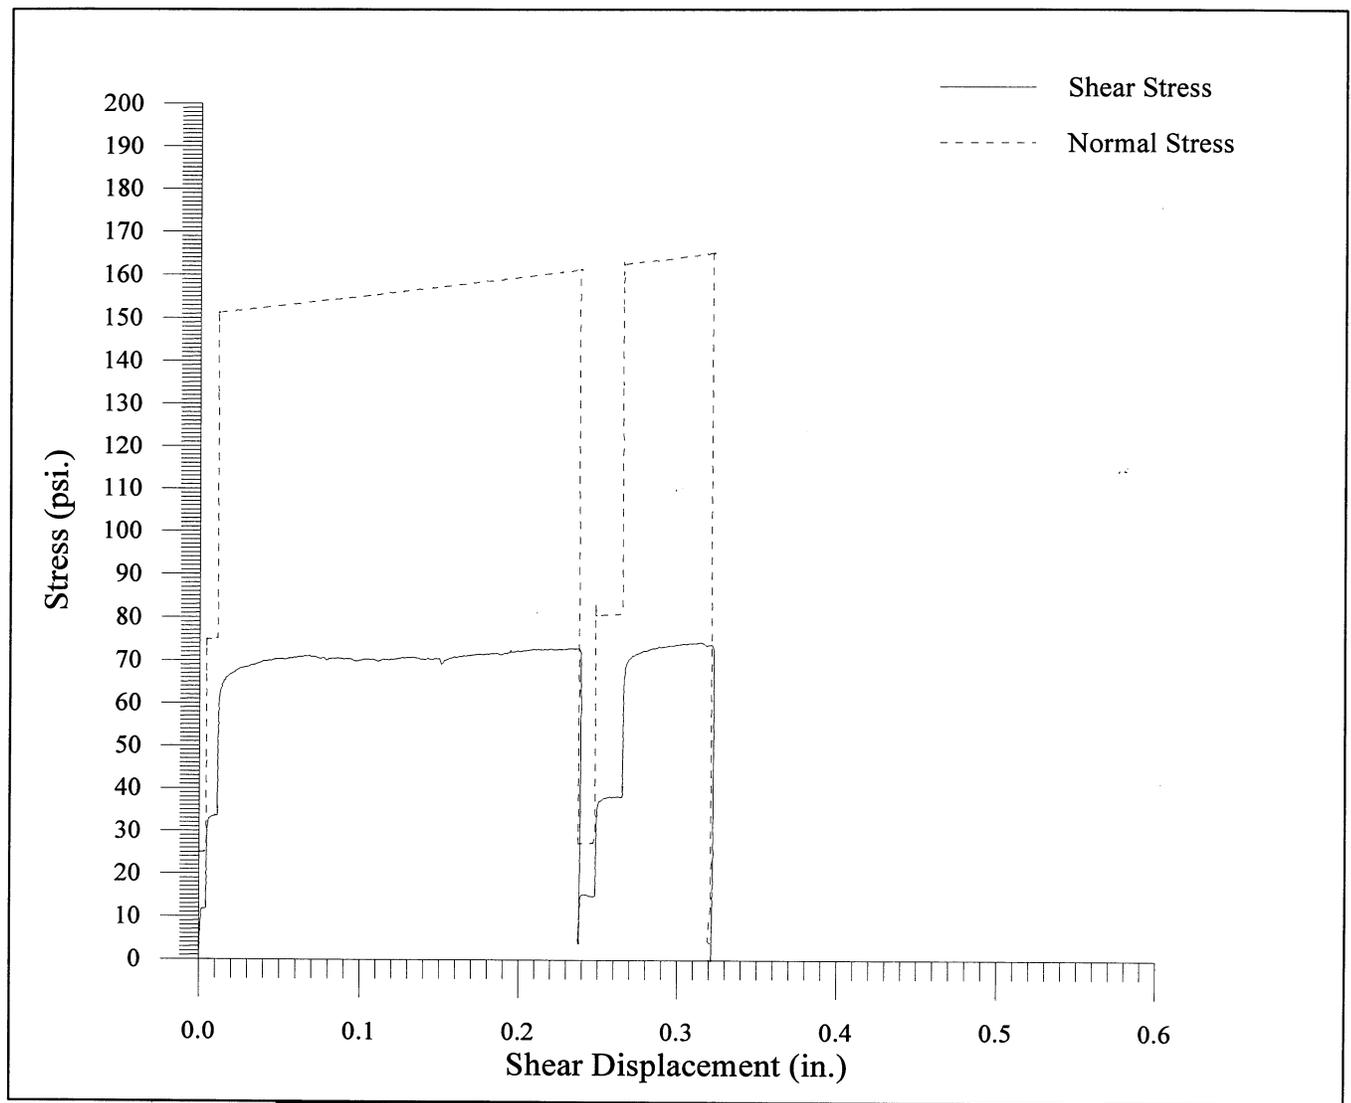
**DIRECT SHEAR TEST**  
**Shear and Normal Stress vs. Shear Displacement**

<p><b>SAMPLE ID:</b> Boring: 98-24          Sample: 21b          Depth: 79'</p> <p style="text-align: center;"><b>DESCRIPTION</b></p> <p>Planar bedding plane joint in dark gray claystone at a claystone/siltstone interface.</p>

<p><b>Geo Test Unlimited</b></p> </div> <p style="text-align: right;">800 Peralta Ave          San Leandro, CA 94577</p> <hr/> <p><b>Client:</b> Fugro West, Inc.          5855 Olivas Park Dr.          Ventura, CA 93003</p> <p><b>Project:</b> San Francisco Oakland Bay Bridge          East Span Replacement Project</p> <p><b>Job Number:</b> 98-42-0053</p> <hr/> <p><b>Test Date:</b> October 30, 1998</p>
	Normal Stress	Shear Strength																
Initial	25	12																
	75	34																
	153	70																
Final	27.5	15																
	81	38.5																
	165	74

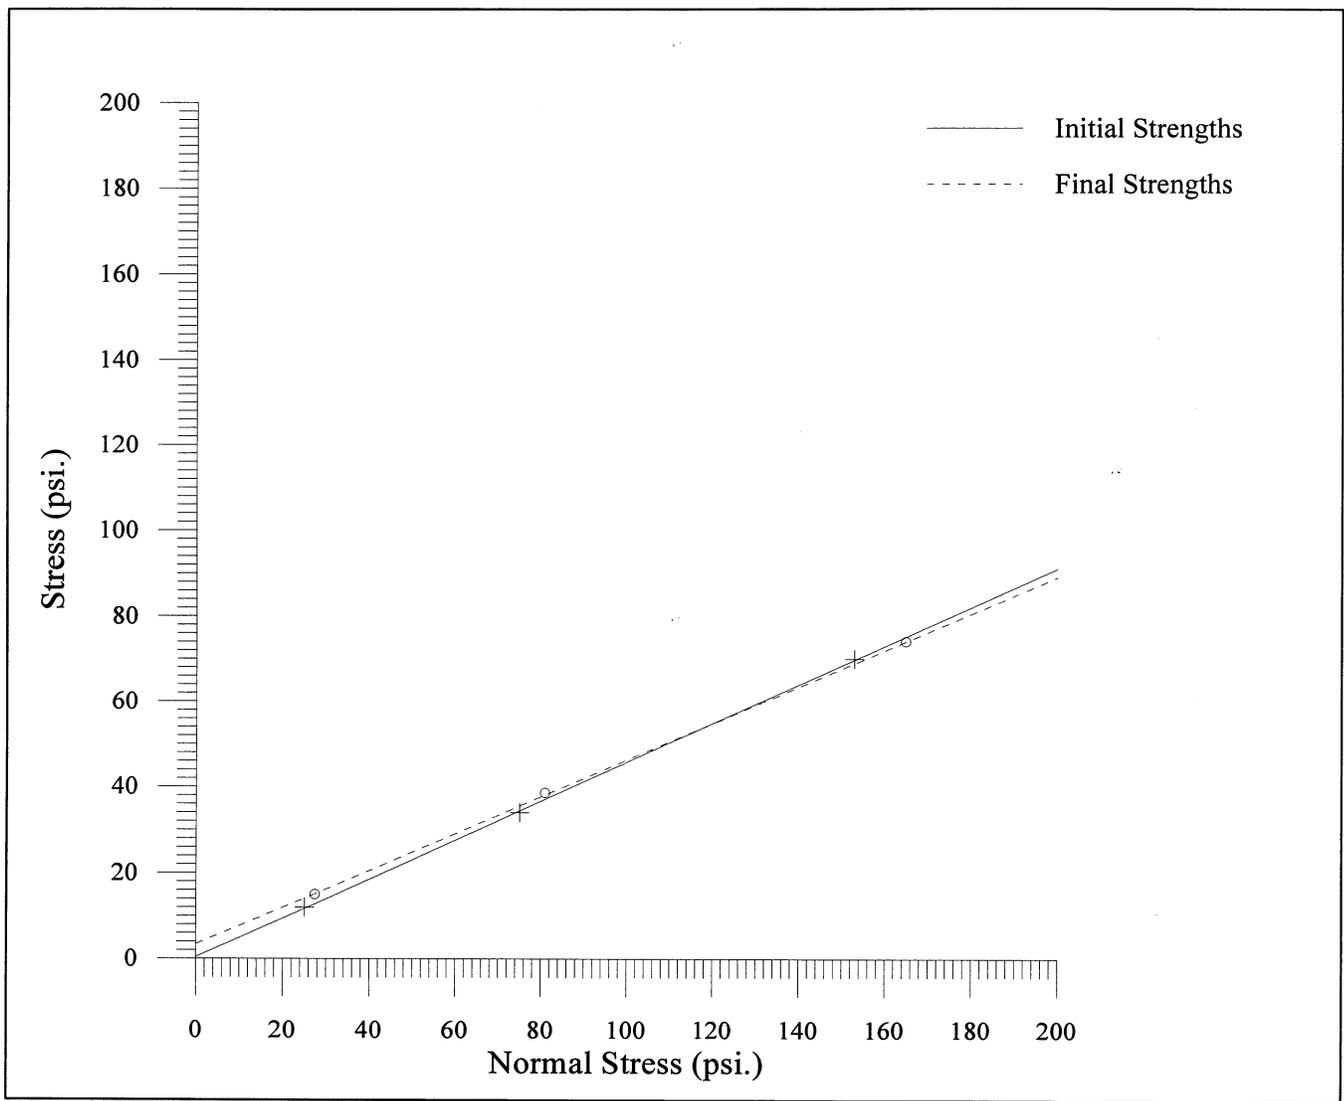
**DIRECT SHEAR TEST  
Failure Envelope**

<p><b>SAMPLE ID:</b> Boring: 98-24 Sample: 21b Depth: 79'</p> <p align="center"><b>DESCRIPTION</b></p> <p>Planar bedding plane joint in dark gray claystone at a claystone/siltstone interface.</p>

<i>Test</i>  <b>Unlimited</b> 800 Peralta Ave  San Leandro, CA 94577 </p>
		Shear Intercept (psi)	Friction Angle (degrees)							
Initial	0.4	24.4								
Final	3.4	23.2								
<p><b>Client:</b> Fugro West, Inc. 5855 Olivas Park Dr. Ventura, CA 93003</p> <p><b>Project:</b> San Francisco Oakland Bay Bridge East Span Replacement Project</p> <p><b>Job Number:</b> 98-42-0053</p> <p><b>Test Date:</b> October 30, 1998</p>

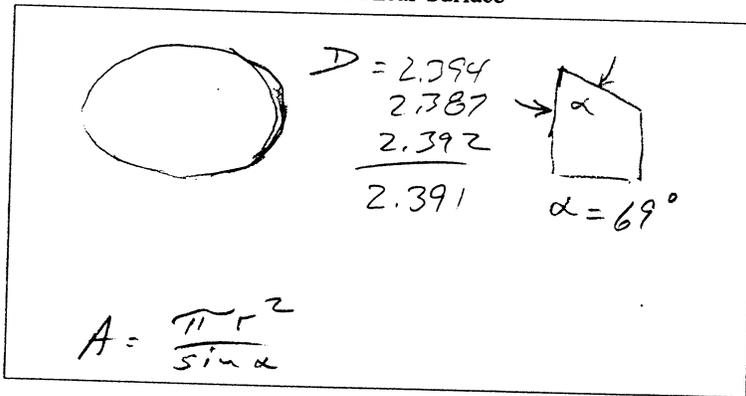
Sketch of Shear Surface

Sample Water Condition: received & tested moist

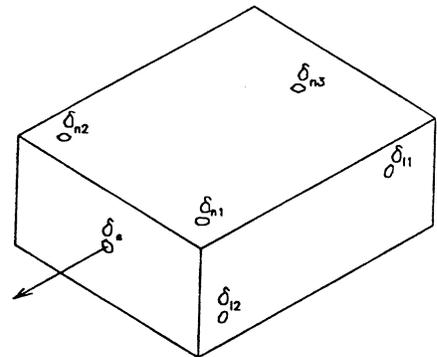
Location of LVDTs on top shear box

Measured Top Box Weight: 16.1

$\sigma_n$	<u>25</u>	<u>75</u>	<u>150</u>	psi
$F_n$	<u>120</u>	<u>360</u>	<u>720</u>	lb
$F_n - W_b$	<u>104</u>	<u>344</u>	<u>704</u>

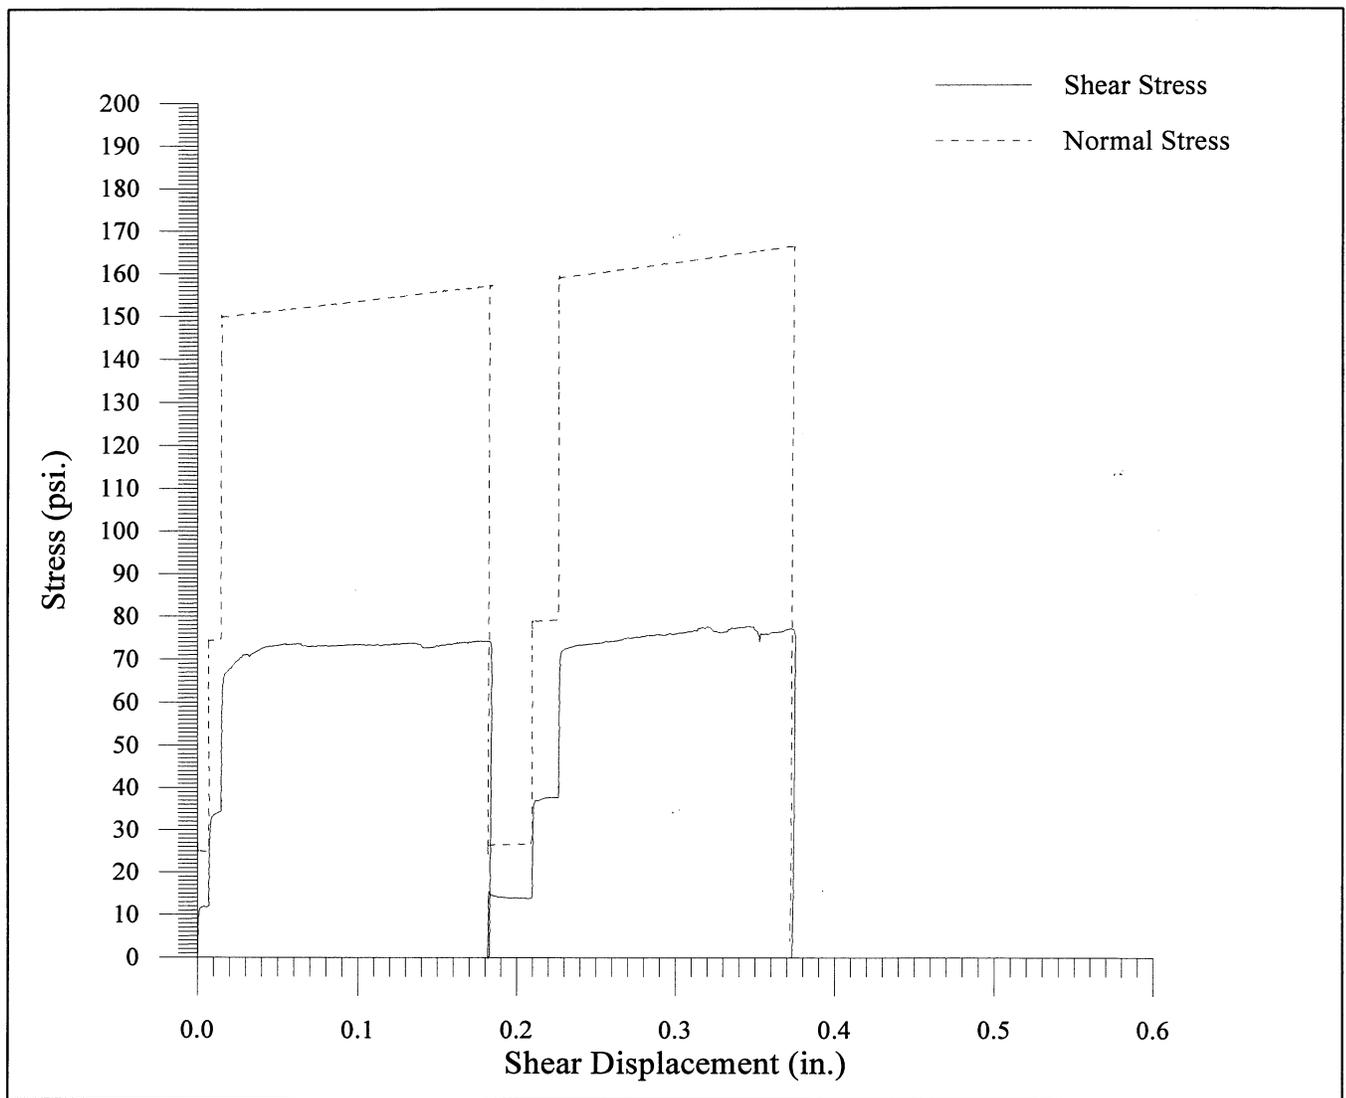
**DIRECT SHEAR TEST**  
**Shear and Normal Stress vs. Shear Displacement**

<p><b>SAMPLE ID:</b> Boring: 98-24          Sample: 21c          Depth: 80'</p> <p style="text-align: center;"><b>DESCRIPTION</b></p> <p style="text-align: center;">Planar bedding plane joint in          dark gray claystone.</p>	<div style="text-align: center;">

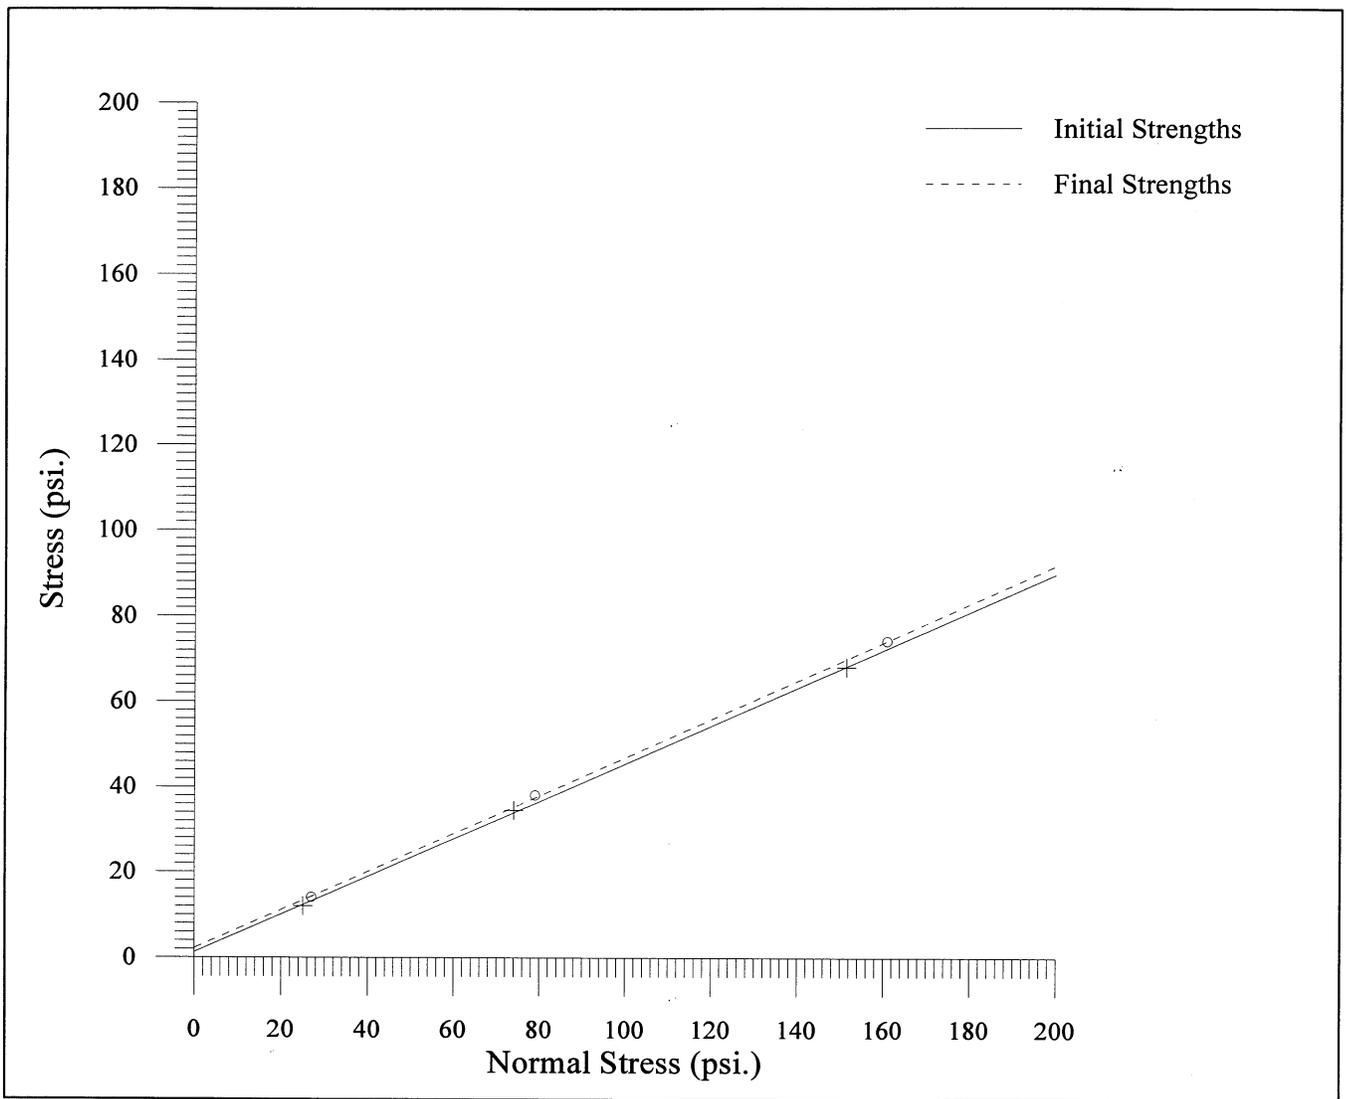
**DIRECT SHEAR TEST  
Failure Envelope**

<p><b>SAMPLE ID:</b> Boring: 98-24 Sample: 21c Depth: 80'</p> <p style="text-align: center;"><b>DESCRIPTION</b></p> <p style="text-align: center;">Planar bedding plane joint in dark gray claystone.</p>

<p><b>800 Peralta Ave San Leandro, CA 94577</b></p> </div> <p><b>Client:</b> Fugro West, Inc. 5855 Olivas Park Dr. Ventura, CA 93003</p> <p><b>Project:</b> San Francisco Oakland Bay Bridge East Span Replacement Project</p> <p><b>Job Number:</b> 98-42-0053</p> <p><b>Test Date:</b> October 30, 1998</p>
	Shear Intercept (psi)	Friction Angle (degrees)								
Initial	1.3	23.8								
Final	2.2	24.1

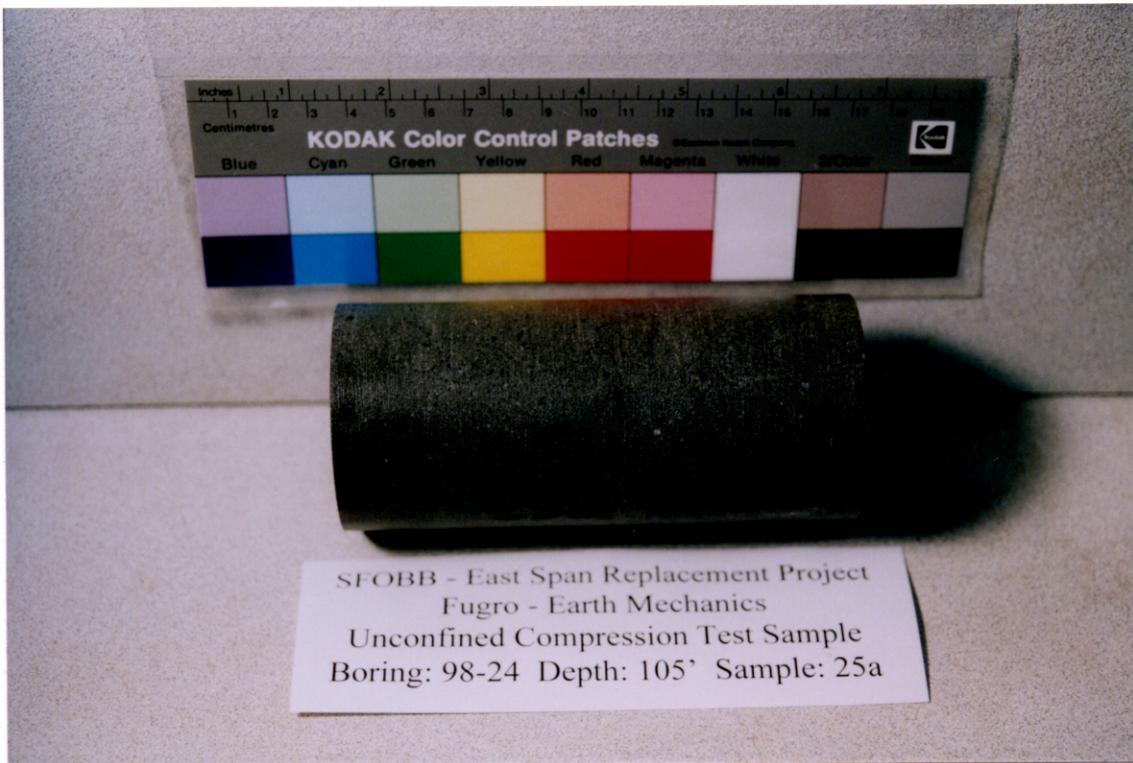
SFOBB - East Span Replacement Project  
Fugro - Earth Mechanics  
Unconfined Compression Test Sample  
Boring: 98-24 Depth: 105' Sample: 25a

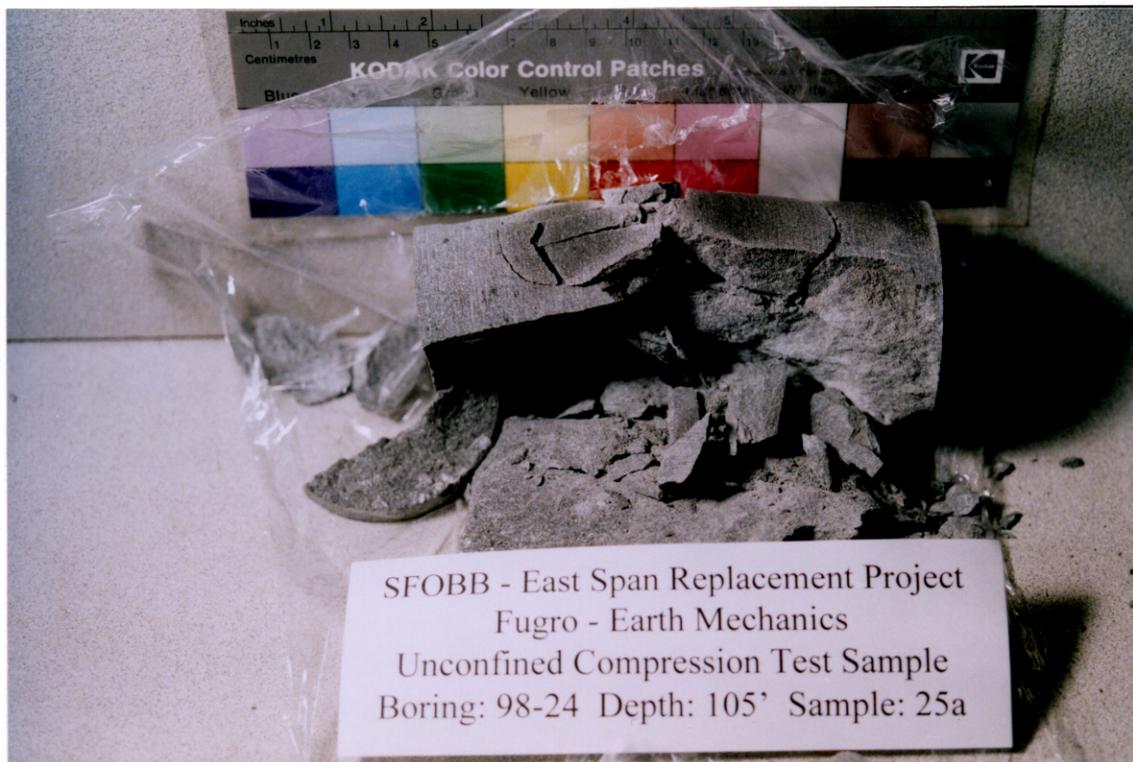
SFOBB - East Span Replacement Project  
Fugro - Earth Mechanics  
Unconfined Compression Test Sample  
Boring: 98-24 Depth: 105' Sample: 25a

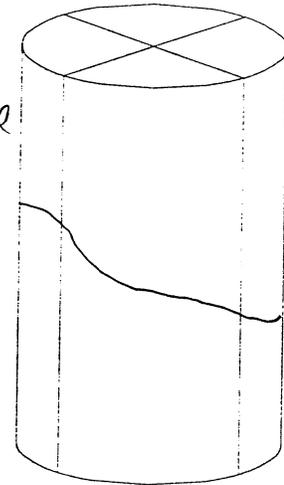
l <sub>1</sub>	l <sub>2</sub>
- .0023	- .0014
± .0001	± .0001
+ .0022	+ .0010

non-parallel due to open joint

Avg. diameter: 2.387

Avg. length: 5.005"

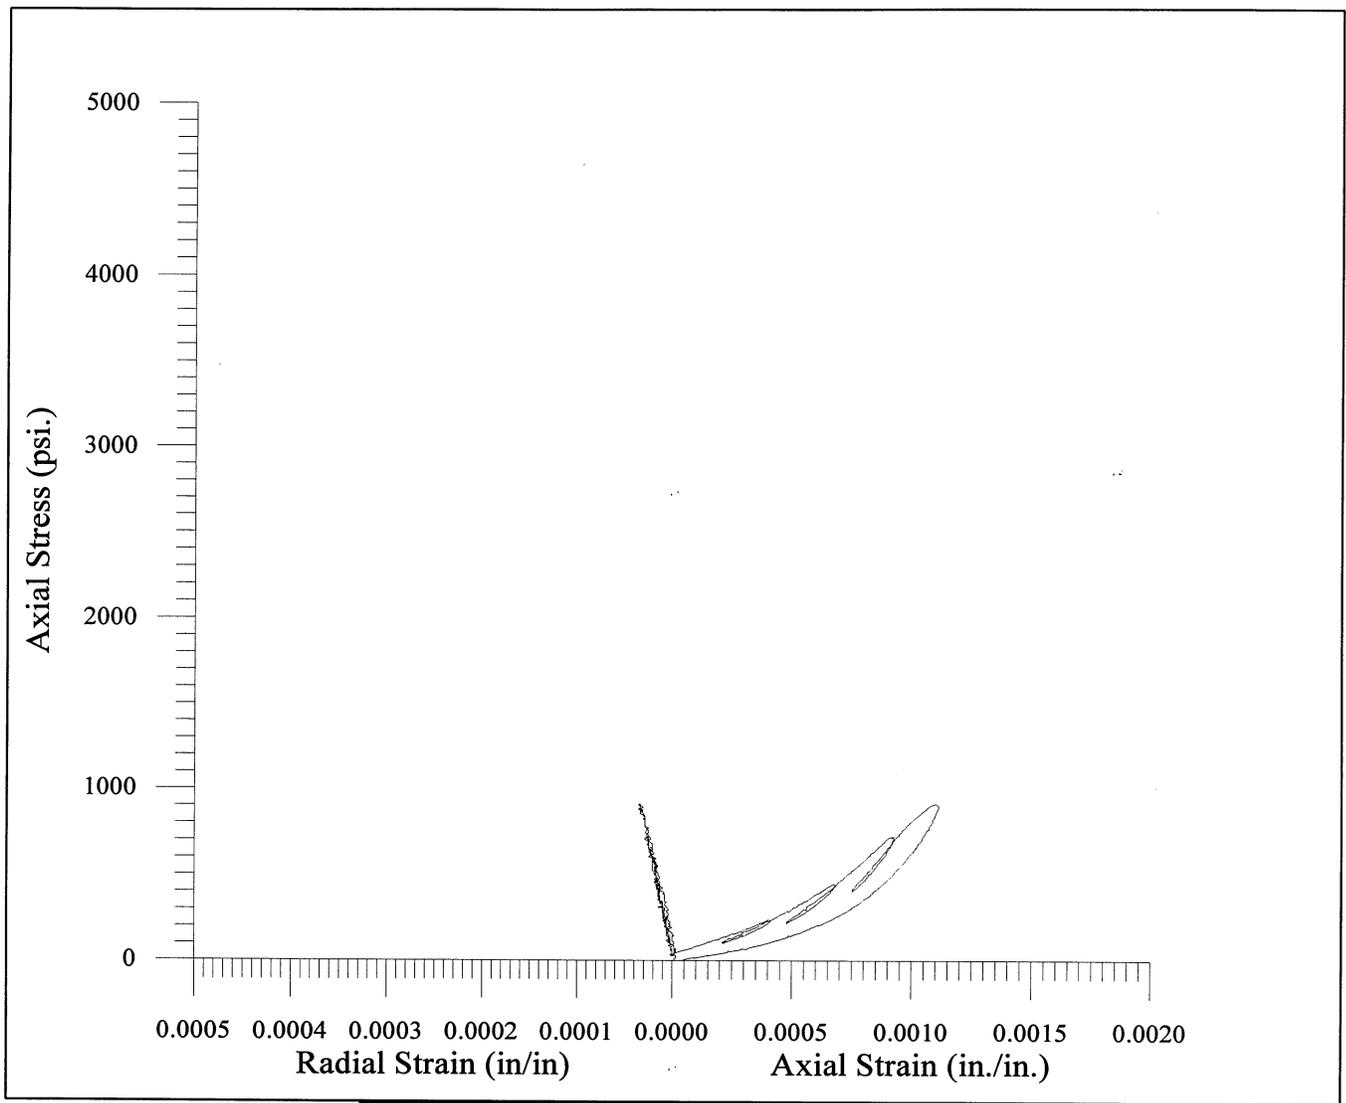
**ELASTIC MODULUS TEST**  
**Axial Stress vs. Axial & Radial Strain**

Comments: Bad v due to open fracture (very low E)

may be able to use this test to determine joint normal stiffness! Assume v, use E<sub>r</sub> to get E<sub>n</sub> of intact rock & then S<sub>a</sub>ness - S<sub>a</sub> assumed = S<sub>a</sub> across fracture.

<p><b>SAMPLE ID:</b> Boring: 98-24a  Sample: 6a  Depth: 33'</p> <p style="text-align: center;"><b>DESCRIPTION</b></p> <p>Massive tan sandstone with an unhealed fracture about 72 degrees to the core axis.</p> <p><b>MODULUS:</b> 1,690,000 psi (NA?)  <b>POISSON'S RATIO:</b> NA (.07)</p>	<div style="text-align: center;">

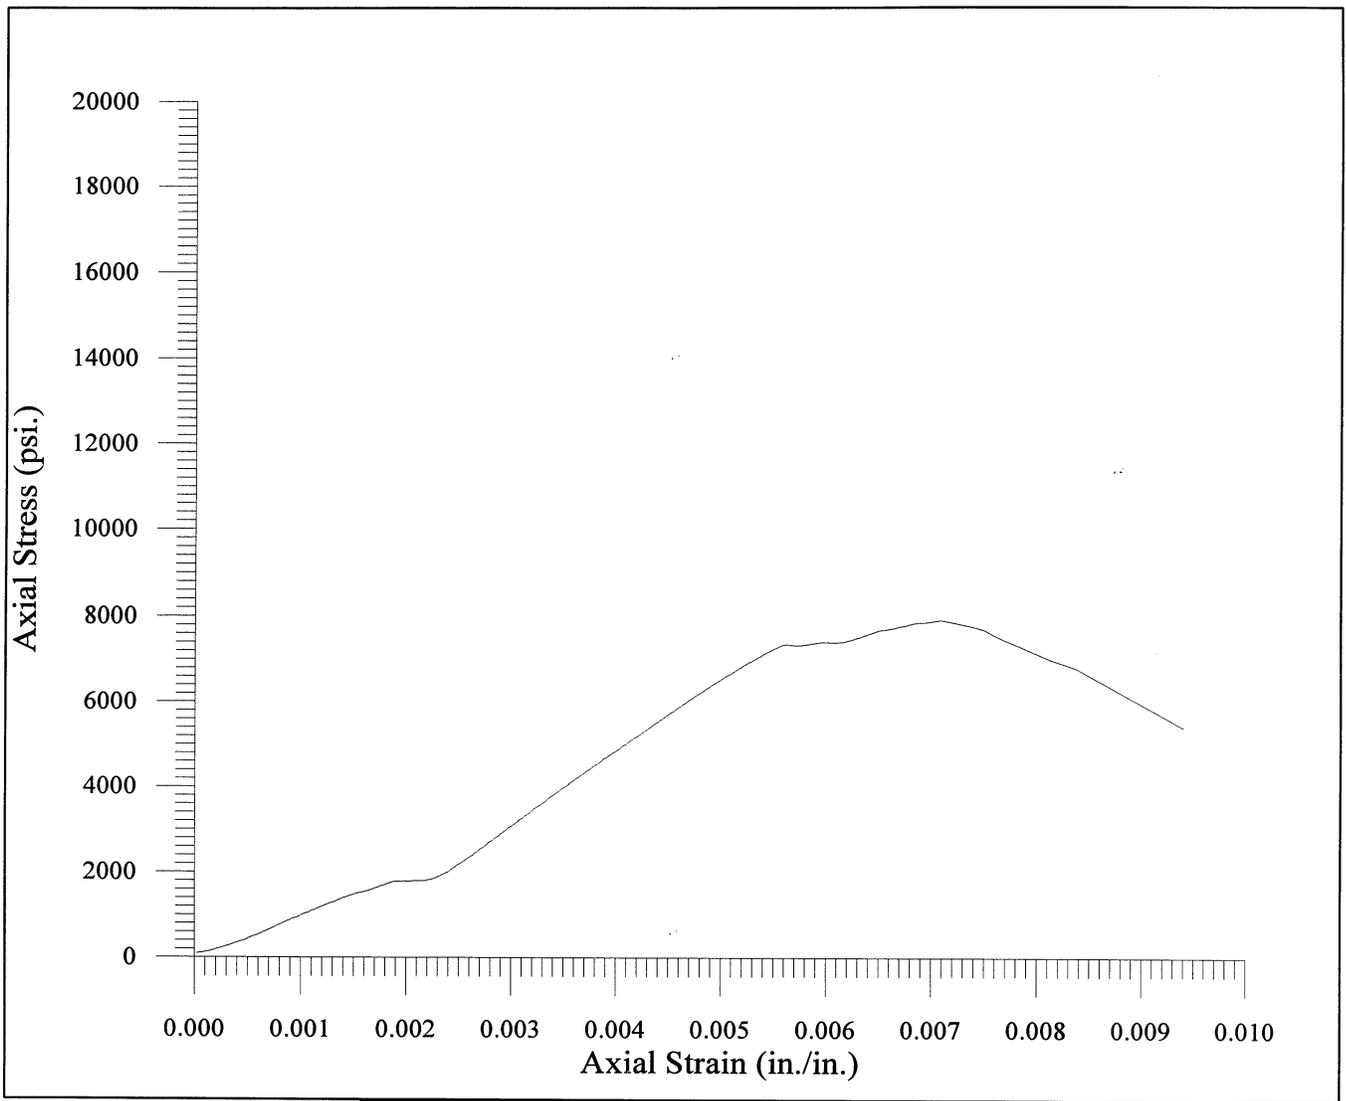
**UNCONFINED COMPRESSION TEST**  
**Axial Stress vs. Axial Strain**

UC: 1<sup>st</sup> relaxation probably due to compression of the joint. Failed by splitting.

**SAMPLE ID:** Boring : 98-24A  
 Sample: 6a  
 Depth: 33'

Massive tan sandstone with an unhealed fracture about 72 degrees to the core axis.

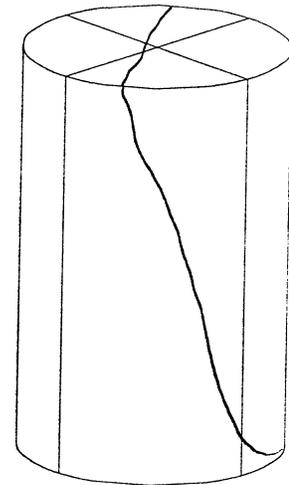
l <sub>1</sub>	l <sub>2</sub>
-0.0009	-0.0002
±0.0001	±0.0001
+0.0009	+0.0001

Avg. diameter: 2.393

Avg. length: 5.325

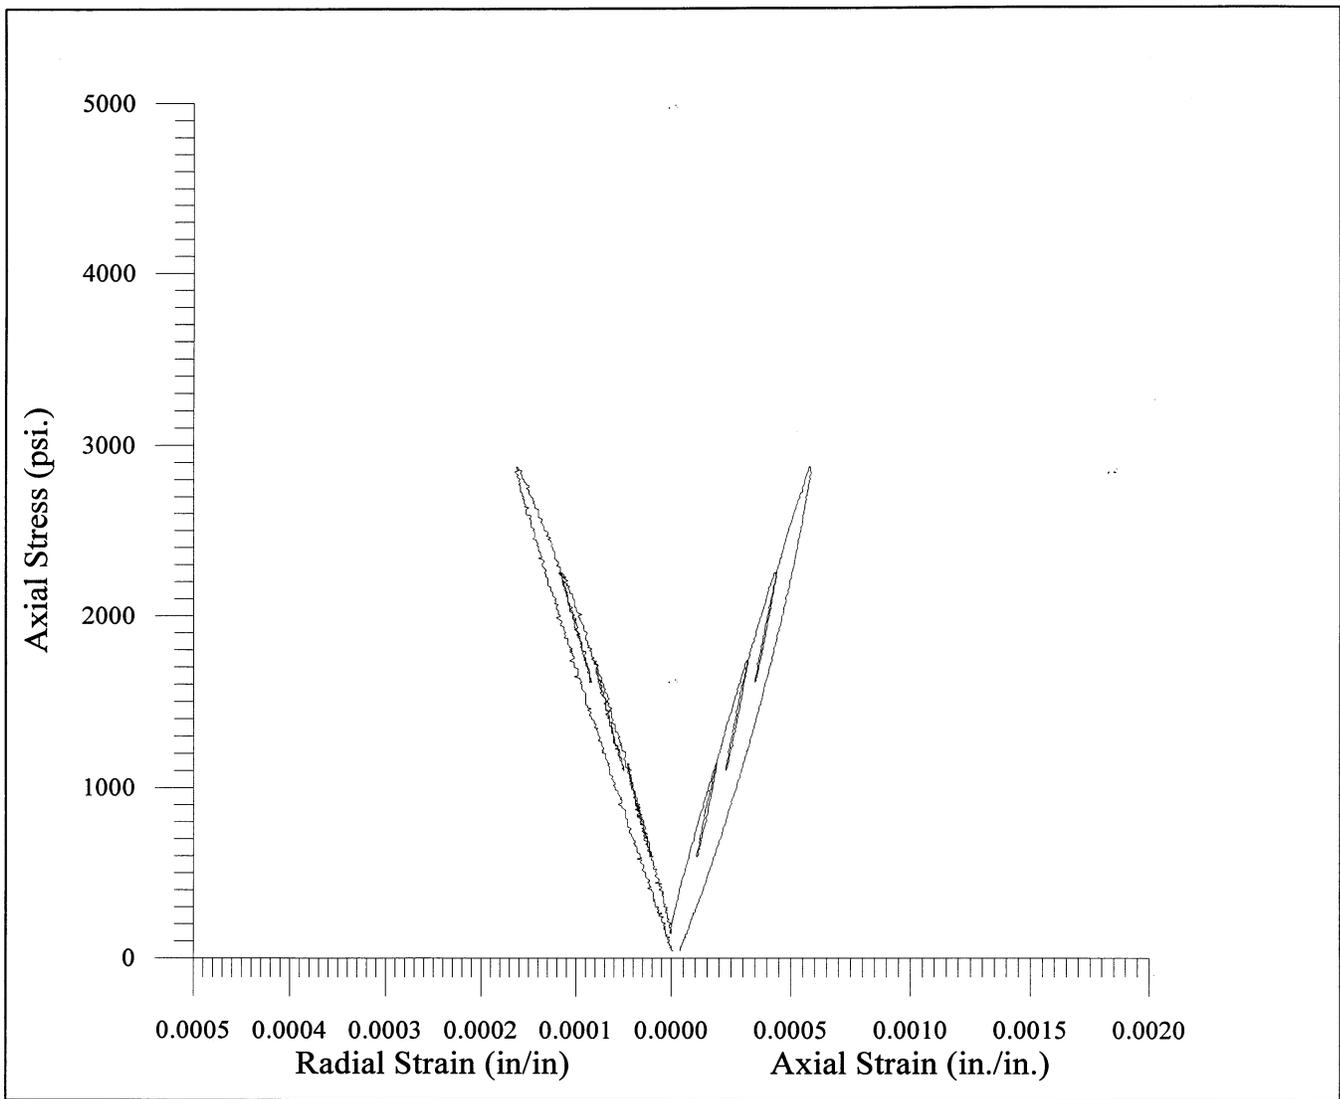
**ELASTIC MODULUS TEST**  
**Axial Stress vs. Axial & Radial Strain**

<p><b>SAMPLE ID:</b> Boring: 98-24a  Sample: 7a  Depth: 38'</p>	<p align="center"> <i>Geo</i>

<i>Test</i>  <b>Unlimited</b> 800 Peralta Ave  San Leandro, CA 94577 </p>
<p align="center"><b>DESCRIPTION</b></p> <p>Medium dark gray fine sandy siltstone with a calcite healed hairline fracture about 15 degrees to the core axis.</p> <p><b>MODULUS:</b> 6,670,000 psi  <b>POISSON'S RATIO:</b> .33</p>	<p><b>Client:</b> Fugro West, Inc.  5855 Olivas Park Dr.  Ventura, CA 93003</p> <p><b>Project:</b> San Francisco Oakland Bay Bridge  East Span Replacement Project</p> <p><b>Job Number:</b> 98-42-0053</p>
	<p><b>Test Date:</b> October 27, 1998</p>

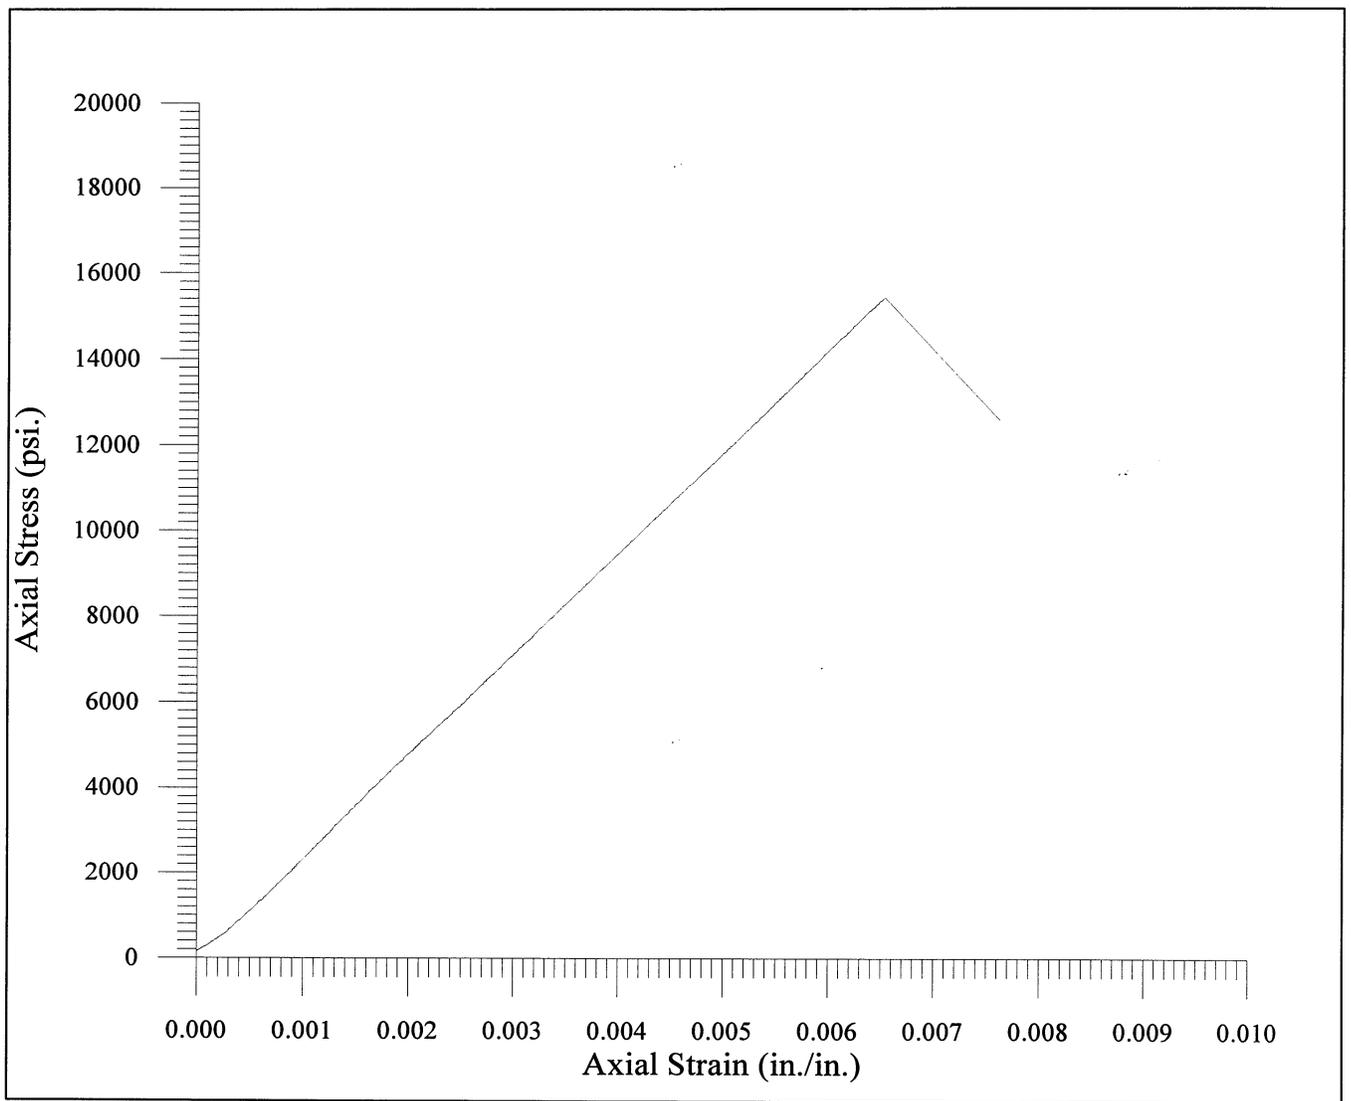
**UNCONFINED COMPRESSION TEST**  
**Axial Stress vs. Axial Strain**

Comments: failed by axial splitting along steep healed joint.

<p><b>SAMPLE ID:</b> Boring : 98-24A  Sample: 7a  Depth: 38'</p> <p align="center"><b>DESCRIPTION</b></p> <p>Medium dark gray fine sandy siltstone with a calcite healed hairline fracture about 15 degrees to the core axis.</p> <p><b>STRENGTH:</b> 15,417 psi</p>

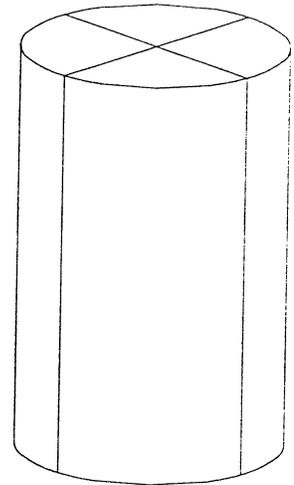
l <sub>1</sub>	l <sub>2</sub>
-.0008	-.0002
+.0001	+.0001
+.0008	+.0001

Avg. diameter: 2.375

Avg. length: 5.306"
