**SUBCONTRACTOR REPORTS  
FINAL GEOTECHNICAL  
SITE CHARACTERIZATION**

**SAN FRANCISCO-OAKLAND BAY BRIDGE  
EAST SPAN SEISMIC SAFETY PROJECT**

**VOLUME 2 OF 3  
(GeoTest Unlimited)**

Letter Report  
San Francisco Oakland Bay Bridge  
East Span Replacement Project  
Rock Testing Program

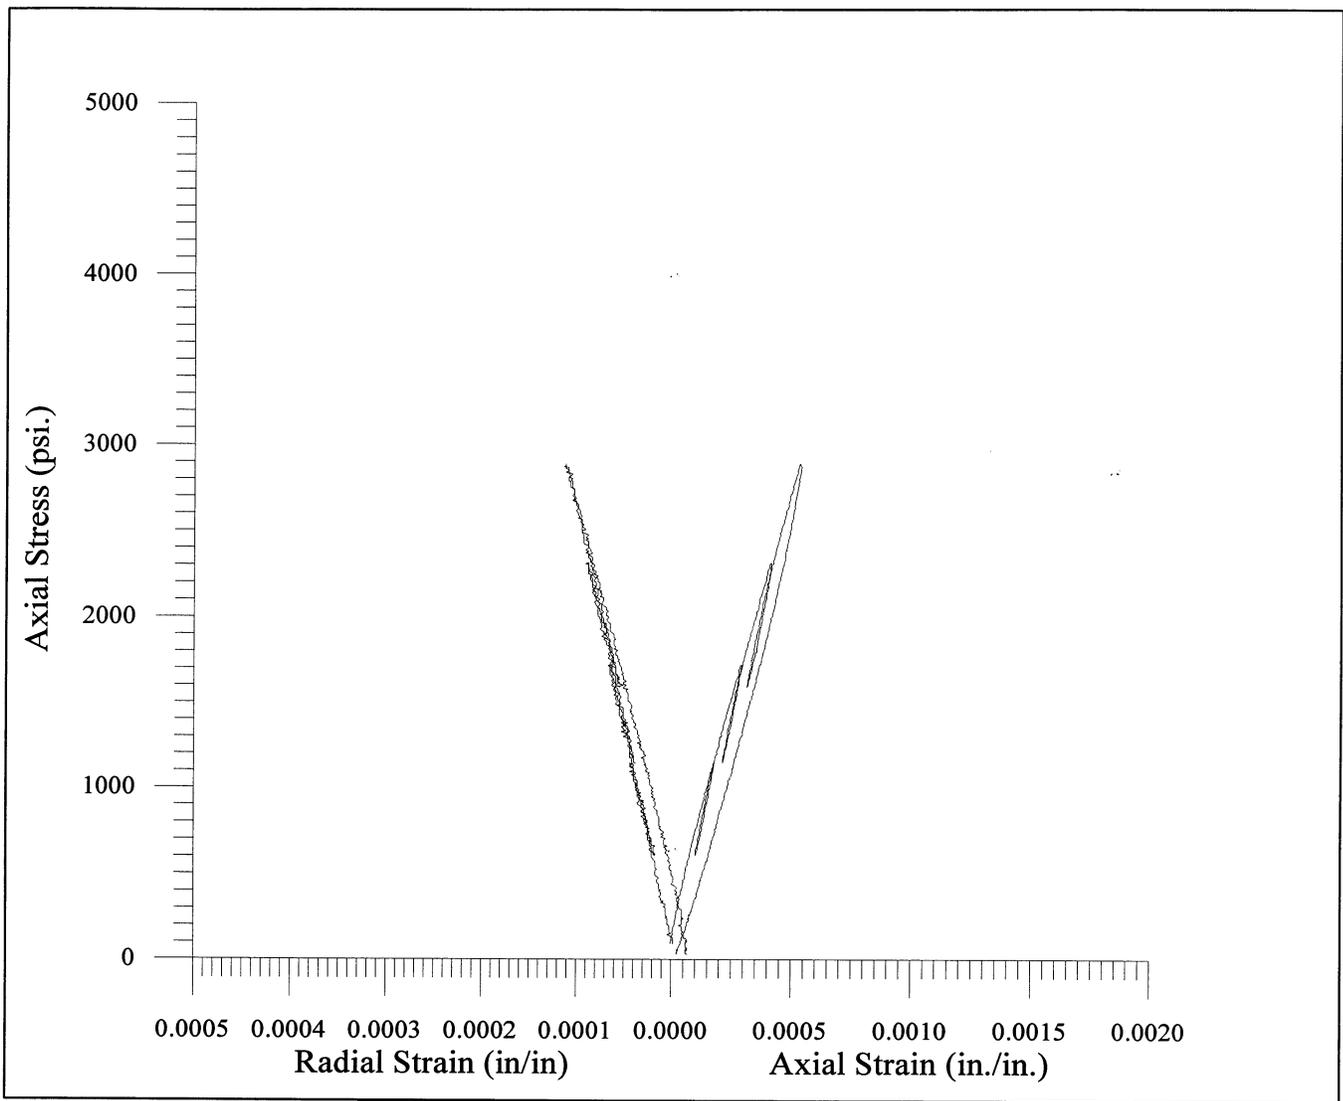
**ELASTIC MODULUS TEST  
Axial Stress vs. Axial & Radial Strain**

<p><b>SAMPLE ID:</b> Boring: 98-24a Sample: 8a Depth: 48'</p> <p><b>DESCRIPTION</b> Dark gray massive fine sandy siltstone with no visible fractures.</p> <p><b>MODULUS:</b> 7,040,000 psi <b>POISSON'S RATIO:</b> .31</p>	<div style="text-align: center;">

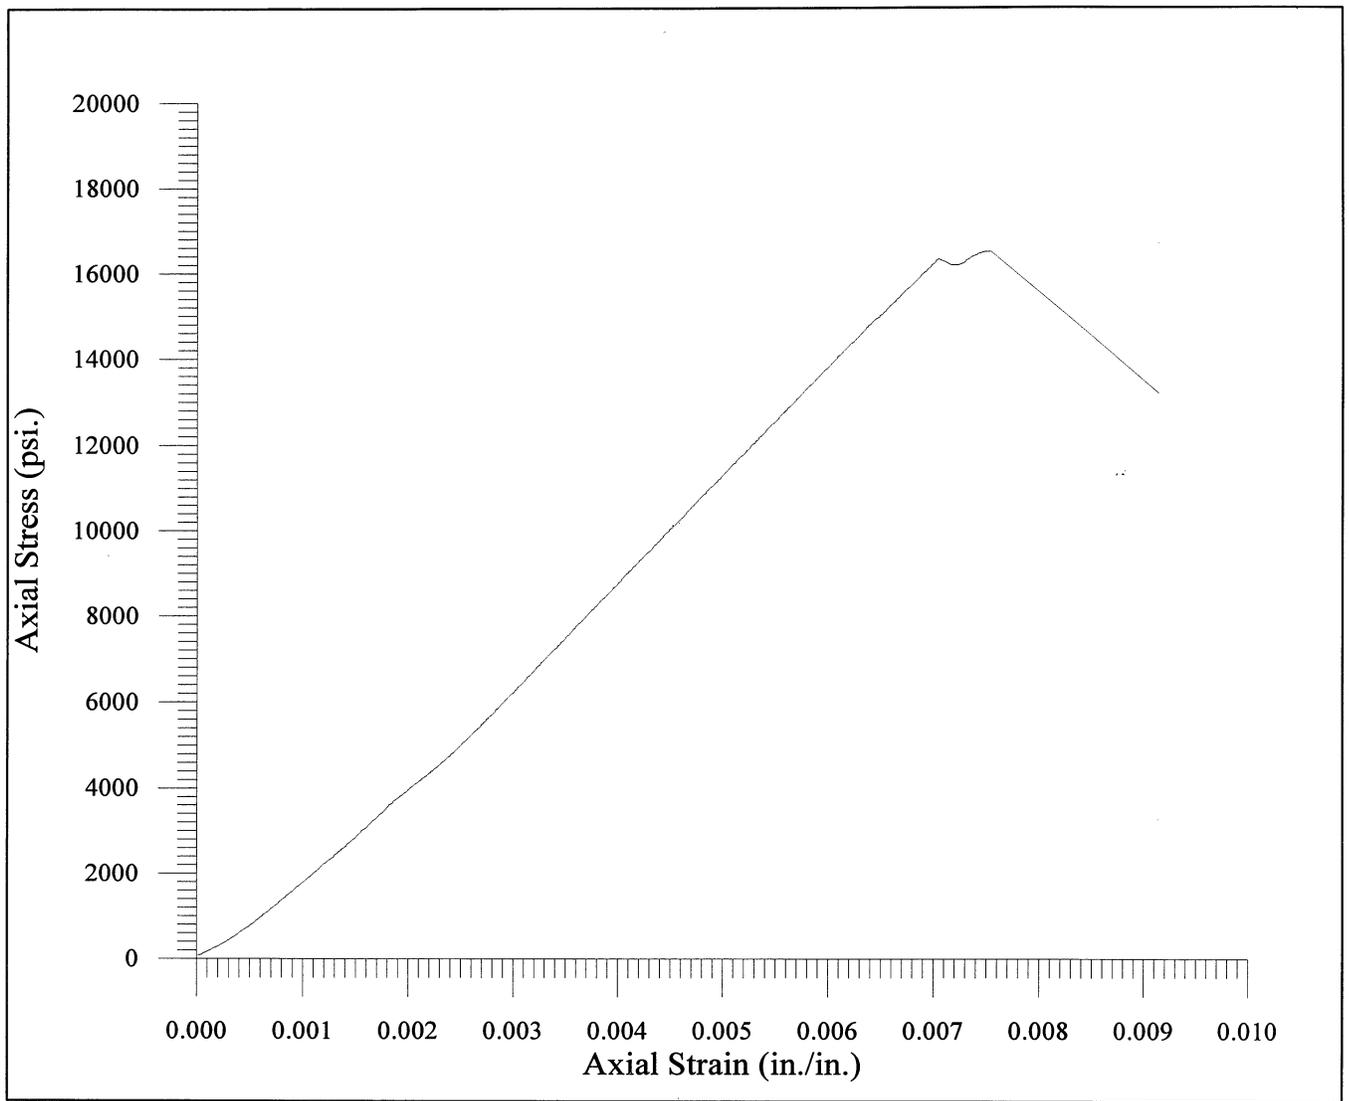
**UNCONFINED COMPRESSION TEST**  
**Axial Stress vs. Axial Strain**

Comments: Failed by axial splitting

<p><b>SAMPLE ID:</b> Boring : 98-24A          Sample: 8a          Depth: 48'</p>	<p align="center"> <i>Geo</i>

<i>Test</i>  <b>Unlimited</b> 800 Peralta Ave          San Leandro, CA 94577       </p>
<p align="center"><b>DESCRIPTION</b></p> <p>Dark gray massive fine sandy siltstone          with no visible fractures.</p> <p><b>STRENGTH:</b> 16,514 psi</p>	<p><b>Client:</b> Fugro West, Inc.          5855 Olivas Park Dr.          Ventura, CA 93003</p> <p><b>Project:</b> San Francisco Oakland Bay Bridge          East Span Replacement Project</p> <p><b>Job Number:</b> 98-42-0053</p>
	<p><b>Test Date:</b> October 27, 1998</p>

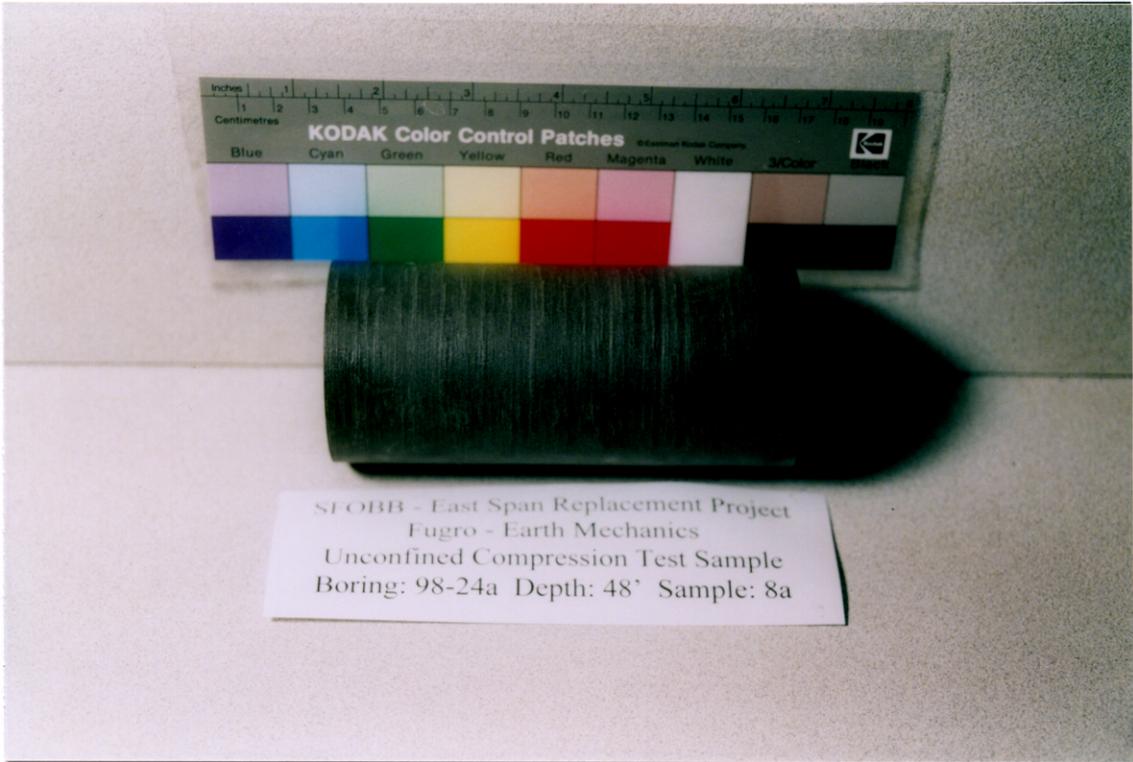
SFOBB - East Span Replacement Project  
Fugro - Earth Mechanics  
Unconfined Compression Test Sample  
Boring: 98-24a Depth: 48' Sample: 8a
