Paint Condition Index (PCI)

Paint Condition Index (PCI) - State Bridges

Bridge Paint (Protective Coating) 5-Year Plan

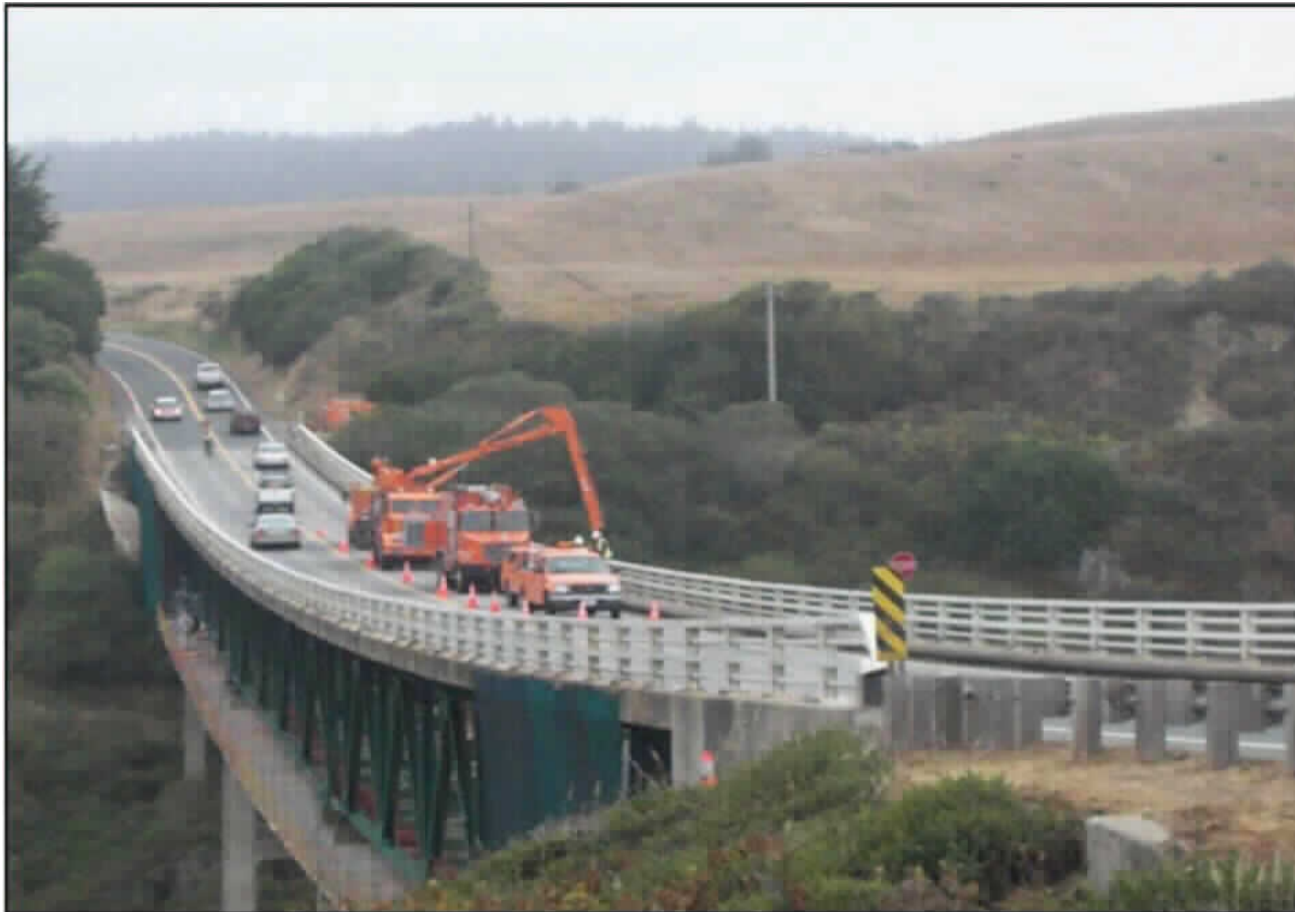
The Paint Condition Index (PCI) is a 0-100 ranking system that utilizes the current paint condition (called condition states) of the various painted steel elements on the bridge.

The PCI weighs the quantity and condition states of the various painted elements as well as the importance of that element in the bridge. A ranking of 80-100 would indicate a paint system in good to excellent condition; a ranking of 0-20 would indicate a totally failed paint system. SM&I inspectors make paint work recommendations for all bridges where the PCI ranking is less than 65.
