FHWA/CA/TE-98/15

Over-Embankment Accidents on Rural 2-Lane Conventional Highways

October 1998

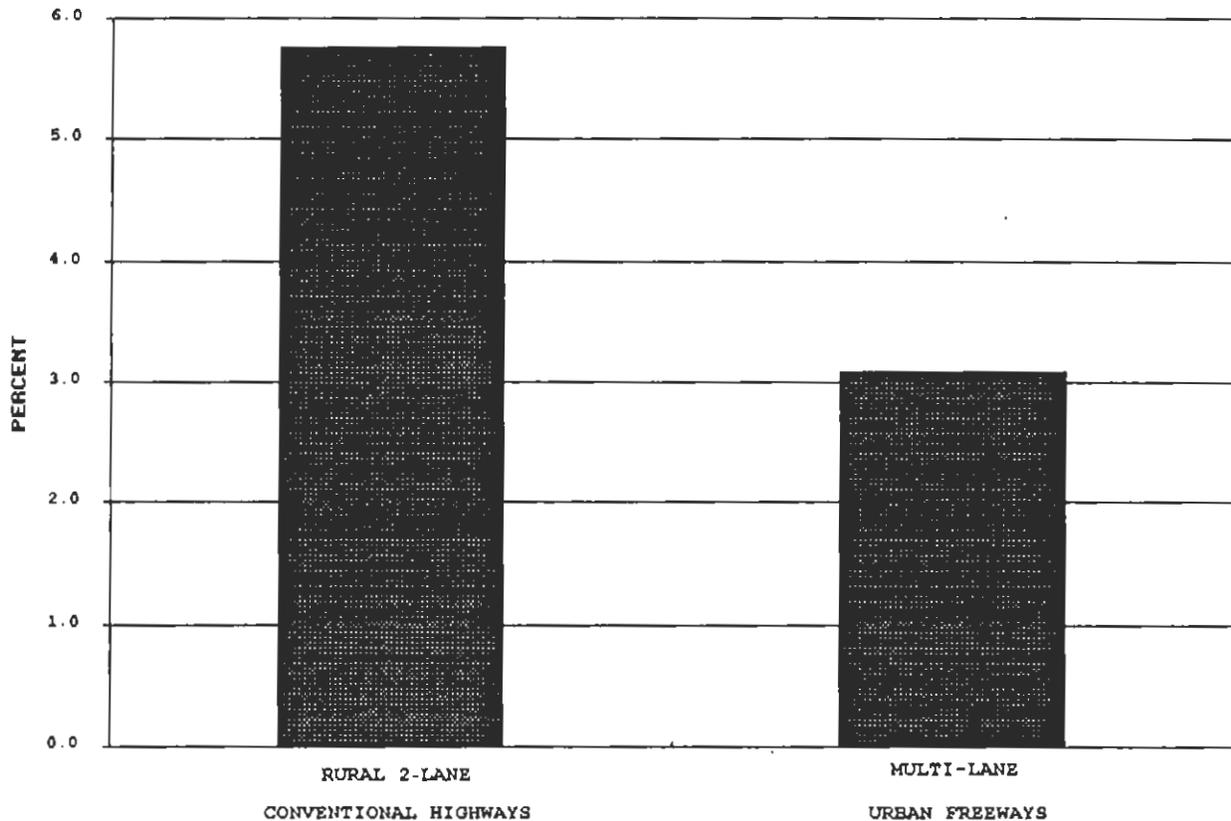
PERCENTAGE OF OVER-EMBANKMENT ACCIDENTS
INVOLVING FATALITIES BY ROADWAY TYPE (1992)

Research regarding over-embankment accidents by the California Department of Transportation (Caltrans) began in the 1960's. The first study¹ compared the severity of over-embankment accidents with that of hitting guardrail on freeways. The over-embankment accidents investigated did not include accidents where the vehicle hit a fixed object or where the vehicle went into the water. The results of this study and an updated study² led to the development of the "equal severity curve" as well as guidelines for the placement of embankment guardrail. These guidelines have been effective in reducing the number and severity of over-embankment accidents on freeways. However, as the following graph shows, in 1992 the percentage of over-embankment accidents on rural 2-lane conventional highways involving fatalities was nearly two times higher than that on multi-lane urban freeways.
