TOLL PROGRAM/DIST. 4 CONSTR.

Job Stamp:  
04-SF-80-13.2/13.9 04-0120F4  
SFOBB SAS  
San Francisco Co. in San Francisco  
Fm 0.6 km to 1.3 km East of Yerba Buena  
Tunnel East Portal

**ASSISTANT RESIDENT ENGINEER'S DAILY**

Location: <b>W2 Cap Beam</b>	7-day const. cal.: <b>519</b>	Weather: <b>clear/warm</b>
Remark: <b>Hinge K, CBT ducts,</b>	Project work day: <b>729</b>	<b>Hi 99F/Lo 61F</b>

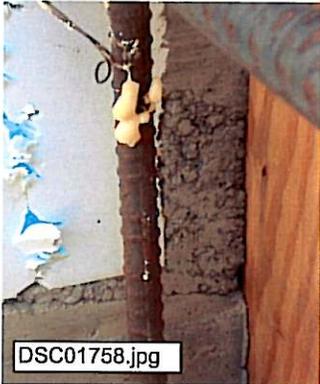
Weekly Safety Meeting - "sun safety"  
ABF continued to assemble the second 2nd Hinge K assembly on the ground. They have the anchor plate up as well as the template. They are also starting to drill holes in their prefabricated forms with the styrofoam. Up above, ABF is continuing to remove the bulkheads at the ends of the walls and diaphragms. There are a few locations that had poor consolidation of the SCC concrete (DSC01758). The right side of the picture is the east face of W2 Cap Beam - south bulkhead on the east wall. Overall (from forms removed thus far), the consolidation looks adequate with random locations of bug holes. I have not seen any rock pockets yet. The cooling hoses are being disconnected from the manifolds.  
RPS continues to place duct for the CBT tendons through the south column area.  
The horizontal placement of the ducts thus far have been verified (east side). The grades for these ducts are also good on the East side of the column cages.
