**DEPARTMENT OF TRANSPORTATION**

Contract #: 04-0120F4Cty: SF/ALA Rte: 80 PM: 13.2/13.9File #: 99.15**SOURCE INSPECTION REPORT****Resident Engineer:** Pursell, Gary**Address:** 333 Burma Road**City:** Oakland, CA 94607**Report No:** SIR-000323**Date Inspected:** 12-Dec-2008**Project Name:** SAS Superstructure**OSM Arrival Time:** 1900**Prime Contractor:** American Bridge/Fluor Enterprises, a JV**OSM Departure Time:** 2300**Contractor:** Zhenhua Port Machinery Company, Ltd (ZPMC), Changxing Island**Location:** Changxing Dao, Shanghai**Quality Control Contact:** William Oak (ABF)**Quality Control Present:** Yes No**Material transfer:** Yes No N/A**Sampled Items:** Yes No N/A**Stock Transfer:** Yes No N/A**OK to Cut:** Yes No N/A**Rebar Test Witness:** Yes No N/A**Delayed/Cancelled:** Yes No N/A**Other:** Coatings Inspection**Bridge No:** 34-0006**Component:****Bid Item:** 79**Lot No:****Summary of Items Observed:**

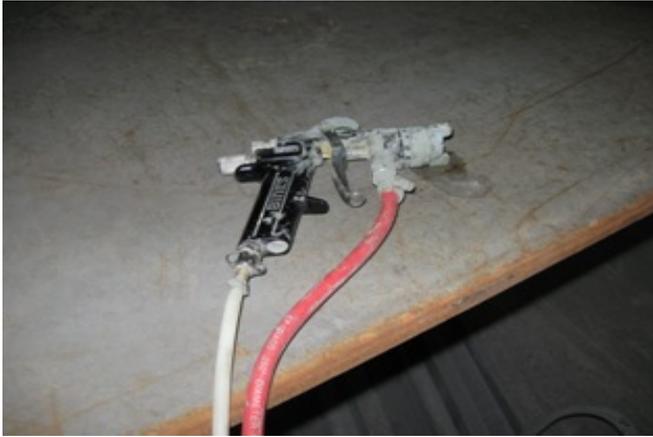
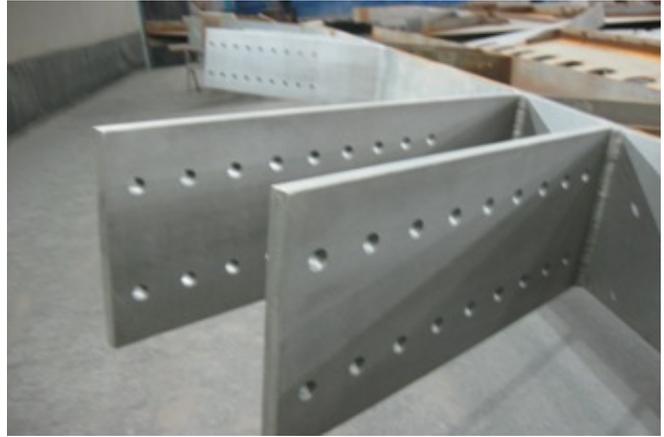
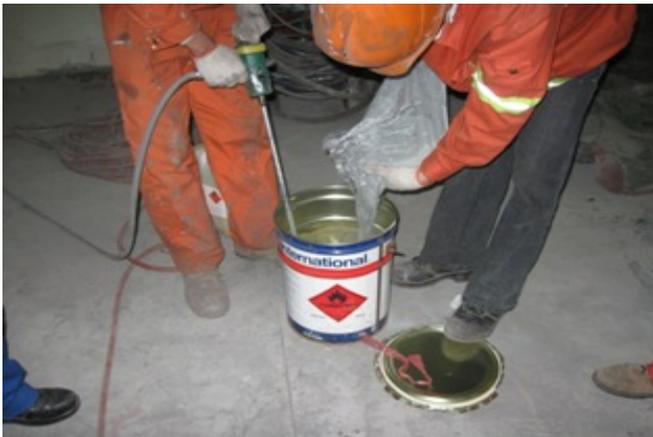
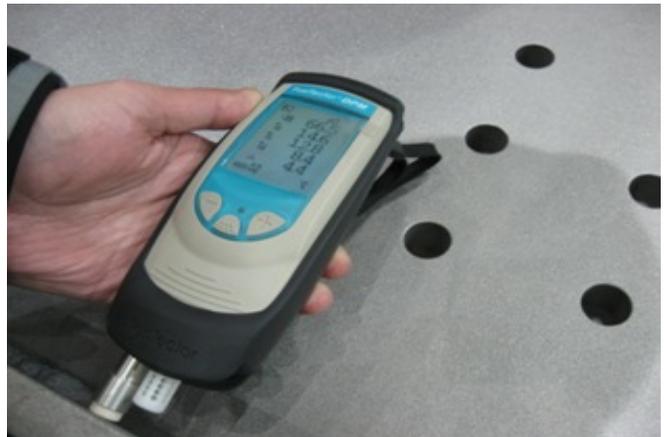
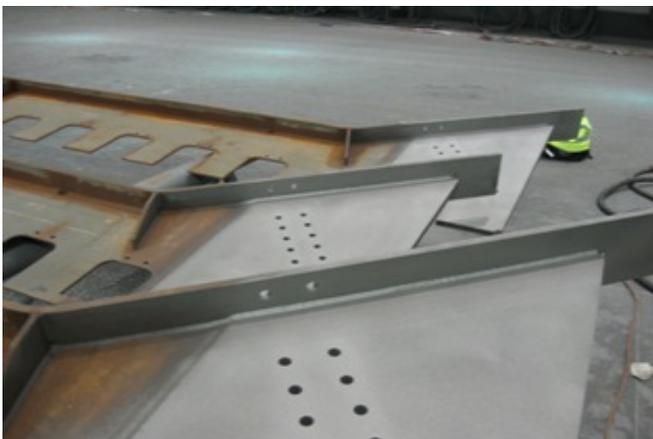
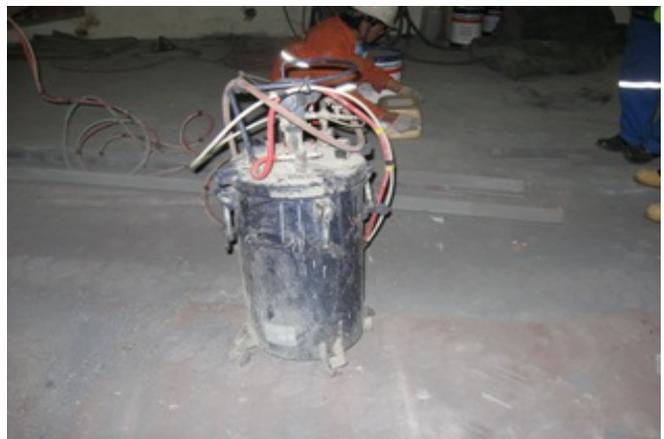
used an overlapping method (appearing to be approximately 50% overlap visually) keeping the flow of material parallel to the steel (no flipping or fanning of the wrist).

A blast inspection was requested by ABF at 20:30. They completed the blasting early so the inspection was moved up to 19:30. ZPMC and ABF QC inspectors and International Coatings representative were present and performing their tasks. The faying surfaces of (5pcs) Diaphragm top part: FB003-021, FB003-031, FB003-032, FB003-43, FB03-049; (4 pcs) Diaphragm bottom part: FB005-008, FB013-009, FB013-013, FB015-043 were abrasive blasted using steel recyclable abrasive in a controlled environment. Deficiencies were corrected prior to QA inspection. ZPMC QC performed ambient conditions and profile readings witnessed by all parties to be satisfactory. Relative Humidity in the blast area was 66%. The Testex blast profile tapes (X-Course) taken were read using a micrometer. 3 tapes were taken on different pieces in the faying surface area. Micrometer readings were 66ug, 78ug and 76ug averaging 73.33ug blast profile.

One kit of International Coatings Interzinc 22 (Part A base batch # JF0964PV, Part B zinc powder batch # JF0963PV, Thinner available batch # JK3204PV) was mixed using a hand held power mixer. Addition of thinner if any was not witnessed by QA. The zinc powder was slowly poured into the base as it was being agitated. The mixed coating was then poured into a conventional spray pot of suitable size to contain the entire mixed kit. Mixed coating temperature was not observed by QA. The spray pot is equipped with a working agitator to keep the material mixed. The spray gun is of the conventional type with separate air and fluid lines running from the spray pot to the gun. With this type of spray gun the fluid is released from the gun by pulling the trigger. Air from the air cap atomizes the fluid outside the gun to create a spray fan.

Ambient conditions in the paint area taken prior to applying the steel were 65.6% RH, 8.6°C dew point, 11.7°C steel temp. Application of the coating began within the specified 4 hour window from blasting. The applicator
