DEPARTMENT OF TRANSPORTATION

SOURCE INSPECTION REPORT

Report No: SIR-002115
Date Inspected: 09-Apr-2010

Project Name: SAS Superstructure **OSM Arrival Time:** 900
Prime Contractor: American Bridge/Fluor Enterprises, a JV **OSM Departure Time:** 1900
Contractor: Zhenhua Port Machinery Company, Ltd (ZPMC), Changxing Island **Location:** Shanghai, China

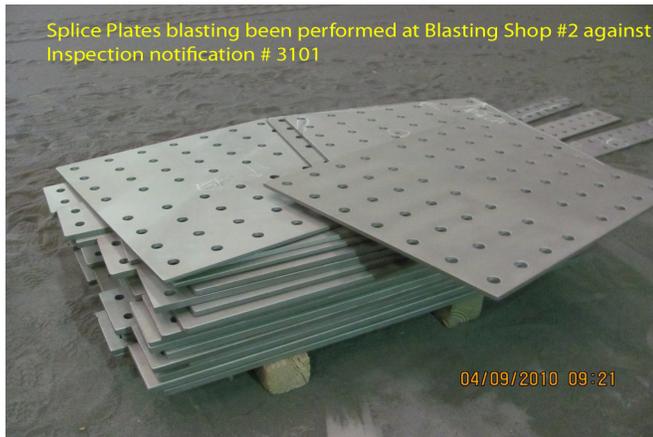
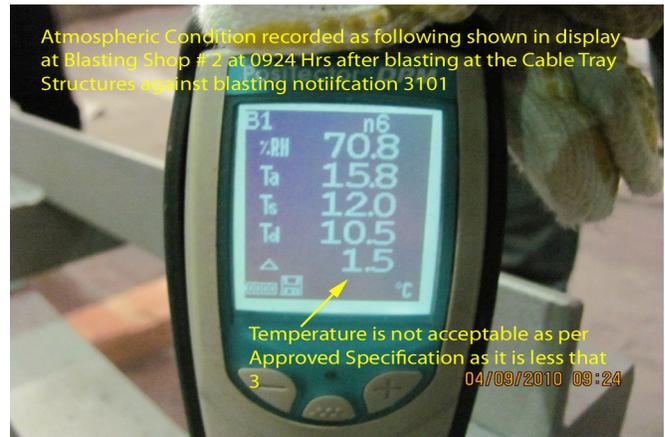
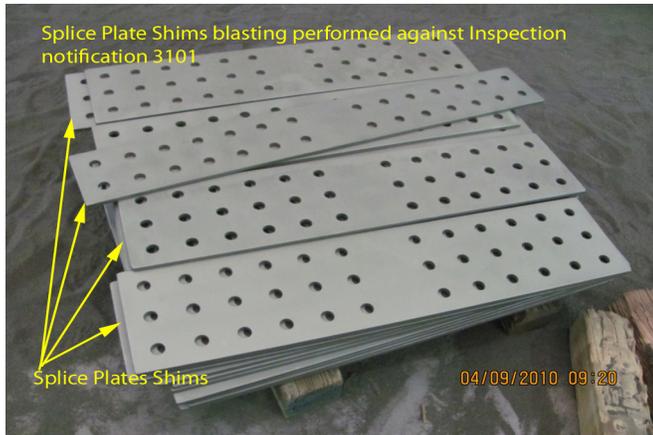
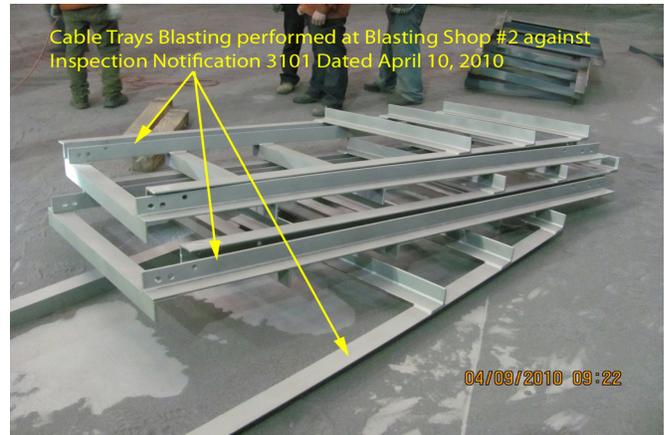
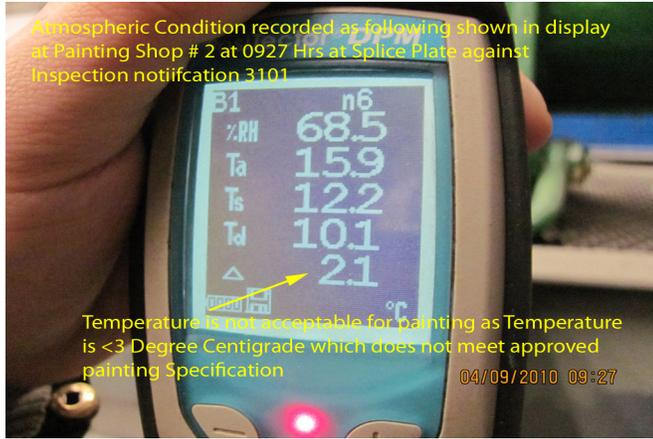
Please refer the pictures attached for more comprehensive details.

Inspection Conclusions: Accepted by ABF QA's 6 Locations of Profile Test performed and profile roughness observed between 70 to 85 microns, 1 Location Residual Chloride Test performed and result observed as 10 microns/cm the Atmospheric Temperatures were recorded at 0922 Hrs (at Blast shop no.2) and 0927 Hrs (at Painting shop no.2) and observed not meeting the Painting Specification Finally Atmospheric Temperature was recorded at 1500 Hrs (Painting Shop no. 2) and found atmospheric conditions satisfactory and Caltrans QA concurred with the ABF QA's Inspection.

Inspection Conclusions: Rejected by ABF QA's reason been Fabrication defects were located and asked for performing Magnetic Particle Test (MT) and Grinding, 2 Locations Residual Chloride Test performed and result observed as 10 microns/cm and 30 microns/cm and Caltrans QA concurred with the ABF QA's Inspection.
