DEPARTMENT OF TRANSPORTATION

Office of Structural Materials

Contract #: 04-0120F4Cty: SF/ALA Rte: 80 PM: 13.2/13.9File #: 69.28**WELDING INSPECTION REPORT****Resident Engineer:** Pursell, Gary**Address:** 333 Burma Road**City:** Oakland, CA 94607**Report No:** WIR-000713**Date Inspected:** 29-Oct-2007**Project Name:** SAS Superstructure**OSM Arrival Time:** 1330**Prime Contractor:** American Bridge/Fluor Enterprises, a JV**OSM Departure Time:** 2300**Contractor:** Zhenhua Port Machinery Company, Ltd (ZPMC), Changxing Island **Location:** Shanghai, China**CWI Name:** Zhu Zhong Hai**CWI Present:** Yes No**Inspected CWI report:** Yes No N/A**Rod Oven in Use:** Yes No N/A**Electrode to specification:** Yes No N/A**Weld Procedures Followed:** Yes No N/A**Qualified Welders:** Yes No N/A**Verified Joint Fit-up:** Yes No N/A**Approved Drawings:** Yes No N/A**Approved WPS:** Yes No N/A**Delayed / Cancelled:** Yes No N/A**Bridge No:** 34-0006**Component:** 77 Skin-D & E**Summary of Items Observed:**

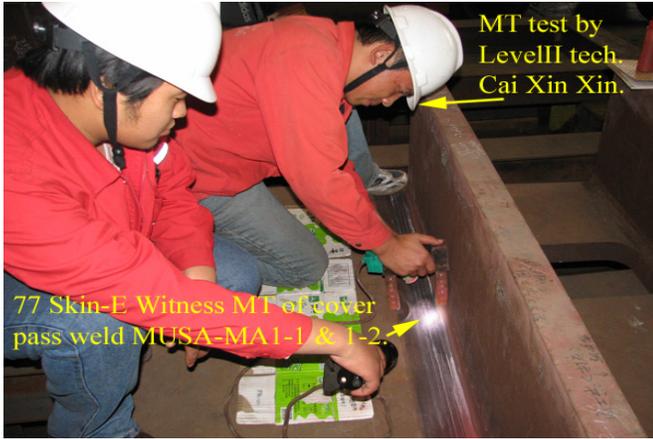
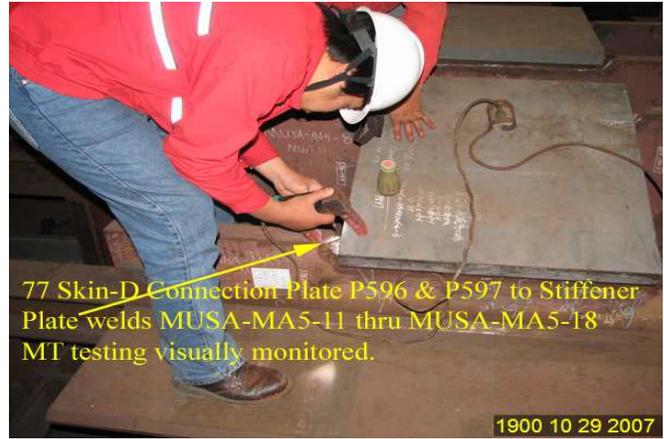
Item-1 77 Skin-D The top of stiffener plates MP3, MP4, MP8-2 and MP8-1 at the 1 to 1 transition where the stiffeners are in contact and welded to the underside of connection plates P597 and P596 a Magnetic Particle (MT) test was performed by Zhenhua Port Machinery Company (ZPMC) Level II MT technicians Cai Xin Xin and Zhou Dong Yun. This test was visually monitored by Caltrans QA Inspector and was MT/OK. This QA Inspector did MT test areas of these welds, MUSA-MA5-11 through MUSA-MA5-18, and found them to be in compliance with the project specifications.

Item-2 77 Skin-E Stiffener plate 3 #MA1-3 to base plate MA15 welds MA1-1 and MA1-2 were visually monitored during the MT test performed by ZPMC Level II MT technician Cai Xin Xin and was MT/OK. This Caltrans QA Inspector did an MT test on areas of these welds and found them to be in compliance with the project specifications.
