Contract #: 04-0120F4Cty: SF/ALA Rte: 80 PM: 13.2/13.9File #: 69.28**WELDING INSPECTION REPORT****Resident Engineer:** Pursell, Gary**Address:** 333 Burma Road**City:** Oakland, CA 94607**Report No:** WIR-010400**Date Inspected:** 18-Nov-2009**Project Name:** SAS Superstructure**OSM Arrival Time:** 700**Prime Contractor:** American Bridge/Fluor Enterprises, a JV**OSM Departure Time:** 1900**Contractor:** Zhenhua Port Machinery Company, Ltd (ZPMC), Changxing Island **Location:** Shanghai, China**CWI Name:** Chen Xi**CWI Present:** Yes No**Inspected CWI report:** Yes No N/A**Rod Oven in Use:** Yes No N/A**Electrode to specification:** Yes No N/A**Weld Procedures Followed:** Yes No N/A**Qualified Welders:** Yes No N/A**Verified Joint Fit-up:** Yes No N/A**Approved Drawings:** Yes No N/A**Approved WPS:** Yes No N/A**Delayed / Cancelled:** Yes No N/A**Bridge No:** 34-0006**Component:** OBG Crossbeams**Summary of Items Observed:**

OBG CROSS BEAM CB1

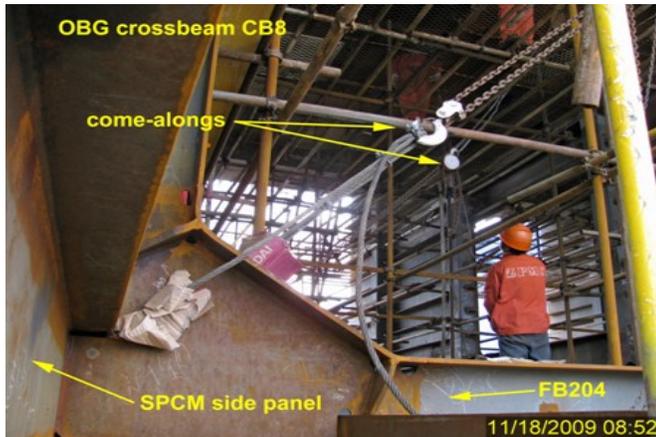
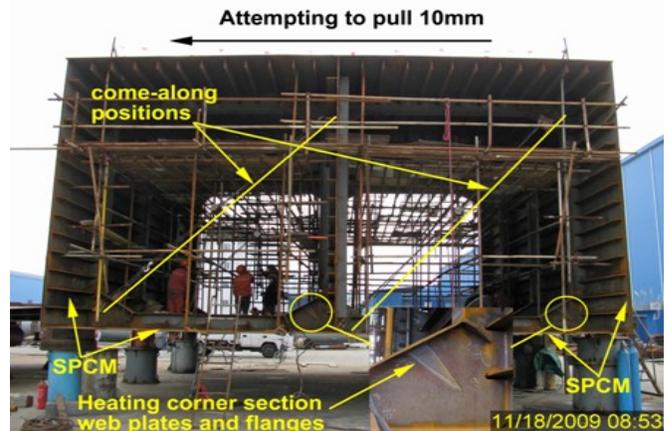
Unless otherwise noted, all work observed on this date appeared to be in general compliance with the applicable contract documents.

This QA observed ZPMC personnel attempting to correct an “out of square” condition on this crossbeam. According to ZPMC Quality Control (QC) inspector identified as Mr. Liu Cheun Gang, this crossbeam was fabricated 10mm out of square. This QA noted that all welding has been completed on this crossbeam. This QA observed ZPMC personnel rigging hand operated winches (come-alongs) diagonally, top to bottom, inside of the crossbeam at two floor beam diaphragm locations on each side of the intermediate panel. This QA observed that ZPMC appears to have heated the web and flange plates on the floor beam diaphragm corner sections. ZPMC QC presented this QA with two Heat Straightening Records (HSRs) for review. This QA observed the work being performed did not appear to comply with either one of the HSRs. The HSRs do not mention the use of come-alongs and the locations of the heat applications appear to be inconsistent with the locations detailed on the HSRs. See attached photos for details. This QA informed ZPMC QA identified as Mr. Zhang Wei and ABF QA inspector identified as Mr. Kelvin Cheung of this issue and that an incident report would be generated.
