DEPARTMENT OF TRANSPORTATION

Office of Structural Materials

Contract #: 04-0120F4Cty: SF/ALA Rte: 80 PM: 13.2/13.9File #: 69.28**WELDING INSPECTION REPORT****Resident Engineer:** Pursell, Gary**Address:** 333 Burma Road**City:** Oakland, CA 94607**Report No:** WIR-014093**Date Inspected:** 08-May-2010**Project Name:** SAS Superstructure**OSM Arrival Time:** 700**Prime Contractor:** American Bridge/Fluor Enterprises, a JV**OSM Departure Time:** 1900**Contractor:** Zhenhua Port Machinery Company, Ltd (ZPMC), Changxing Island **Location:** Shanghai, China**CWI Name:** Gao Zhi Chun, Tu Jun**CWI Present:** Yes No**Inspected CWI report:** Yes No N/A**Rod Oven in Use:** Yes No N/A**Electrode to specification:** Yes No N/A**Weld Procedures Followed:** Yes No N/A**Qualified Welders:** Yes No N/A**Verified Joint Fit-up:** Yes No N/A**Approved Drawings:** Yes No N/A**Approved WPS:** Yes No N/A**Delayed / Cancelled:** Yes No N/A**Bridge No:** 34-0006**Component:** Tower**Summary of Items Observed:**

Bay 11, East Tower lift 4, Step Plate (GREEN TAG NO. 12518)

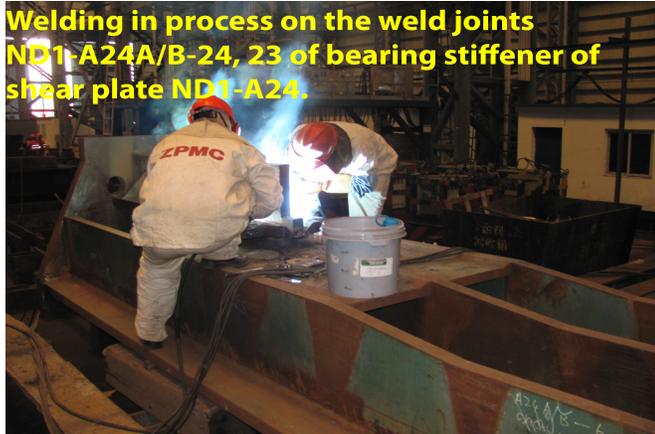
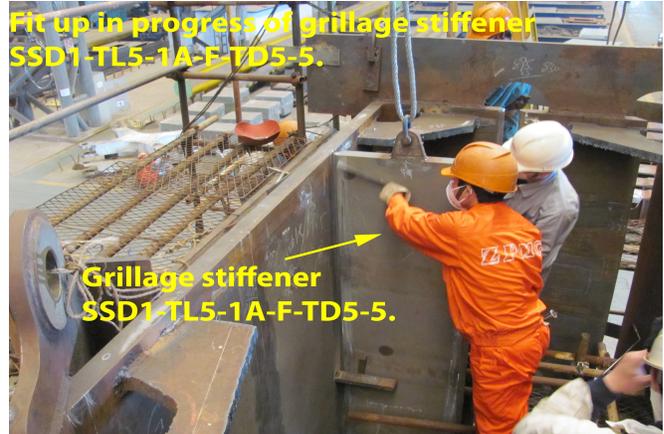
The welding variables recorded by QC appeared to comply with WPS-B-T-2112/2113/2114.
