**DEPARTMENT OF TRANSPORTATION**

Contract #: 04-0120F4Cty: SF/ALA Rte: 80 PM: 13.2/13.9File #: 99.28**WELDING INSPECTION REPORT****Resident Engineer:** Pursell, Gary**Address:** 333 Burma Road**City:** Oakland, CA 94607**Report No:** WIR-016254**Date Inspected:** 17-Aug-2010**Project Name:** SAS Superstructure**OSM Arrival Time:** 700**Prime Contractor:** American Bridge/Fluor Enterprises, a JV**OSM Departure Time:** 1900**Contractor:** Zhenhua Port Machinery Company, Ltd (ZPMC)**Location:** Shanghai, China

<b>CWI Name:</b>	N/A	<b>CWI Present:</b>	Yes	No
<b>Inspected CWI report:</b>	Yes No N/A	<b>Rod Oven in Use:</b>	Yes No N/A	
<b>Electrode to specification:</b>	Yes No N/A	<b>Weld Procedures Followed:</b>	Yes No N/A	
<b>Qualified Welders:</b>	Yes No N/A	<b>Verified Joint Fit-up:</b>	Yes No N/A	
<b>Approved Drawings:</b>	Yes No N/A	<b>Approved WPS:</b>	Yes No N/A	
		<b>Delayed / Cancelled:</b>	Yes No N/A	
<b>Bridge No:</b>	34-0006	<b>Component:</b>	OBG Trial Assembly

Orthotropic Box Girder (OBG) at Trial Assembly Areas

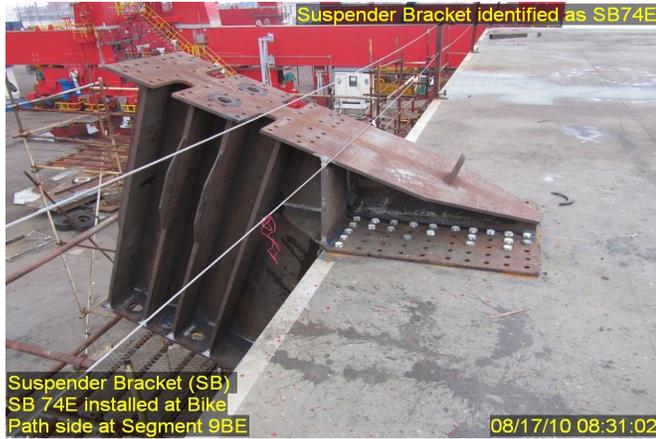
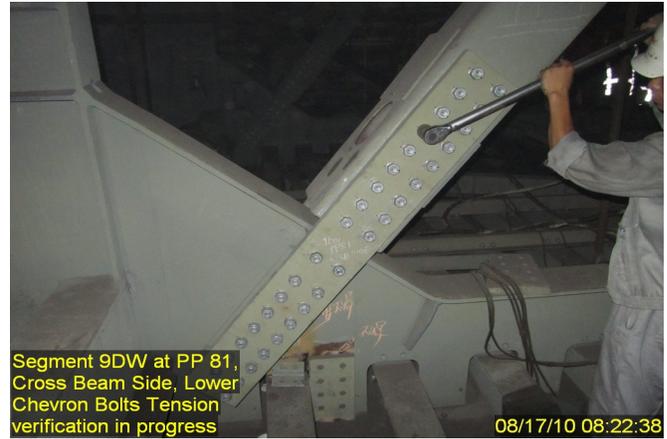
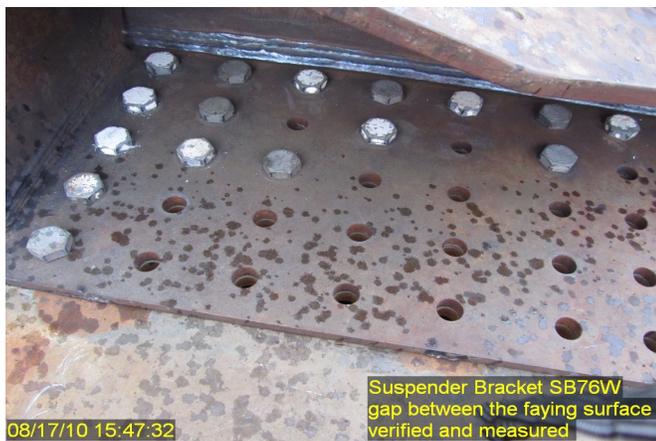
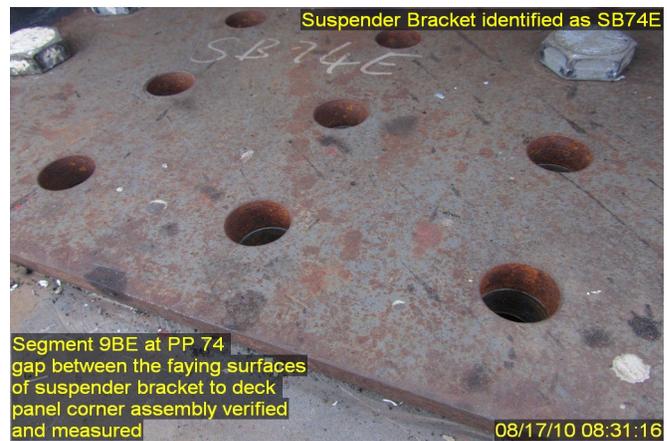
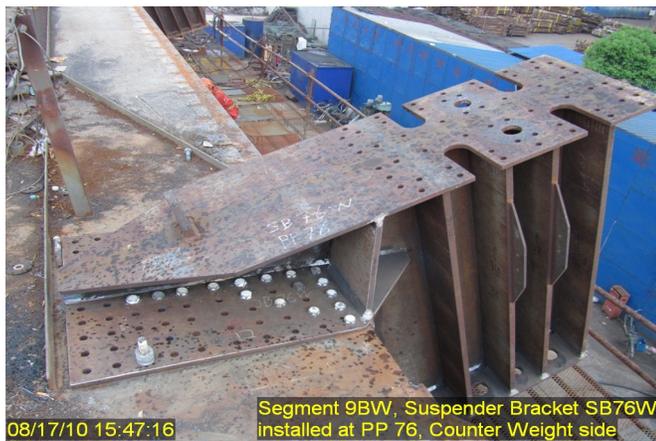
This Quality Assurance (QA) Inspector witnessed final bolt tension verification for Lower Chevron and Upper Chevron at Panel Point (PP) 81 for Segment 9AW at Cross Beam. Inspected 10% on a random basis and found the tension to be in general compliance. Inspection was performed against the Notification No. 00455 Dated August 17, 2010.

This Quality Assurance (QA) Inspector verified and measured the gap between the faying surfaces of Deck Panel Corner Assembly to Suspender Bracket (SB) flange at the pre-installation stage along with ZPMC QC Inspector Mr. Shen Jian Bo and observed the gap to be in general compliance with contact requirements. Inspection was performed against the Notification No. 00012 Dated August 17, 2010.

This QA Inspector performed Joint Inspection along with the ABF QA Inspector to check the Skin Flatness between Segment 9CE to Segment 9DE between Panel Points (PP) 79 and PP 80 at the following locations after repairing the out of tolerance area:
