DEPARTMENT OF TRANSPORTATION

Office of Structural Materials

Contract #: 04-0120F4Cty: SF/Ala Rte: 80 PM: 13.2/13.9File #: 69.28**WELDING INSPECTION REPORT****Resident Engineer:** Pursell, Gary**Address:** 333 Burma Road**City:** Oakland, CA 94607**Report No:** WIR-016320**Date Inspected:** 07-Aug-2010**Project Name:** SAS Superstructure**OSM Arrival Time:** 1900**Prime Contractor:** American Bridge/Fluor Enterprises, a JV**OSM Departure Time:** 700**Contractor:** Zhenhua Port Machinery Company, Ltd (ZPMC), Changxing Island **Location:** Shanghai, China**CWI Name:** See below**CWI Present:** Yes No**Inspected CWI report:** Yes No N/A**Rod Oven in Use:** Yes No N/A**Electrode to specification:** Yes No N/A**Weld Procedures Followed:** Yes No N/A**Qualified Welders:** Yes No N/A**Verified Joint Fit-up:** Yes No N/A**Approved Drawings:** Yes No N/A**Approved WPS:** Yes No N/A**Delayed / Cancelled:** Yes No N/A**Bridge No:** 34-0006**Component:** Tower Components**Summary of Items Observed:**

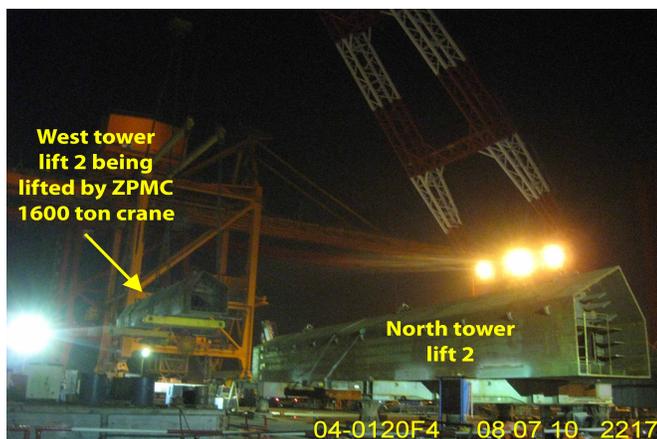
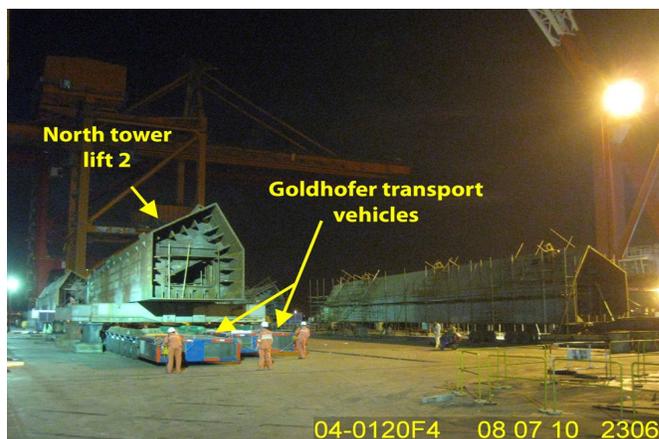
This QA Inspector observed no apparent welding related work was being performed on the Heavy Dock. All 4 tower lift's 3 were connected and positioned on a base pedestal at end of the heavy dock. All 4 tower lift's 2 were positioned horizontally on stanchions on the deck at the end of the heavy dock. The ZPMC 1600 ton floating crane lifted west tower, lift 2 while ZPMC personnel repositioned stanchions underneath to accommodate Goldhofer transport vehicles. Goldhofer transport vehicles then moved under north tower, lift 2. See photos below. ABF Representative Kang Li informed this QA Inspector that no welding work was being performed during this night shift.
