DEPARTMENT OF TRANSPORTATION

Office of Structural Materials

Contract #: 04-0120F4Cty: SF/ALA Rte: 80 PM: 13.2/13.9File #: 69.28**WELDING INSPECTION REPORT****Resident Engineer:** Siegenthaler, Peter**Address:** 333 Burma Road**City:** Oakland, CA 94607**Report No:** WIR-021787**Date Inspected:** 11-Mar-2011**Project Name:** SAS Superstructure**OSM Arrival Time:** 700**Prime Contractor:** American Bridge/Fluor Enterprises, a JV**OSM Departure Time:** 1900**Contractor:** Zhenhua Port Machinery Company, Ltd (ZPMC), Changxing Island **Location:** Shanghai, China**CWI Name:** Li Yang and Zhu Zhong Hai**CWI Present:** Yes No**Inspected CWI report:** Yes No N/A**Rod Oven in Use:** Yes No N/A**Electrode to specification:** Yes No N/A**Weld Procedures Followed:** Yes No N/A**Qualified Welders:** Yes No N/A**Verified Joint Fit-up:** Yes No N/A**Approved Drawings:** Yes No N/A**Approved WPS:** Yes No N/A**Delayed / Cancelled:** Yes No N/A**Bridge No:** 34-0006**Component:** OBG Trial Assembly**Summary of Items Observed:**

Orthotropic Box Girder (OBG) at Trial Assembly Areas

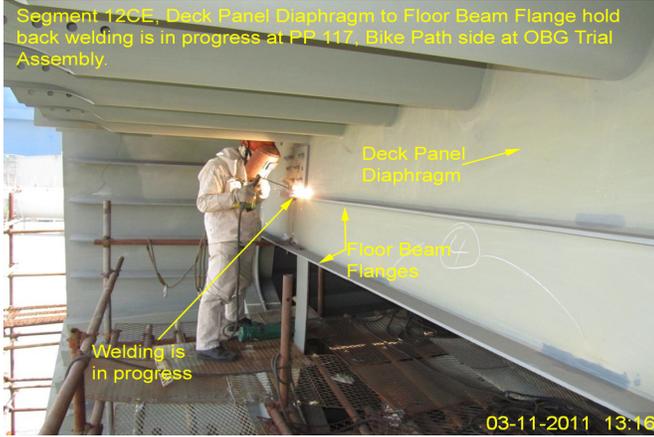
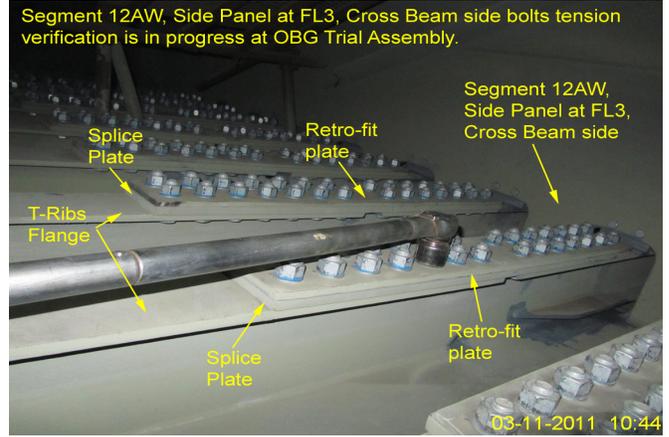
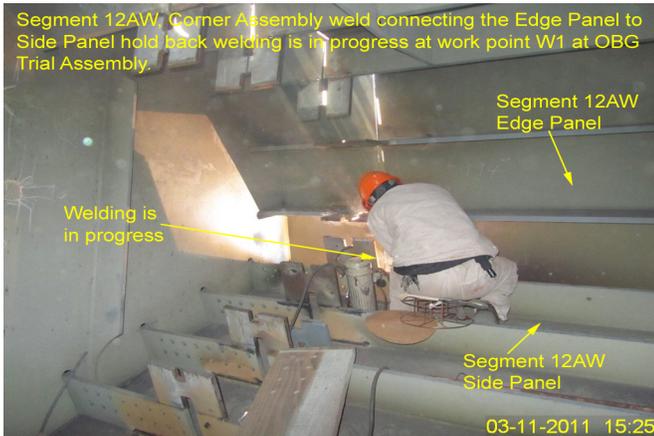
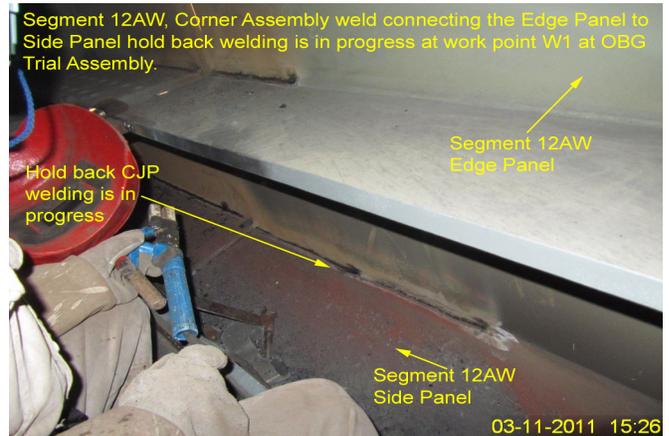
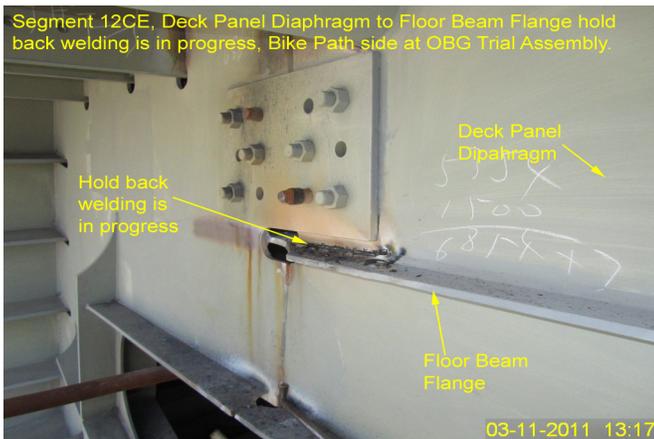
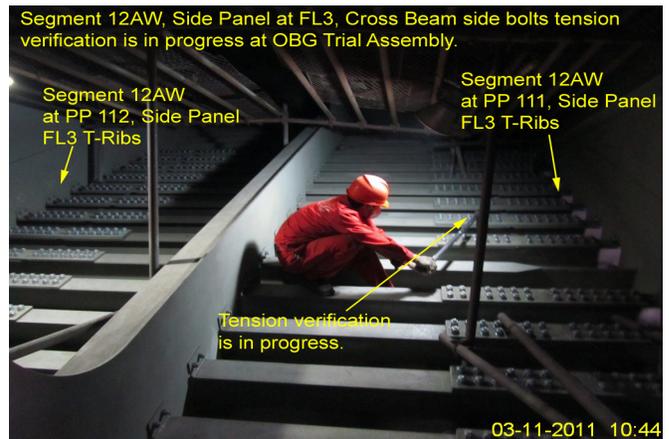
This QA Inspector witnessed the final bolt tension verification on bolts connecting the T-Rib to T-Rib at Side Panel Cross Beam side at Panel Points (PP) 110, PP 111 and PP 112 for Segment 12AW. The QA Inspector verified the bolt tension on a random basis and the results appeared to be in general compliance. The Inspection was performed against Notification No. 00625 dated March 11, 2011. The QA inspector observed reinforced splice plates are installed at following locations.

This QA Inspector observed the in-process welding by Shielded Metal Arc Welding (SMAW) process on a Fillet weld. The weld joint was designated as CA3005E-269. The welder identification was 040378 and observed welding in the 2F (Horizontal) position using approved Welding Procedure Specification WPS-B-P-2112-FCM-1. The piece mark was identified as weld connecting the Deck Panel Diaphragm to Floor Beam Flange at PP 117, Bike Path side.

This QA Inspector observed the in-process welding by Shielded Metal Arc Welding (SMAW) process on a Complete Joint Penetration (CJP) groove weld. The Weld joint was designated as CA3006-006. The welder identification was 046709 and was observed welding in the 2G (Horizontal) position using approved Welding Procedure Specification WPS-B-P-2212-Tc-U4b-FCM-1. The piece mark was identified as Side Panel to Edge Panel hold back weld at work point W1.
