DEPARTMENT OF TRANSPORTATION

Office of Structural Materials

Contract #: 04-0120F4Cty: SF/ALA Rte: 80 PM: 13.2/13.9File #: 69.28**WELDING INSPECTION REPORT****Resident Engineer:** Siegenthaler, Peter**Address:** 333 Burma Road**City:** Oakland, CA 94607**Report No:** WIR-024988**Date Inspected:** 11-Jun-2011**Project Name:** SAS Superstructure**OSM Arrival Time:** 700**Prime Contractor:** American Bridge/Fluor Enterprises, a JV**OSM Departure Time:** 1900**Contractor:** Zhenhua Port Machinery Company, Ltd (ZPMC), Changxing Island **Location:** Shanghai, China**CWI Name:** Lei/Wen/Shigang/Feng /Wen**CWI Present:** Yes No**Inspected CWI report:** Yes No N/A**Rod Oven in Use:** Yes No N/A**Electrode to specification:** Yes No N/A**Weld Procedures Followed:** Yes No N/A**Qualified Welders:** Yes No N/A**Verified Joint Fit-up:** Yes No N/A**Approved Drawings:** Yes No N/A**Approved WPS:** Yes No N/A**Delayed / Cancelled:** Yes No N/A**Bridge No:** 34-0006**Component:** OBG Bike Path**Summary of Items Observed:**

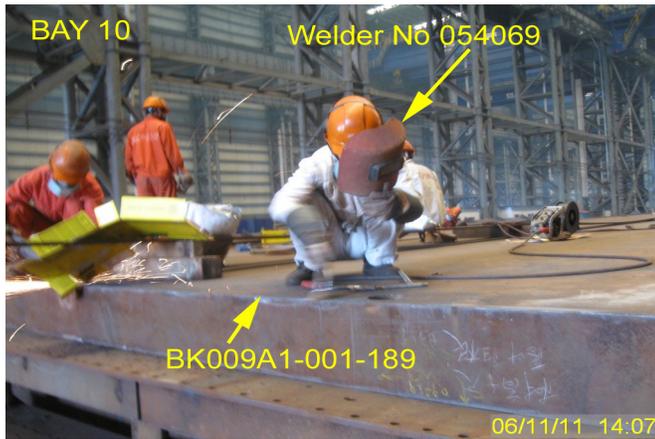
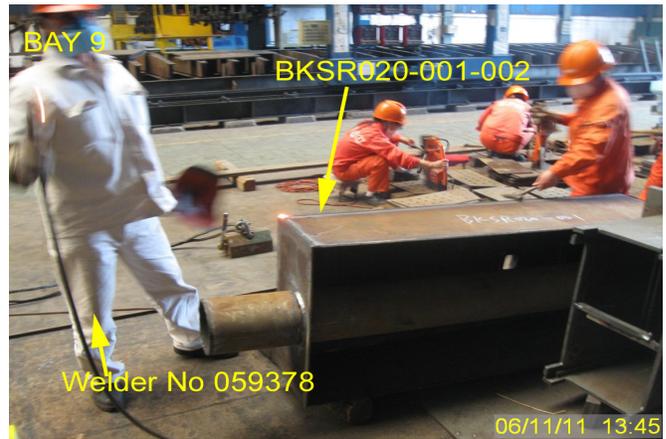
Unless otherwise noted, all work observed on this date appeared to generally comply with applicable contract documents.
