DEPARTMENT OF TRANSPORTATION

Contract #: 04-0120F4Cty: SF/ALA Rte: 80 PM: 13.2/13.9File #: 69.28**WELDING INSPECTION REPORT****Resident Engineer:** Pursell, Gary**Address:** 333 Burma Road**City:** Oakland, CA 94607**Report No:** WIR-005866**Date Inspected:** 30-Mar-2009**Project Name:** SAS Superstructure**OSM Arrival Time:** 700**Prime Contractor:** American Bridge/Fluor Enterprises, a JV**OSM Departure Time:** 1900**Contractor:** Zhenhua Port Machinery Company, Ltd (ZPMC), Changxing Island **Location:** Shanghai, China

CWI Name:	ZPMC and ABF	CWI Present:	Yes	No
Inspected CWI report:	Yes No N/A	Rod Oven in Use:	Yes	No N/A
Electrode to specification:	Yes No N/A	Weld Procedures Followed:	Yes	No N/A
Qualified Welders:	Yes No N/A	Verified Joint Fit-up:	Yes	No N/A
Approved Drawings:	Yes No N/A	Approved WPS:	Yes	No N/A
		Delayed / Cancelled:	Yes	No N/A
Bridge No:	34-0006	Component:	SAS tower

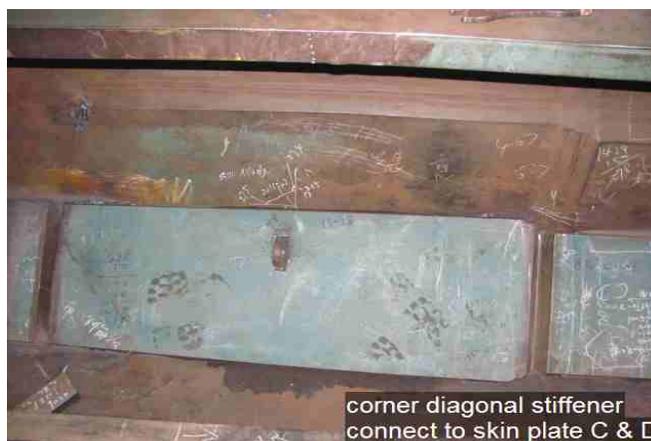
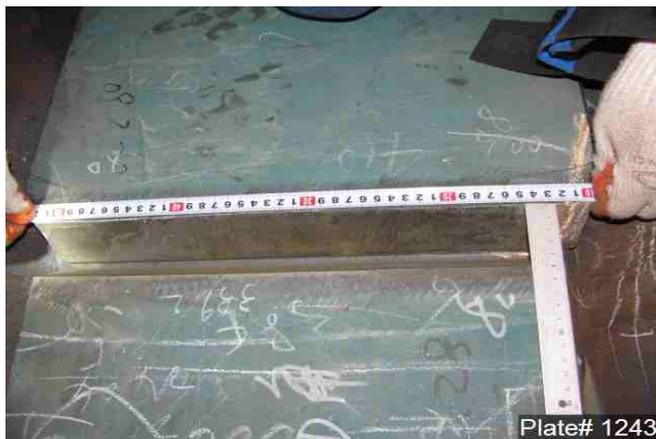
East tower lift #2:- Caltrans QA inspector performed final VT inspection on the fit lug welds and diaphragm welds of skin plate A to D for east tower lift #2. The fit lug welds and diaphragm located at elevation 68m to 77m. Base on Caltrans inspection, the fit lug welds and diaphragm welds appeared to be in compliance with requirements of AWS D1.5 2002 and Caltrans contract documents.
