DEPARTMENT OF TRANSPORTATION

Contract #: 04-0120F4Cty: SF/ALA Rte: 80 PM: 13.2/13.9File #: 69.28**WELDING INSPECTION REPORT****Resident Engineer:** Pursell, Gary**Address:** 333 Burma Road**City:** Oakland, CA 94607**Report No:** WIR-009679**Date Inspected:** 03-Oct-2009**Project Name:** SAS Superstructure**OSM Arrival Time:** 700**Prime Contractor:** American Bridge/Fluor Enterprises, a JV**OSM Departure Time:** 1900**Contractor:** Zhenhua Port Machinery Company, Ltd (ZPMC), Changxing Island **Location:** Shanghai, China**CWI Name:** ZPMC and ABF**CWI Present:** Yes No**Inspected CWI report:** Yes No N/A**Rod Oven in Use:** Yes No N/A**Electrode to specification:** Yes No N/A**Weld Procedures Followed:** Yes No N/A**Qualified Welders:** Yes No N/A**Verified Joint Fit-up:** Yes No N/A**Approved Drawings:** Yes No N/A**Approved WPS:** Yes No N/A**Delayed / Cancelled:** Yes No N/A**Bridge No:** 34-0006**Component:** OBG**Summary of Items Observed:**

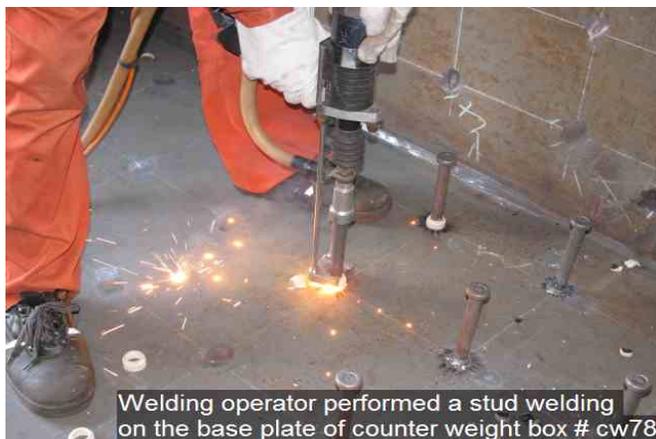
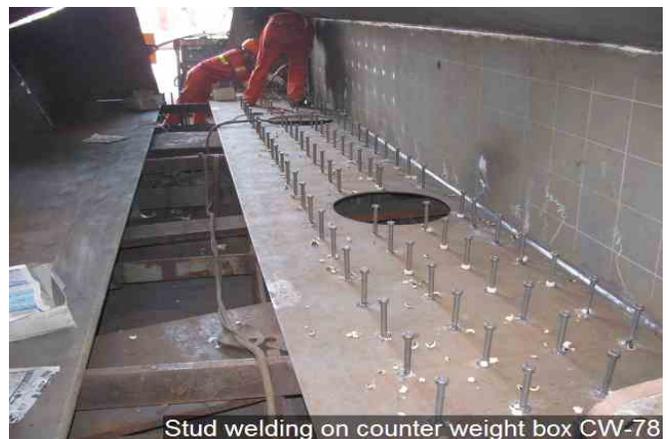
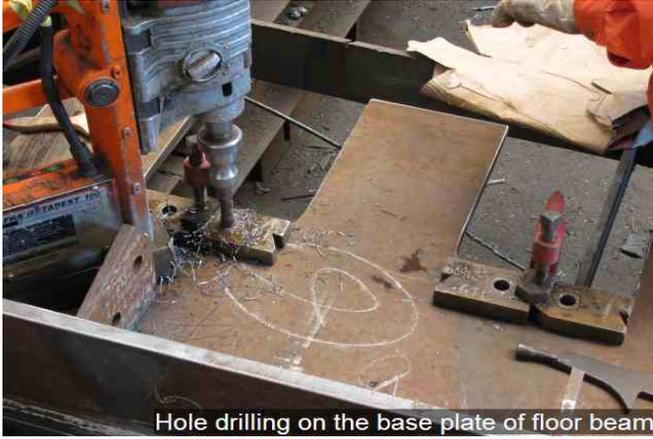
Counter weight box: - Caltrans QA inspector observed two ZPMC welding operators performed an electric arc stud weld process on the interior surface of base plate for counter weight box #78. The stud size is 19mm diameter x150mm length. A stud and ceramic ferrule are loaded into the gun, and the gun properly positioned against the base plate on the assigned location with down hand welding position. The stud welding has been completed approximately two hours on one side of base plate. The counter weight box need rotate to another side for stud welding. The stud welding process was monitored and recorded by ZPMC and ABF QC inspector. Based on Caltrans QA Inspector observations, no discrepancies were noted.

Floor beam type 1:- Caltrans QA inspector observed two ZPMC welders performed FCAW fillet weld process on stiffeners for type-1 of floor beam #FB-3002-001 AND #FB-3084A-001. The fillet weld size is 6mm and 8mm with single pass and multiple pass. The FCAW fillet welds process were monitored and recorded by ZPMC and ABF QC inspector. Based on Caltrans QA Inspector observations, no discrepancies were noted.

Bottom plate: - Caltrans QA inspector performed final dry MT inspection on fillet welds for stiffeners of bottom plate. The bottom plate and weld ID number is BP201-015-001~004, BP-3010-001-053~055, 071, BP3010-001-023,024, 027~030, 037, 038, 041~044, 049, 050, BP3010-001-001~008, BP3010-001-017~022, 025, 026, 031, 032, BP-3010-001-033~036, 039, 049, 045, 046 and BP3010-001-047, 048, 051, 052. The fillet welds for dry MT inspection have been accepted by ZPMC prior Caltrans QA inspection. Base on Caltrans inspection, the welds appeared to be in compliance with requirements of AWS D1.5 2002 and Caltrans contract documents.
