DEPARTMENT OF TRANSPORTATION

Contract #: 04-0120F4Cty: SF/ALA Rte: 80 PM: 13.2/13.9File #: 1x.28**WELDING INSPECTION REPORT****Resident Engineer:** Pursell, Gary**Address:** 333 Burma Road**City:** Oakland, CA 94607**Report No:** WIR-013965**Date Inspected:** 12-May-2010**Project Name:** SAS Superstructure**OSM Arrival Time:** 1000**Prime Contractor:** American Bridge/Fluor Enterprises, a JV**OSM Departure Time:** 1830**Contractor:** American Bridge/Fluor Enterprises, a JV**Location:** Job Site**CWI Name:** Jim Cunningham**CWI Present:** Yes No**Inspected CWI report:** Yes No N/A**Rod Oven in Use:** Yes No N/A**Electrode to specification:** Yes No N/A**Weld Procedures Followed:** Yes No N/A**Qualified Welders:** Yes No N/A**Verified Joint Fit-up:** Yes No N/A**Approved Drawings:** Yes No N/A**Approved WPS:** Yes No N/A**Delayed / Cancelled:** Yes No N/A**Bridge No:** 34-0006**Component:** Orthotropic Box Girder**Summary of Items Observed:**

Caltrans Office of Structural Material (OSM) Quality Assurance Inspector (QAI) Joselito Lizardo was present at the Self Anchored Suspension (SAS) job site as requested to perform observations on the welding of components for the San Francisco

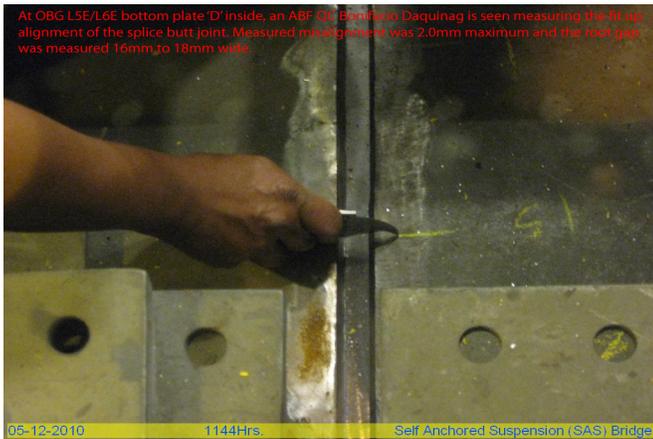
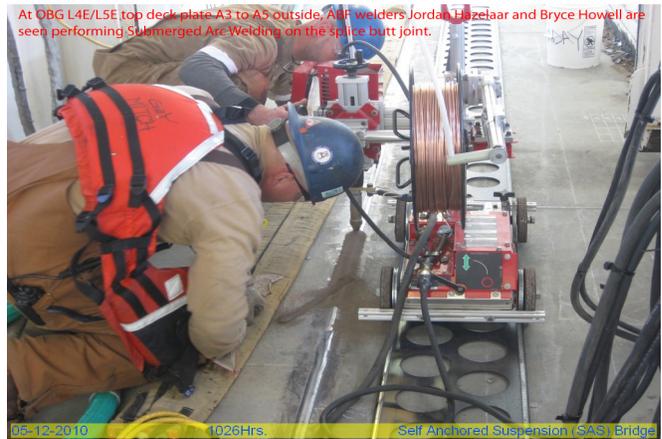
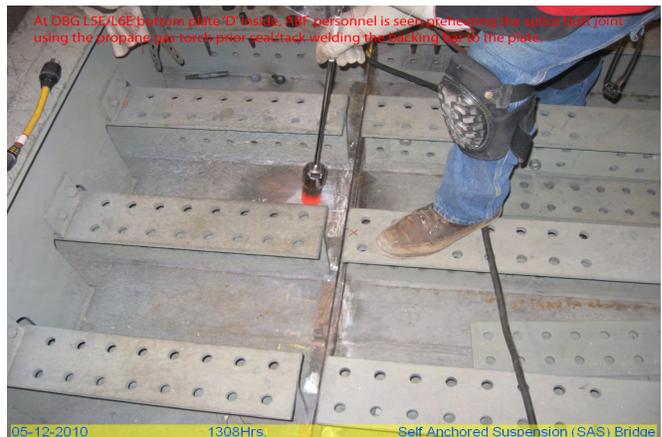
At OBG L4E/L5E plate A1 to A5, ABF welder Jordan Hazelaar (ID #2135) was seen completely welded the splice butt joint at location A1 to A3 while ABF welder Bryce Howell (ID #5591) was still performing flat (1G) Submerged Arc Welding (SAW). The welder was utilizing F7A6-EM12K-H8, 3.2mm electrode with corresponding Esab OK Flux 10.62 flux and implementing Caltrans approved Welding Procedure Specification (WPS) ABF-WPS-D15-4042B-1. The welder was using a track mounted Lincoln Electric "Cruiser Tractor" wire feeder and a Lincoln Electric AC/DC 1000 SD Power Wave welding machine. The plates were preheated to >150 degree F using two Miller Proheat 35 Induction Heating System located at the other side of the plate prior/during welding. Welding parameters was monitored by ABF/QC Tom Pasqualone with measured parameters of 550 amperes, 32.2 volts and 380mm per minute travel speed. QA noted the welding parameters, the workmanship and appearance of the completed fill and cover passes satisfactory and were deemed acceptable to contract requirements. After completing the weld on this side A3 to A5, two ABF personnel were seen flush grinding the cover weld reinforcement using a belted sanding machine. At the end of the shift, the work was not completed and it was still ongoing.

At OBG L3E/L4E side plate 'C' outside, QA randomly observed ABF/JV qualified welder Mitch Sittinger continue perform CJP groove welding repair. The welder was observed welding in the 4G (overhead) position utilizing Shielded metal Arc Welding (SMAW) with 1/8" diameter E7018H4R electrode implementing welding

procedure ABF-WPS-D15-1000-Repairs. The weld repair was excavated to a boat shape and having a dimension of 305mm long X 21mm wide X 12mm deep. The repair excavation was preheated to more than 140 degree Fahrenheit using propane gas torch prior welding. During the shift, ABF QC William Sherwood was noted monitoring the welder. Prior welding, ABF QC William Sherwood was also observed performing Magnetic Particle Testing (MT) using Parker Contour Probe and red magnetic powder as detecting media on the repair excavation. During the shift, the welder has completed one welding repair outside and was noted flush grinding the repaired area and fixing the temporary welding attachment removal.

QA randomly observed ABF/JV qualified welder Jordan Hazelaar perform tack welding backing bar to one side of the splice butt joint at OBG L5E/L6E bottom plate 'D' inside. The welder was using SMAW with 1/8" diameter E7018H4R electrode and implementing Caltrans approved welding procedure ABF-WPS-D15-F1200. Prior to welding, QA and ABF QC Bonifacio Daquinag performed a joint inspection of the butt joint fit up. The root gap was noted greater than 16mm wide minimum and 18mm wide maximum and the misalignment was noted 2.0mm maximum which appears in conformance to the contract requirements. During welding, ABF QC Bonifacio Daquinag was noted monitoring the welder and welding parameters.

Other work activities by ABF noted during the shift include installation of backing bar to the bottom of top deck plate 'A' at OBG L5E/L6E top deck plate 'A' which is still in progress and Ultrasonic Testing (UT) by ABF QC at the splice butt joint of L3E/L4E side plate 'C' inside.
