DEPARTMENT OF TRANSPORTATION

Office of Structural Materials

Contract #: 04-0120F4Cty: SF/ALA Rte: 80 PM: 13.2/13.9File #: 69.28**WELDING INSPECTION REPORT****Resident Engineer:** Pursell, Gary**Address:** 333 Burma Road**City:** Oakland, CA 94607**Report No:** WIR-014372**Date Inspected:** 25-May-2010**Project Name:** SAS Superstructure**OSM Arrival Time:** 700**Prime Contractor:** American Bridge/Fluor Enterprises, a JV**OSM Departure Time:** 1900**Contractor:** Zhenhua Port Machinery Company, Ltd (ZPMC), Changxing Island **Location:** Shanghai, China**CWI Name:** Li Yang**CWI Present:** Yes No**Inspected CWI report:** Yes No N/A**Rod Oven in Use:** Yes No N/A**Electrode to specification:** Yes No N/A**Weld Procedures Followed:** Yes No N/A**Qualified Welders:** Yes No N/A**Verified Joint Fit-up:** Yes No N/A**Approved Drawings:** Yes No N/A**Approved WPS:** Yes No N/A**Delayed / Cancelled:** Yes No N/A**Bridge No:** 34-0006**Component:** OBG**Summary of Items Observed:**

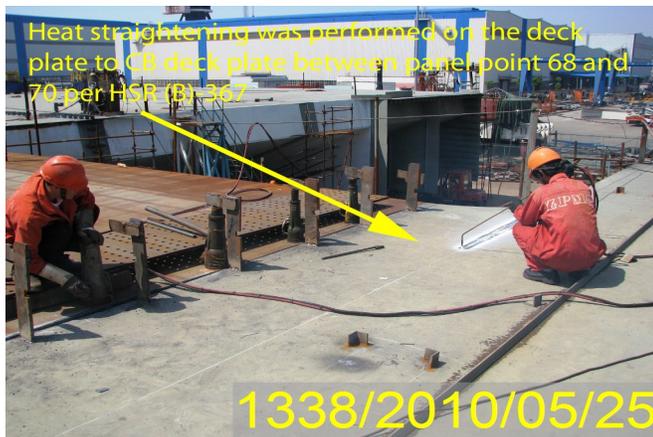
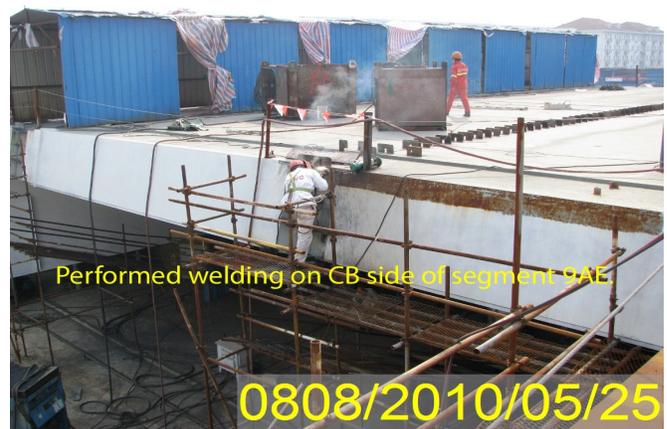
1. Heat straightening was performed on the deck plate to CB deck plate between panel point 68 and 70 per HSR (B)-367.
