DEPARTMENT OF TRANSPORTATION

Contract #: 04-0120F4Cty: SF/ALA Rte: 80 PM: 13.2/13.9File #: 1.28**WELDING INSPECTION REPORT****Resident Engineer:** Pursell, Gary**Address:** 333 Burma Road**City:** Oakland, CA 94607**Report No:** WIR-014683**Date Inspected:** 09-Jun-2010**Project Name:** SAS Superstructure**OSM Arrival Time:** 1000**Prime Contractor:** American Bridge/Fluor Enterprises, a JV**OSM Departure Time:** 1830**Contractor:** American Bridge/Fluor Enterprises, a JV**Location:** Job Site

CWI Name:	Jesse Cayabyab and Bonifacio Daqui			CWI Present:	Yes	No	
Inspected CWI report:	Yes	No	N/A	Rod Oven in Use:	Yes	No	N/A
Electrode to specification:	Yes	No	N/A	Weld Procedures Followed:	Yes	No	N/A
Qualified Welders:	Yes	No	N/A	Verified Joint Fit-up:	Yes	No	N/A
Approved Drawings:	Yes	No	N/A	Approved WPS:	Yes	No	N/A
				Delayed / Cancelled:	Yes	No	N/A
Bridge No:	34-0006			Component:	Orthotropic Box Girder

Caltrans Office of Structural Material (OSM) Quality Assurance Inspector (QAI) Joselito Lizardo was present at the Self Anchored Suspension (SAS) job site as requested to perform observations on the welding of components for the San Francisco Oakland Bay Bridge (SFOBB) Project.

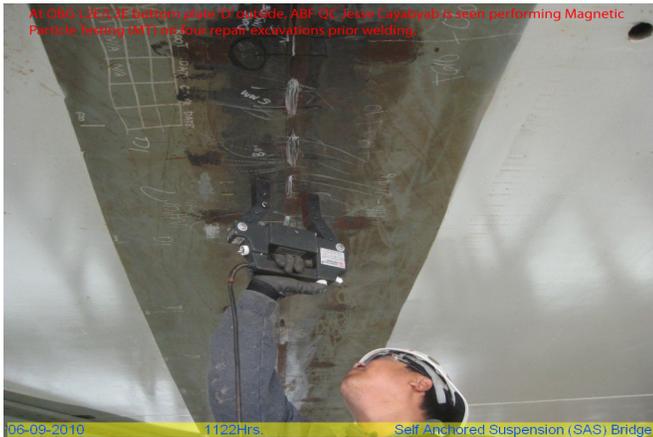
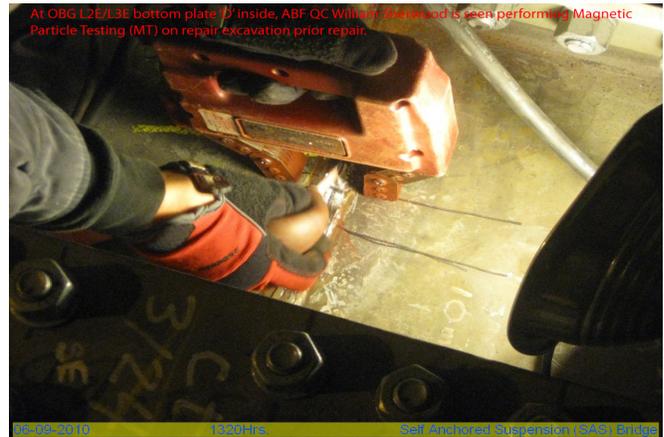
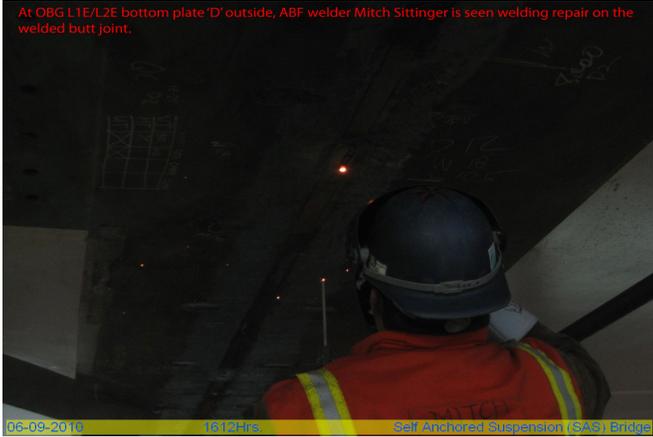
At OBG L1E/L2E bottom plate 'D' outside, QA randomly observed ABF/JV qualified welder Mitch Sittinger ID #0315 perform CJP groove welding repair. The welder was observed welding in the 4G (overhead) position utilizing Shielded metal Arc Welding (SMAW) with 1/8" diameter E7018H4R electrode implementing welding procedure ABF-WPS-D15-1000-Repairs. The repair excavations were preheated to more than 140 degree Fahrenheit using propane gas torch prior welding. During the shift, ABF QC Jesse Cayabyab was noted monitoring the welder. Prior welding, ABF QC Jesse Cayabyab was also observed performing Magnetic Particle Testing (MT) using Parker Contour Probe with red magnetic powder as detecting media on the repair excavation. There were no significant defects noted during the test. During the shift, the welder has completed two repairs and was excavating the 3rd welding repair at the end of the shift.

At OBG L1E/L2E bottom plate 'D' inside, QA randomly observed ABF/JV qualified welder Fred Kaddu ID # 2188 perform CJP groove welding repair. The welder was observed welding in the 1G (flat) position utilizing Shielded metal Arc Welding (SMAW) with 1/8" diameter E7018H4R electrode implementing welding procedure ABF-WPS-D15-1000-Repairs. The repair excavations were preheated to more than 140 degree Fahrenheit using propane gas torch prior welding. During the shift, ABF QC Jesse Cayabyab was noted monitoring the welder. Prior welding, ABF QC Jesse Cayabyab was also observed performing Magnetic Particle Testing (MT) using Parker Contour Probe with red magnetic powder as detecting media on the repair excavation. There were no

At OBG L3W/L4W side plate 'C1' (2640mm to 5280mm) inside, QA randomly observed ABF/JV qualified welder Sungtao, Huang ID # 3794 continue perform CJP groove (splice) welding root then fill pass. The welder was observed perform automatic welding in the 3G (vertical) position utilizing a dual shield Flux Cored Arc Welding (FCAW-G) with E71T-1M, 1/16" diameter wire electrode and implementing Caltrans approved Welding Procedure Specification (WPS) ABF-WPS-D15-3042A-1. The joint being welded has a single V-groove butt joint with backing bar. The splice joint was preheated and maintained to greater than 200 degree Fahrenheit using Miller Proheat 35 Induction Heating System located at the opposite side of the plate prior/during welding. During welding, ABF Quality Control (QC) Bernie Docena was noted monitoring the welding parameters of the welder.

At OBG L1W/L2W side plate 'C' inside, QA observed ABF welders Chun Fai Tsui and James Zhen perform welding repairs on the splice butt joint. The welders were observed welding in the 3G (vertical) position utilizing Shielded metal Arc Welding (SMAW) with 1/8" diameter E7018H4R electrode implementing welding procedure ABF-WPS-D15-1000-Repairs. The repair excavations were preheated to more than 140 degree Fahrenheit using propane gas torch prior welding. During the shift, ABF QC Bonifacio Daquinag was noted monitoring the welder. Prior welding, ABF QC Bonifacio Daquinag was also observed performing Magnetic Particle Testing (MT) using Parker Contour Probe with red magnetic powder as detecting media on the repair excavation. There were no significant defects noted during the test. During the shift, welder Chun Fai Tsui has completed four repairs while James Zhen has completed two repairs. After completely welded the repairs inside, both welders were noted moving to the longitudinal stiffener plates near bottom plate 'D' inside to set up welding equipment and perform welding repairs on the stiffeners.
