DEPARTMENT OF TRANSPORTATION

Office of Structural Materials

Contract #: 04-0120F4Cty: SF/ALA Rte: 80 PM: 13.2/13.9File #: 69.28**WELDING INSPECTION REPORT****Resident Engineer:** Pursell, Gary**Address:** 333 Burma Road**City:** Oakland, CA 94607**Report No:** WIR-015418**Date Inspected:** 03-Jul-2010**Project Name:** SAS Superstructure**OSM Arrival Time:** 700**Prime Contractor:** American Bridge/Fluor Enterprises, a JV**OSM Departure Time:** 1900**Contractor:** Zhenhua Port Machinery Company, Ltd (ZPMC), Changxing Island **Location:** Shanghai, China

CWI Name:	Li Yang and Wu Zhi Cheng	CWI Present:	Yes	No
Inspected CWI report:	Yes No N/A	Rod Oven in Use:	Yes	No N/A
Electrode to specification:	Yes No N/A	Weld Procedures Followed:	Yes	No N/A
Qualified Welders:	Yes No N/A	Verified Joint Fit-up:	Yes	No N/A
Approved Drawings:	Yes No N/A	Approved WPS:	Yes	No N/A
		Delayed / Cancelled:	Yes	No N/A
Bridge No:	34-0006	Component:	OBG Trial Assembly

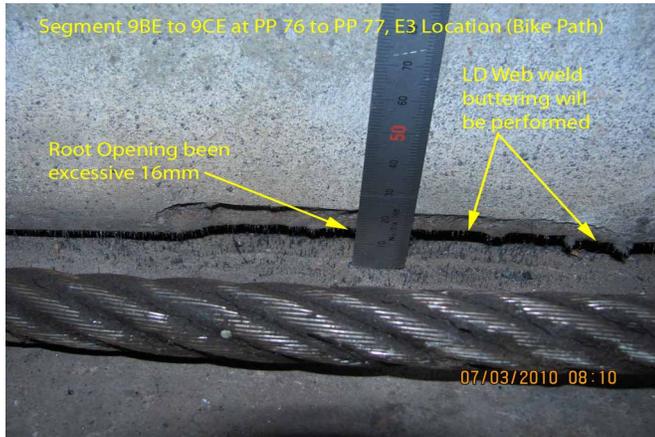
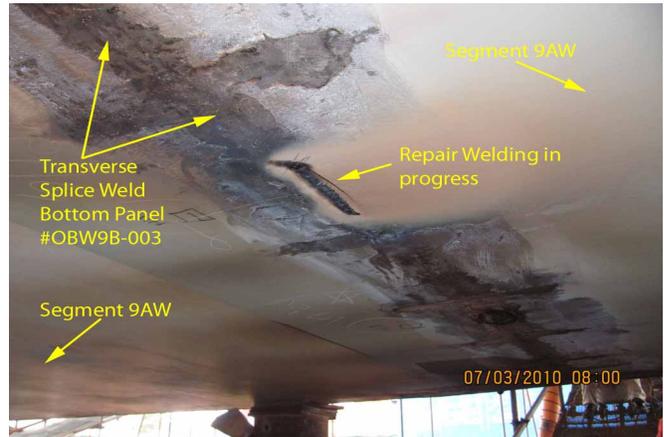
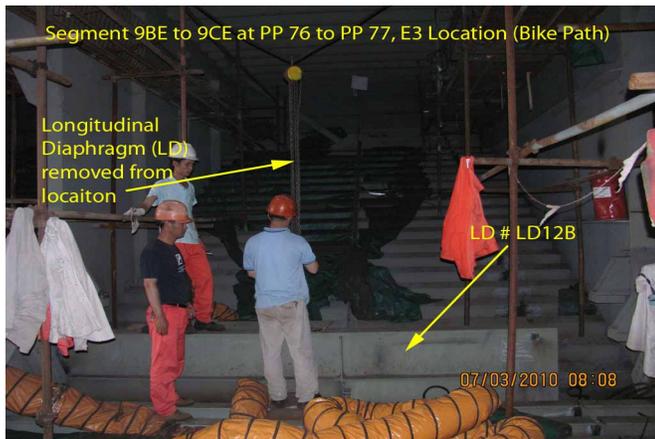
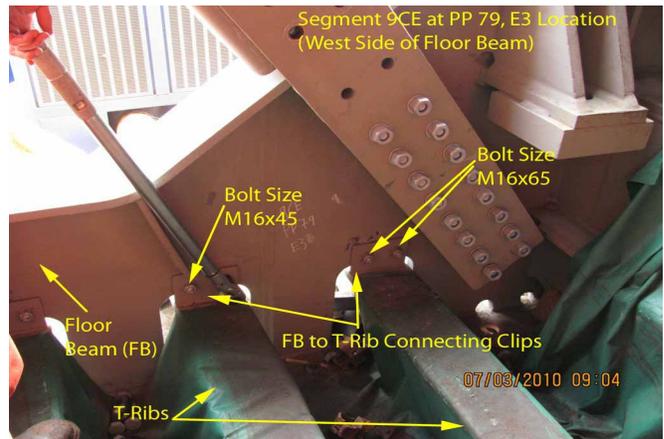
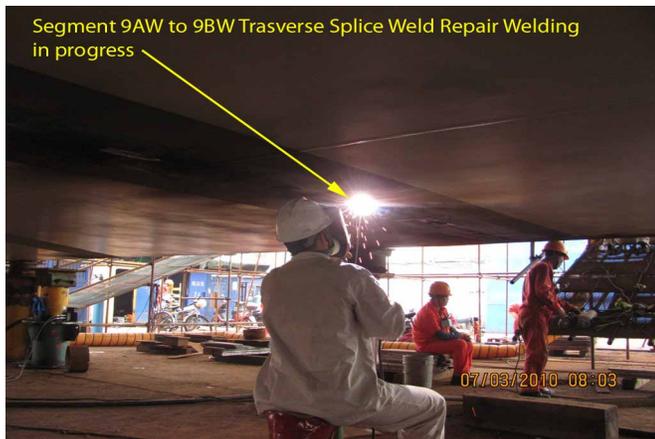
This QA Inspector observed welding by Shielded Metal Arc Welding (SMAW) in progress of Complete Joint Penetration (CJP). The Weld joint is designated as Seg9B-003. The welder number is identified as 067588 and was observed welding in the 4G (Overhead) position using approved Welding Procedure Specification WPS-345-SMAW-4G (4F)-Repair-FCM-1. PMCK identified as Transverse Splice Weld at Bottom Panel. The repair weld is been performed against the Welding Repair Report # BWR13906. Please refer the pictures attached for more comprehensive details.
