DEPARTMENT OF TRANSPORTATION

Quality Assurance and Source Inspection

Contract #: 04-0120F4Cty: SF/ALA Rte: 80 PM: 13.2/13.9File #: 1.28**WELDING INSPECTION REPORT****Resident Engineer:** Pursell, Gary**Address:** 333 Burma Road**City:** Oakland, CA 94607**Report No:** WIR-015637**Date Inspected:** 13-Jul-2010**Project Name:** SAS Superstructure**OSM Arrival Time:** 1000**Prime Contractor:** American Bridge/Fluor Enterprises, a JV**OSM Departure Time:** 1830**Contractor:** American Bridge/Fluor Enterprises, a JV**Location:** Job Site

Caltrans Office of Structural Material (OSM) Quality Assurance Inspector (QAI) Joselito Lizardo was present at the Self Anchored Suspension (SAS) job site as requested to perform observations on the welding of components for the San Francisco Oakland Bay Bridge (SFOBB) Project.

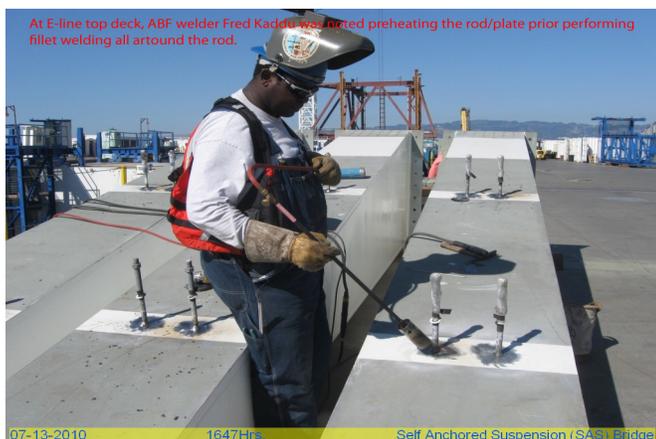
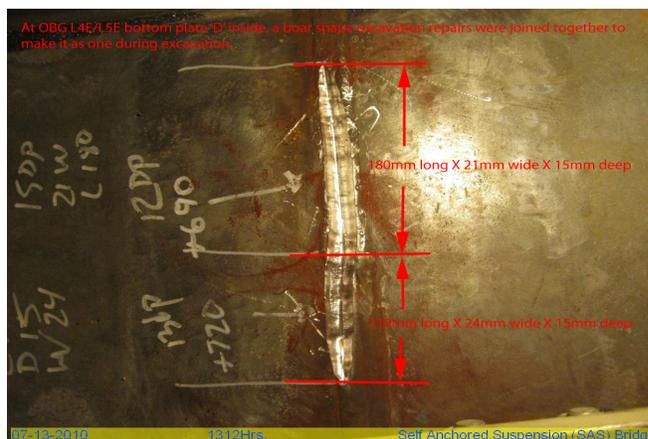
At the E-line top deck, QA randomly observed ABF/JV qualified welder Fred Kaddu perform fillet welding all around 3/4" diameter X 12" long bolt to the cantilever bike path support. The welder was noted adding more weld to the existing fillet weld that was welded from ZPMC, China per Contractor Change Order CCO 99. The welder was observed welding in the 2F (horizontal) position utilizing Shielded Metal Arc Welding (SMAW) with 1/8" diameter E7018H4R electrode implementing welding procedure ABF-WPS-D15-F1200A Rev. 1. The existing fillet weld connection was preheated to more than 150 degree Fahrenheit using propane gas torch prior welding. The welding activity was monitored by ABF QC William Sherwood. During the shift, the welder has completed the 10mm fillet weld on 20 connections (five bike path supports with 4 bolts per support) and was working on the 6th support at the end of the shift.

During QA's conversation with ABF QC William Sherwood, QC mentioned that they were adding more weld to the undersize fillet weld between the 3/4" diameter X 12" long bolt/rod to the cantilever bike path support that was welded from ZPMC China. According to QC, the task to make the fillet weld size to 10mm had been approved per Contractor Change Order CCO 99.
