DEPARTMENT OF TRANSPORTATION

Contract #: 04-0120F4Cty: SF/ALA Rte: 80 PM: 13.2/13.9File #: 69.28**WELDING INSPECTION REPORT****Resident Engineer:** Pursell, Gary**Address:** 333 Burma Road**City:** Oakland, CA 94607**Report No:** WIR-015918**Date Inspected:** 26-Jul-2010**Project Name:** SAS Superstructure**OSM Arrival Time:** 700**Prime Contractor:** American Bridge/Fluor Enterprises, a JV**OSM Departure Time:** 1900**Contractor:** Zhenhua Port Machinery Company, Ltd (ZPMC), Changxing Island **Location:** Shanghai, China

CWI Name:	N/a	CWI Present:	Yes	No
Inspected CWI report:	Yes No N/A	Rod Oven in Use:	Yes	No N/A
Electrode to specification:	Yes No N/A	Weld Procedures Followed:	Yes	No N/A
Qualified Welders:	Yes No N/A	Verified Joint Fit-up:	Yes	No N/A
Approved Drawings:	Yes No N/A	Approved WPS:	Yes	No N/A
		Delayed / Cancelled:	Yes	No N/A
Bridge No:	34-0006	Component:	OBG Trial Assembly

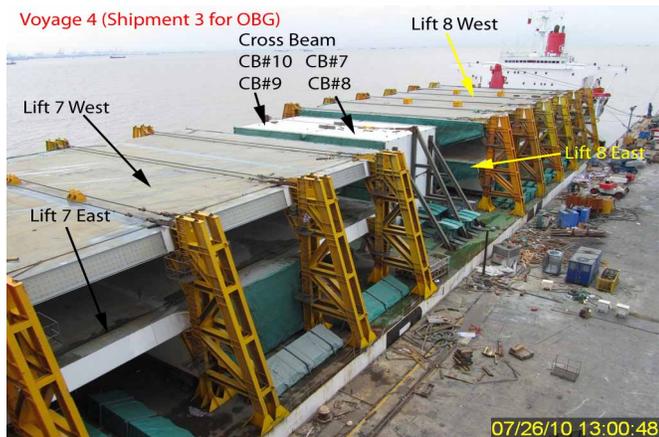
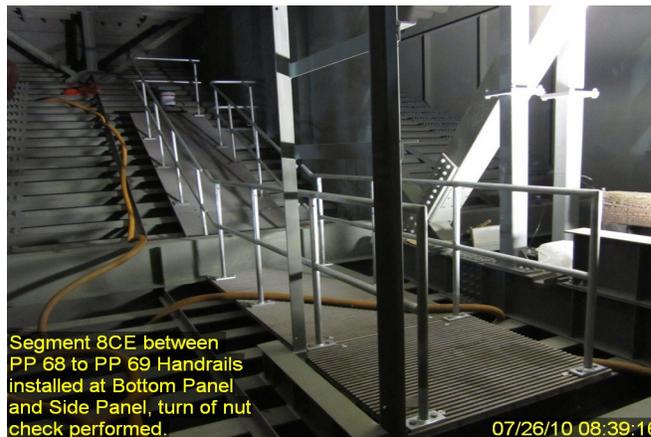
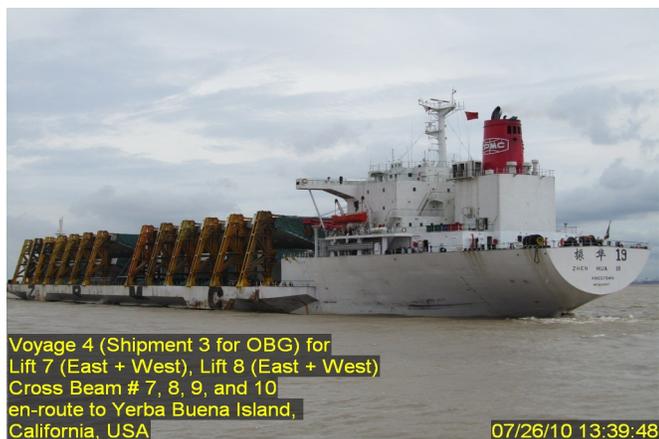
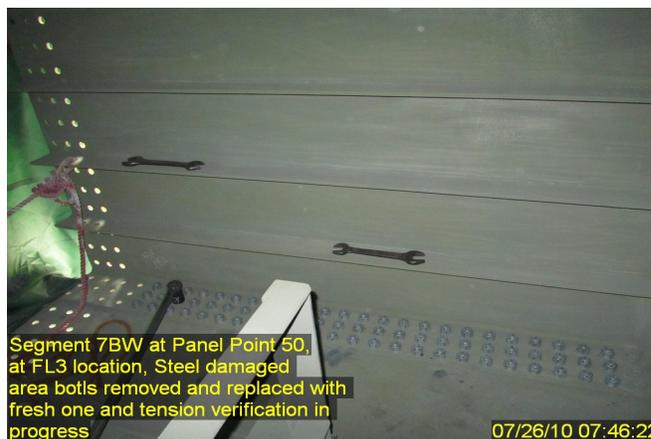
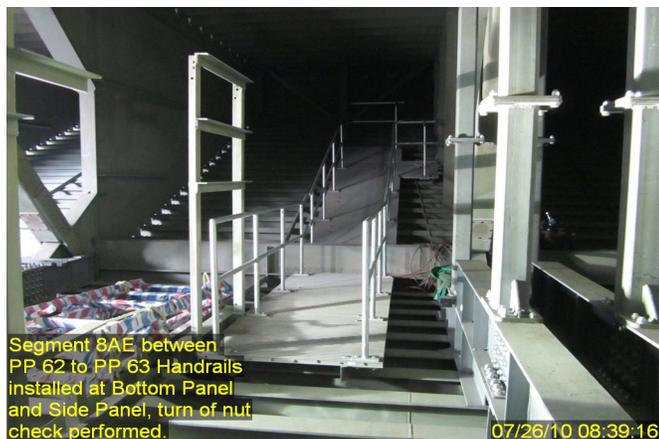
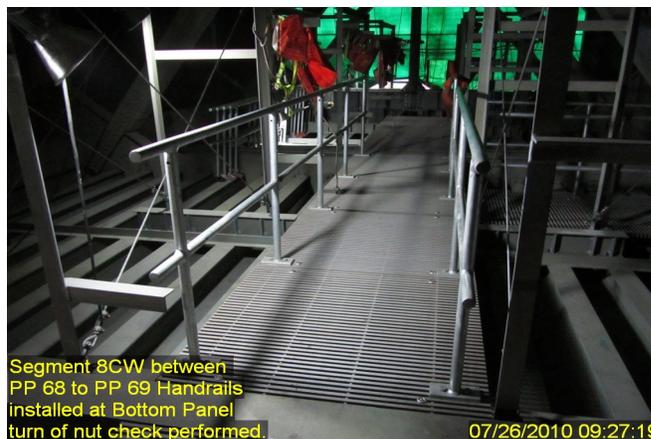
This QA Inspector observed that the ZPMC Ship Zhenhua # 19 sailed out from Jetty # 5 en-route to Yerba Buena Island, California, USA at 13:30 Hrs (local time). Ship is en-route to USA for delivering Lift 7(East), Lift 7 West), Lift 8 (East), Lift 8 (West), Cross Beam (CB) # 7, 8, 9 and 10.

This QA Inspector witnessed the final bolt tension verification on bolts connecting the FL3 Flange to the Bottom Plate at Panel Points (PP) 50 for Segment 7BW. The FL3 flange and Bottom Plate was damaged while loading on the ZPMC Ship Zhenhua # 19 thus (3 column x 24 rows) bolts were replaced. The QA Inspector verified the bolt tension on a random basis and the results appeared to be in general compliance. The Inspection was performed against Notification No. 00440.

Please reference the pictures attached for more comprehensive details.

A spanner wrench was used to verify the snug tight condition. Please reference the pictures attached for more comprehensive details.
