**DEPARTMENT OF TRANSPORTATION**

Contract #: 04-0120F4Cty: SF/ALA Rte: 80 PM: 13.2/13.9File #: 69.28**WELDING INSPECTION REPORT****Resident Engineer:** Pursell, Gary**Address:** 333 Burma Road**City:** Oakland, CA 94607**Report No:** WIR-016331**Date Inspected:** 22-Aug-2010**Project Name:** SAS Superstructure**OSM Arrival Time:** 700**Prime Contractor:** American Bridge/Fluor Enterprises, a JV**OSM Departure Time:** 1900**Contractor:** Zhenhua Port Machinery Company, Ltd (ZPMC), Changxing Island **Location:** Shanghai, China**CWI Name:** Li Yang**CWI Present:** Yes No**Inspected CWI report:** Yes No N/A**Rod Oven in Use:** Yes No N/A**Electrode to specification:** Yes No N/A**Weld Procedures Followed:** Yes No N/A**Qualified Welders:** Yes No N/A**Verified Joint Fit-up:** Yes No N/A**Approved Drawings:** Yes No N/A**Approved WPS:** Yes No N/A**Delayed / Cancelled:** Yes No N/A**Bridge No:** 34-0006**Component:** OBG Segment**Summary of Items Observed:**

OBG Trial Assembly Yard

Segment 10AW/10BW

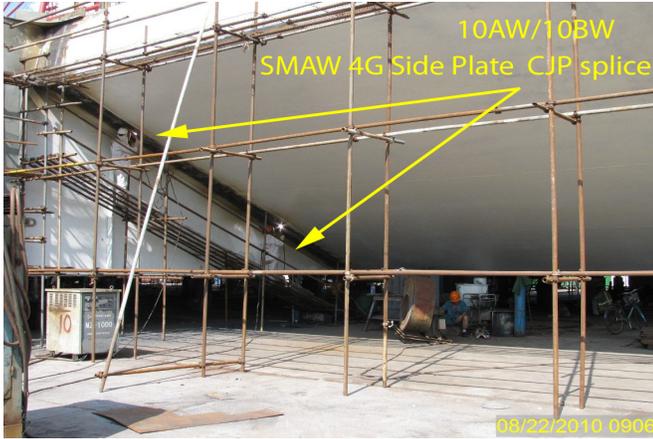
This QA Inspector observed Shielded Metal Arc Welding (SMAW) in progress of a Complete Joint Penetration (CJP) weld joint. The Weld joint is designated as OBW10B-004, Side Plate splice, cross beam side. The welder is identified as #067752 and was observed welding in the 4G (overhead) position using approved Welding Procedure Specification WPS-B-P-2214-B-U2-FCM-1.

This QA Inspector observed Shielded Metal Arc Welding (SMAW) in progress of a Complete Joint Penetration (CJP) weld joint. The Weld joint is designated as OBW10B-005, Side Plate splice, cross beam side. The welder is

identified as #067829 and was observed welding in the 4G (overhead) position using approved Welding Procedure Specification WPS-B-P-2214-B-U2-FCM-1.

This QA Inspector observed Flux Cored Arc Welding (FCAW) in progress of a fillet weld joint. The Weld joint is designated as BP157-001-042, Bottom Plate WT stiffener hold back weld. The welder is identified as #040609 and was observed welding in the 2F (horizontal) position using approved Welding Procedure Specification WPS-B-T-2132.

This QA Inspector observed Flux Cored Arc Welding (FCAW) in progress of a fillet weld joint. The Weld joint is designated as BP103-001-035, Bottom Plate WT stiffener hold back weld. The welder is identified as #202384 and was observed welding in the 2F (horizontal) position using approved Welding Procedure Specification WPS-B-T-2132.

This QA Inspector observed Flux Cored Arc Welding (FCAW) in progress of a fillet weld joint. The Weld joint is designated as BP049-001-031, Bottom Plate WT stiffener hold back weld. The welder is identified as #040609 and

was observed welding in the 2F (horizontal) position using approved Welding Procedure Specification WPS-B-T-2132.
