DEPARTMENT OF TRANSPORTATION

Contract #: 04-0120F4Cty: SF/ALA Rte: 80 PM: 13.2/13.9File #: 99.28**WELDING INSPECTION REPORT****Resident Engineer:** Pursell, Gary**Address:** 333 Burma Road**City:** Oakland, CA 94607**Report No:** WIR-016530**Date Inspected:** 31-Aug-2010**Project Name:** SAS Superstructure**OSM Arrival Time:** 700**Prime Contractor:** American Bridge/Fluor Enterprises, a JV**OSM Departure Time:** 1900**Contractor:** Zhenhua Port Machinery Company, Ltd (ZPMC)**Location:** Shanghai, China

Orthotropic Box Girder (OBG) at Trial Assembly Areas

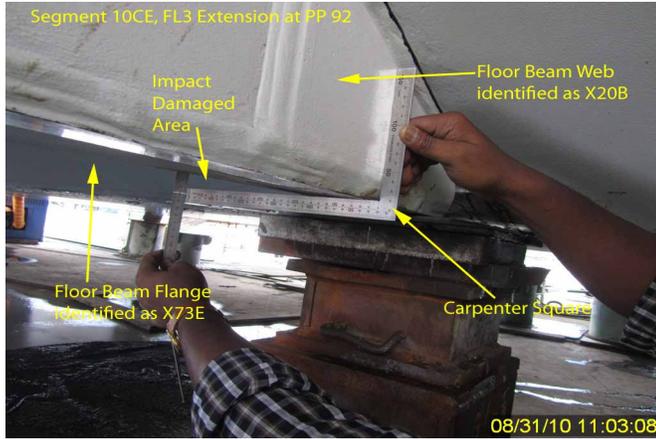
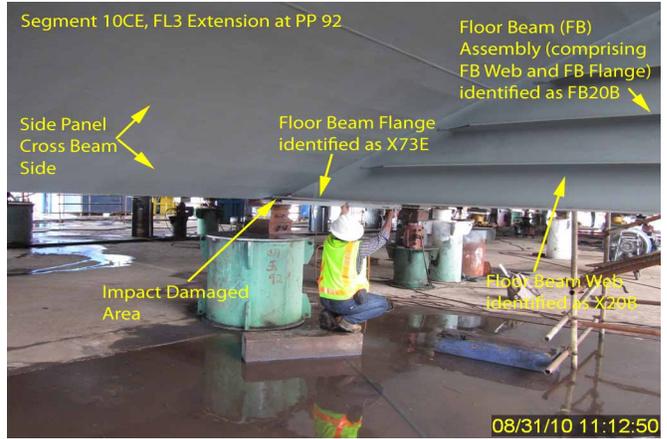
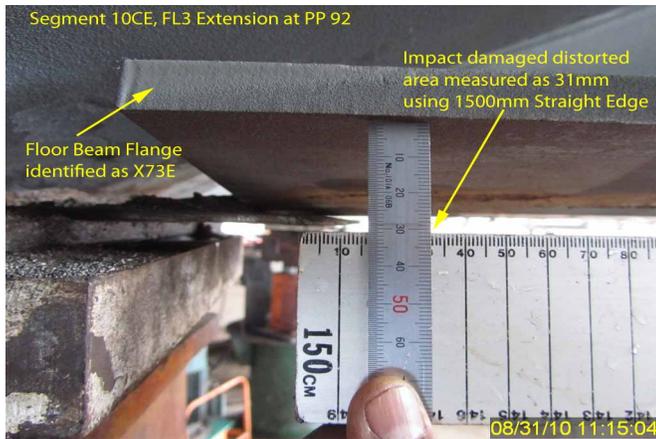
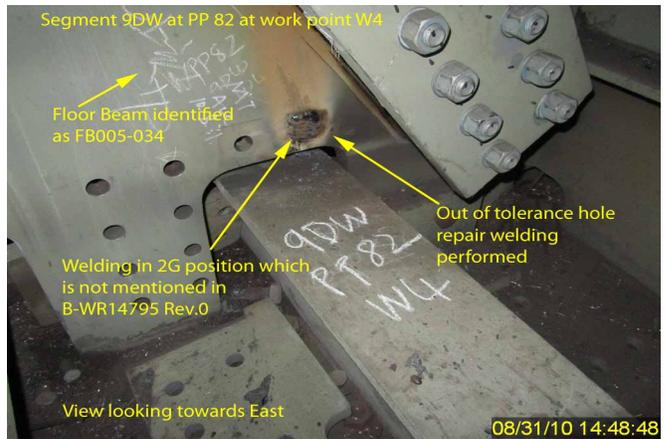
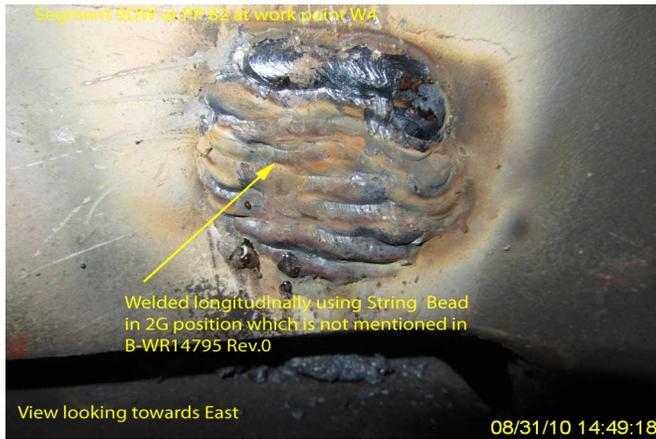
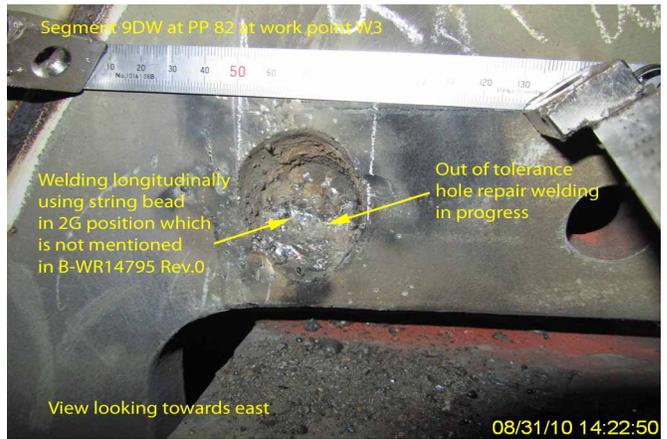
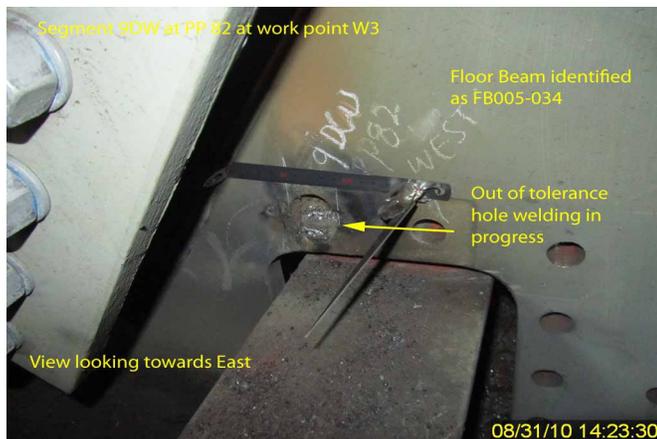
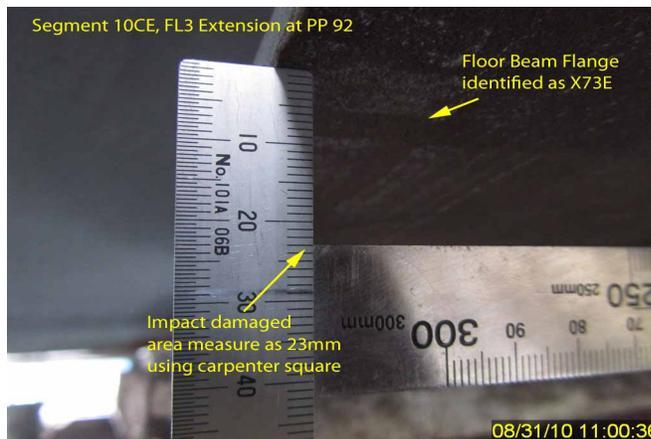
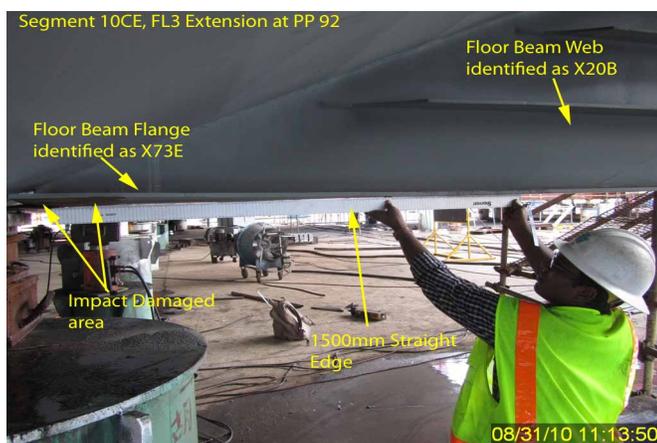
Please reference the pictures attached for more comprehensive details.

This Quality Assurance (QA) Inspector wrote an Incident Report for FL3 flange impact damage at PP 92 for Segment 10CE, Cross Beam side. Please reference the Incident Report 04-0120F4_TL-15_B278_08-31-2010_10CE_FL3_PP92_Flange_Impact Damage dated August 31, 2010 for further details.

This QA Inspector witnessed final bolt tension verification on bolts connecting T-Rib to T-Rib for Transverse Splice at Side Panel Bike Path Side (from work point E1 towards E3), Bottom Panel (from work point E3 towards E4) and Cross Beam side (from work point E4 to E6) between Panel Point (PP) 82 to PP 83 for Segment 9DE to 9EE. Inspected the bolt tensioning on a random basis and found the tension to be in general compliance. Inspection was performed against the Notification No. 00468 Dated August 31, 2010.
