Quality Assurance and Source Inspection

Contract #: 04-0120F4Cty: SF/ALA Rte: 80 PM: 13.2/13.9File #: 69.28**WELDING INSPECTION REPORT****Resident Engineer:** Siegenthaler, Peter**Address:** 333 Burma Road**City:** Oakland, CA 94607**Report No:** WIR-016854**Date Inspected:** 22-Sep-2010**Project Name:** SAS Superstructure**OSM Arrival Time:** 700**Prime Contractor:** American Bridge/Fluor Enterprises, a JV**OSM Departure Time:** 1900**Contractor:** Zhenhua Port Machinery Company, Ltd (ZPMC), Changxing Island **Location:** Shanghai, China**CWI Name:** Lv Li Qing**CWI Present:** Yes No**Inspected CWI report:** Yes No N/A**Rod Oven in Use:** Yes No N/A**Electrode to specification:** Yes No N/A**Weld Procedures Followed:** Yes No N/A**Qualified Welders:** Yes No N/A**Verified Joint Fit-up:** Yes No N/A**Approved Drawings:** Yes No N/A**Approved WPS:** Yes No N/A**Delayed / Cancelled:** Yes No N/A**Bridge No:** 34-0006**Component:** OBG**Summary of Items Observed:**

OBG SEGMENT 10BW-10CW

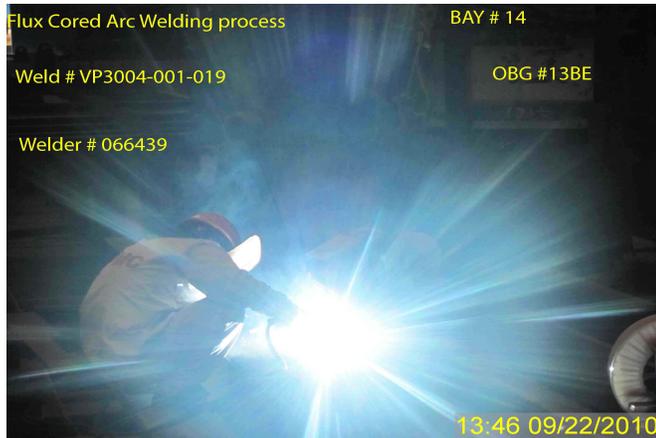
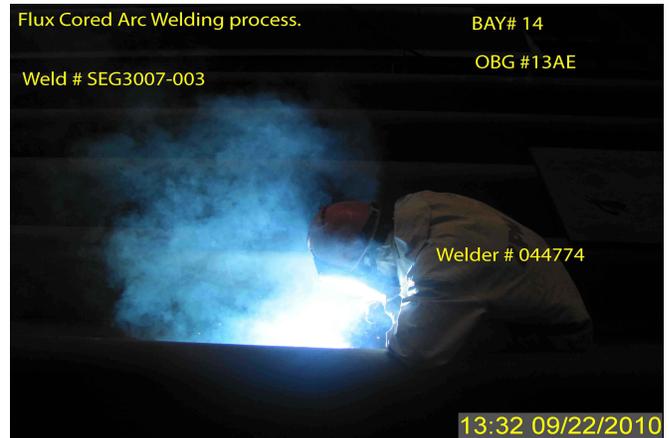
This Quality Assurance (QA) Inspector observed ZPMC qualified welder 044774 performing the Flux Cored Arc Welding process on weld 003 located at PCMK SEG3007. ZPMC QC Mr. Lv Li Qing was monitoring this welding operation. The welding variables recorded by QC appeared to comply with WPS-B-T-2231-B-u2-f.

This Quality Assurance (QA) Inspector observed ZPMC qualified welder 067079 performing the Flux Cored Arc Welding process on weld 012 located at PCMK VP3007-001. ZPMC QC Mr. Lv Li Qing was monitoring this welding operation. The welding variables recorded by QC appeared to comply with WPS-B-T-2232-Tc-u4b-f.
