DEPARTMENT OF TRANSPORTATION

Office of Structural Materials

Contract #: 04-0120F4Cty: SF/ALA Rte: 80 PM: 13.2/13.9File #: 69.28**WELDING INSPECTION REPORT****Resident Engineer:** Pursell, Gary**Address:** 333 Burma Road**City:** Oakland, CA 94607**Report No:** WIR-016910**Date Inspected:** 01-Aug-2010**Project Name:** SAS Superstructure**OSM Arrival Time:** 700**Prime Contractor:** American Bridge/Fluor Enterprises, a JV**OSM Departure Time:** 1900**Contractor:** Zhenhua Port Machinery Company, Ltd (ZPMC), Changxing Island **Location:** Shanghai, China**CWI Name:** Gong Wai**CWI Present:** Yes No**Inspected CWI report:** Yes No N/A**Rod Oven in Use:** Yes No N/A**Electrode to specification:** Yes No N/A**Weld Procedures Followed:** Yes No N/A**Qualified Welders:** Yes No N/A**Verified Joint Fit-up:** Yes No N/A**Approved Drawings:** Yes No N/A**Approved WPS:** Yes No N/A**Delayed / Cancelled:** Yes No N/A**Bridge No:** 34-0006**Component:** OBG COMPONENT**Summary of Items Observed:**

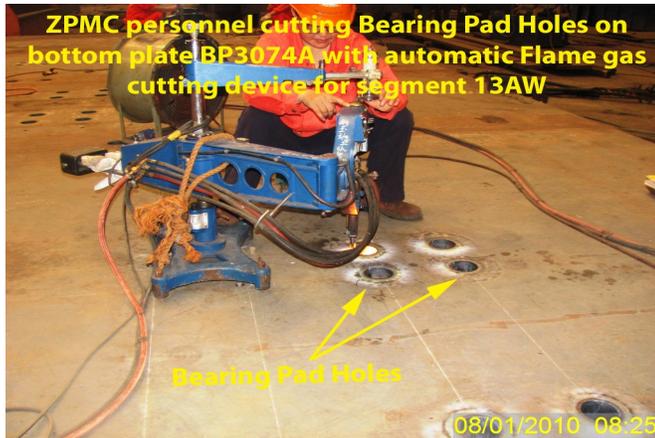
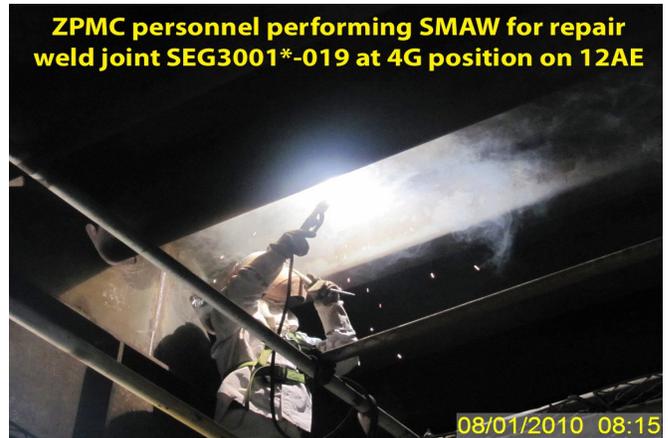
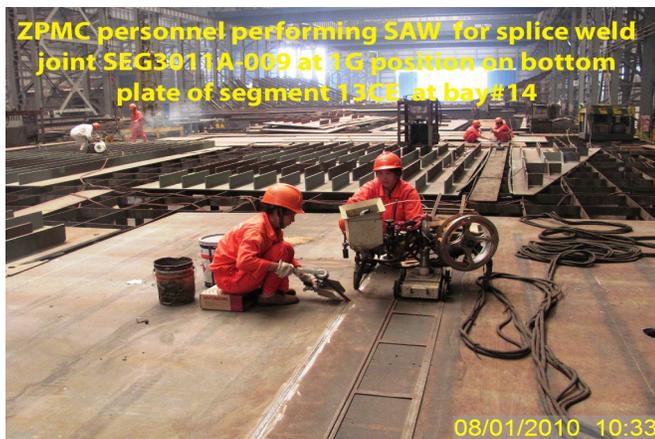
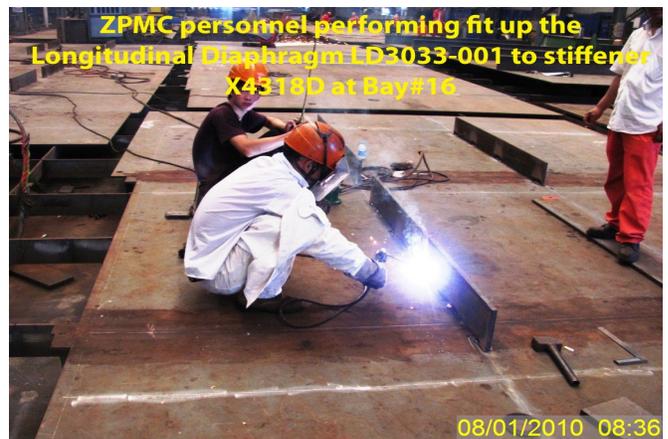
SAW in the 1G position for the OBG Segment 13CE, weld No. SEG3011A-009. The welder is identified as #044771. ZPMC QC is identified as Mr. Zhang Ling. The welding variables recorded by QC appear to comply with WPS-B-T-2221-B-L2c-S-2.

During random visual inspection at bay#16 the QA Inspector observed ZPMC personnel cutting Bearing Pad Holes (75mm diameter) on bottom plate BP3074A with automatic Flame gas cutting device for segment 13AW.

This Quality Assurance (QA) Inspector performed random visual inspection of OBG segment 10BW internal side panel, floor beam and bottom panel surfaces after grit blasting in between panel point PP89 to PP90. Areas that marked for repair were recorded for future repair. Areas requiring additional grinding were marked by QA and repaired by ZPMC personnel.
