**DEPARTMENT OF TRANSPORTATION**

Contract #: 04-0120F4Cty: SF/ALA Rte: 80 PM: 13.2/13.9File #: 1.28**WELDING INSPECTION REPORT****Resident Engineer:** Siegenthaler, Peter**Address:** 333 Burma Road**City:** Oakland, CA 94607**Report No:** WIR-017233**Date Inspected:** 04-Oct-2010**Project Name:** SAS Superstructure**OSM Arrival Time:** 1000**Prime Contractor:** American Bridge/Fluor Enterprises, a JV**OSM Departure Time:** 1830**Contractor:** American Bridge/Fluor Enterprises, a JV**Location:** Job Site

<b>CWI Name:</b>	William Sherwood and Tom Pasqualone			<b>CWI Present:</b>	<b>Yes</b>	<b>No</b>	
<b>Inspected CWI report:</b>	<b>Yes</b>	<b>No</b>	<b>N/A</b>	<b>Rod Oven in Use:</b>	<b>Yes</b>	<b>No</b>	<b>N/A</b>
<b>Electrode to specification:</b>	<b>Yes</b>	<b>No</b>	<b>N/A</b>	<b>Weld Procedures Followed:</b>	<b>Yes</b>	<b>No</b>	<b>N/A</b>
<b>Qualified Welders:</b>	<b>Yes</b>	<b>No</b>	<b>N/A</b>	<b>Verified Joint Fit-up:</b>	<b>Yes</b>	<b>No</b>	<b>N/A</b>
<b>Approved Drawings:</b>	<b>Yes</b>	<b>No</b>	<b>N/A</b>	<b>Approved WPS:</b>	<b>Yes</b>	<b>No</b>	<b>N/A</b>
				<b>Delayed / Cancelled:</b>	<b>Yes</b>	<b>No</b>	<b>N/A</b>
<b>Bridge No:</b>	34-0006			<b>Component:</b>	Or

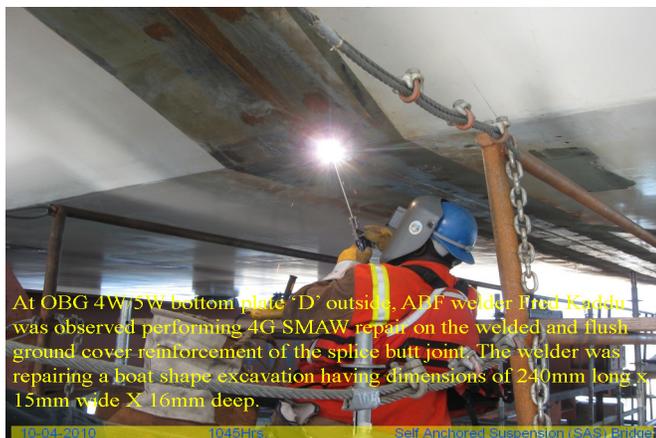
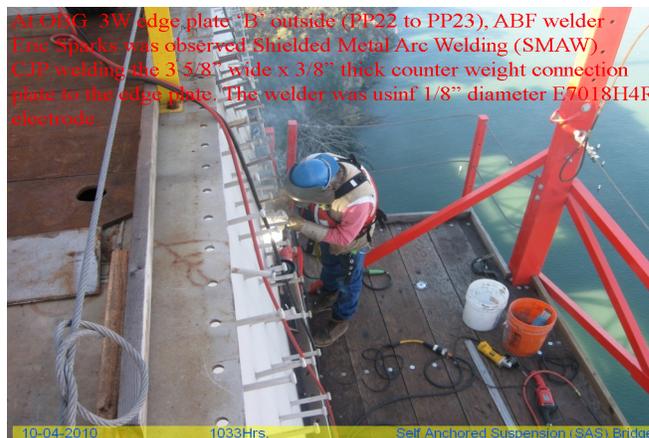
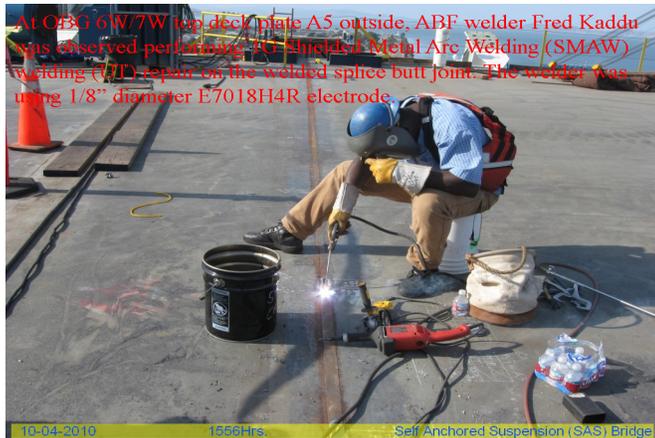
At OBG 6W/7W top deck plate 'A' outside, ABF QC Tom Pasqualone was observed performing Ultrasonic Testing (UT) on the welded splice butt joint. QC was using General Electric USM35 ultrasonic machine. QC was also observed scanning from both sides of face 'A' of the joint. During the shift, ultrasonic testing on the butt joint was still continuing and should remain tomorrow.

the welded splice butt joint. The welder was alternately using 4 1/2" disc grinder and die grinder with a barrel bit. Before the end of the shift, excavation of UT repairs was still continuing and should continue tomorrow.

ABF welder Fred Kaddu was also noted at the top deck of the same plate after he completed welding UT repair at the OBG 4W/5W bottom plate 'D' outside. QA randomly observed ABF/JV qualified welder Fred Kaddu ID # 2188 perform CJP groove welding repair. The welder was observed welding in the 1G (flat) position utilizing Shielded metal Arc Welding (SMAW) with 1/8" diameter E7018H4R electrode implementing welding procedure ABF-WPS-D15-1000-Repairs. The repair excavations were preheated to more than 140 degree Fahrenheit using propane gas torch prior welding. During the shift, ABF QC Tom Pasqualone was noted monitoring the welder. Prior welding, ABF QC Tom Pasqualone was also observed performing Magnetic Particle Testing (MT) using Parker Contour Probe with red magnetic powder as detecting media on the repair excavation. There were no significant defects noted during the test. Welder Fred Kaddu continued welding and has completed seven repairs before the end of the shift. Out of the seven that has been repaired, there are still more to be excavated and repaired which should continue tomorrow.

At OBG 4W/5W bottom plate 'D' outside, QA randomly observed ABF/JV qualified welder Fred Kaddu ID # 2188 perform CJP groove welding repair. The welder was observed welding in the 4G (overhead) position utilizing Shielded metal Arc Welding (SMAW) with 1/8" diameter E7018H4R electrode implementing welding procedure ABF-WPS-D15-1000-Repairs. The boat shape repair excavation having dimensions of 240mm long x 15mm width x 16mm deep was preheated to more than 140 degree Fahrenheit using propane gas torch prior welding. During the shift, ABF QC William Sherwood was noted monitoring the welder. Prior welding, ABF QC William Sherwood was also observed performing Magnetic Particle Testing (MT) using Parker Contour Probe with red magnetic powder as detecting media on the repair excavation. There were no significant defects noted during the test. Repair welding at this location was completed and the welder was instructed to go to the top deck 'A' of OBG 6W/7W.
