**DEPARTMENT OF TRANSPORTATION**

Contract #: 04-0120F4Cty: SF/ALA Rte: 80 PM: 13.2/13.9File #: 99.28**WELDING INSPECTION REPORT****Resident Engineer:** Siegenthaler, Peter**Address:** 333 Burma Road**City:** Oakland, CA 94607**Report No:** WIR-018581**Date Inspected:** 12-Dec-2010**Project Name:** SAS Superstructure**OSM Arrival Time:** 700**Prime Contractor:** American Bridge/Fluor Enterprises, a JV**OSM Departure Time:** 1900**Contractor:** Zhenhua Port Machinery Company, Ltd (ZPMC)**Location:** Shanghai, China**CWI Name:** Li Yang and Zhu Zhong Hai**CWI Present:** Yes No**Inspected CWI report:** Yes No N/A**Rod Oven in Use:** Yes No N/A**Electrode to specification:** Yes No N/A**Weld Procedures Followed:** Yes No N/A**Qualified Welders:** Yes No N/A**Verified Joint Fit-up:** Yes No N/A**Approved Drawings:** Yes No N/A**Approved WPS:** Yes No N/A**Delayed / Cancelled:** Yes No N/A**Bridge No:** 34-0006**Component:** OBG Trial Assembly**Summary of Items Observed:**

Orthotropic Box Girder (OBG) at Trial Assembly Areas

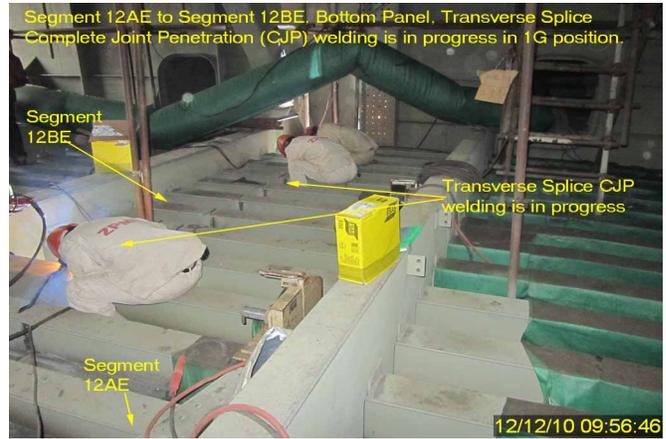
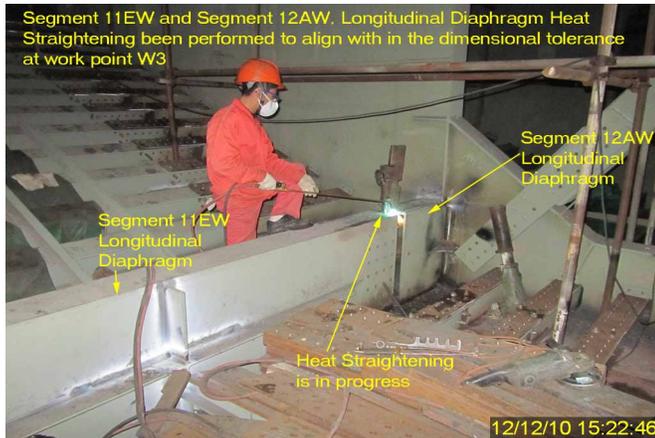
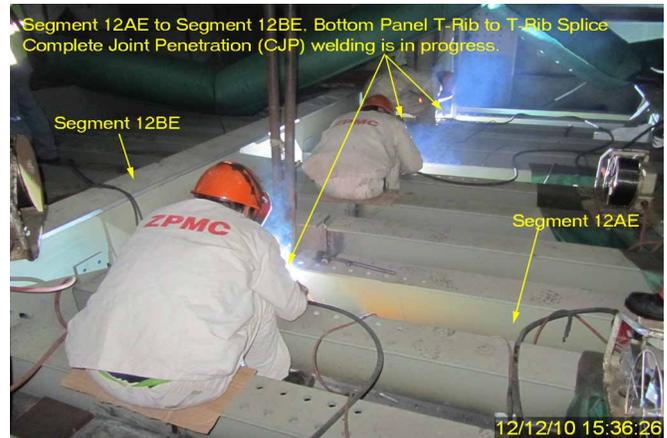
Please reference the pictures attached for more comprehensive details.

Segment 11EW to Segment 12AW (Skin Flatness)

This QA Inspector performed Joint Inspection along with Caltrans QA Inspector Mr. Murugan Manikandan to check the skin flatness between Segment 11EW to Segment 12AW between Panel Points (PP) 108 and PP 109 at the following locations:

The skin flatness was measured on North side (Counter Weight Side at B1 and B2 locations) and South side (Cross Beam side at B3 and B4 locations) at 100mm from the weld connecting Bottom Panel to Side Panel using 5000mm string line to verify overall flatness. The straight edges of 600mm and 630 mm of length were also used to measure the localized flatness.

This QA Inspector observed the ZPMC personnel's performing Heat Straightening at Segment 11EW Longitudinal Diaphragm at work point W3, Counter Weight side. Heat Straightening was performed to align them within the dimensional tolerance to Longitudinal Diaphragm of Segment 12AW.

This QA Inspector observed the ZPMC personnel's performing Heat Straightening at Segment 12AW Longitudinal Diaphragm at work point W3, Cross Beam side. Heat Straightening was performed to align them within the dimensional tolerance to Longitudinal Diaphragm of Segment 11EW.

This QA Inspector observed the repair welding by Shielded Metal Arc Welding (SMAW) process on a Complete Joint Penetration (CJP) groove weld. The 1 (one) cope holes at Floor Beam of Segment 11BE at PP 98, PP 99 and PP 100, due to cutting error of the cope hole. The cope hole was required to be located on the CJP weld on the Floor Beam rather than it was located at wrong place, thus repair welding was been performed.

This QA Inspector observed the repair welding by Shielded Metal Arc Welding (SMAW) process on a Complete Joint Penetration (CJP) groove weld. The 1 (one) cope holes at Floor Beam of Segment 11DE at PP 104, PP 105 and PP 106, due to cutting error of the cope hole. The cope hole was required to be located on the CJP weld on the Floor Beam rather than it was located at wrong place, thus repair welding was been done.

This QA Inspector observed rotation-of-nut after snug tightening is in progress for Bottom Panel T-Rib to T-Rib between Segment 11CE to Segment 11DE, Panel Points PP 103 to PP 104 at Transverse Splice.
