DEPARTMENT OF TRANSPORTATION

Office of Structural Materials

Contract #: 04-0120F4Cty: SF/ALA Rte: 80 PM: 13.2/13.9File #: 99.28**WELDING INSPECTION REPORT****Resident Engineer:** Siegenthaler, Peter**Address:** 333 Burma Road**City:** Oakland, CA 94607**Report No:** WIR-018874**Date Inspected:** 20-Dec-2010**Project Name:** SAS Superstructure**OSM Arrival Time:** 700**Prime Contractor:** American Bridge/Fluor Enterprises, a JV**OSM Departure Time:** 1900**Contractor:** Zhenhua Port Machinery Company, Ltd (ZPMC)**Location:** Shanghai, China**CWI Name:** Li Yang and Zhu Zhong Hai**CWI Present:** Yes No**Inspected CWI report:** Yes No N/A**Rod Oven in Use:** Yes No N/A**Electrode to specification:** Yes No N/A**Weld Procedures Followed:** Yes No N/A**Qualified Welders:** Yes No N/A**Verified Joint Fit-up:** Yes No N/A**Approved Drawings:** Yes No N/A**Approved WPS:** Yes No N/A**Delayed / Cancelled:** Yes No N/A**Bridge No:** 34-0006**Component:** OBG Trial Assembly**Summary of Items Observed:**

Orthotropic Box Girder (OBG) at Trial Assembly Areas

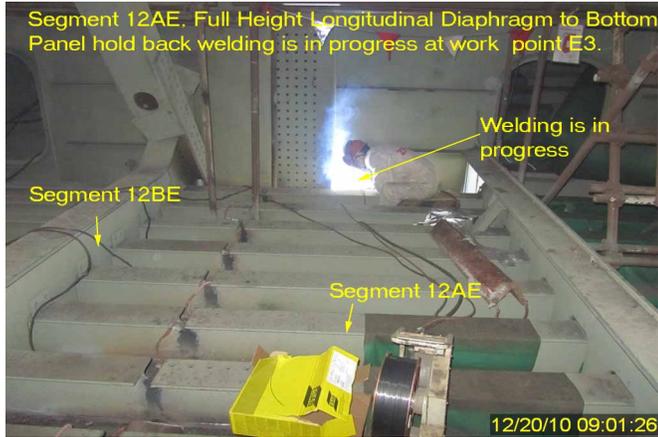
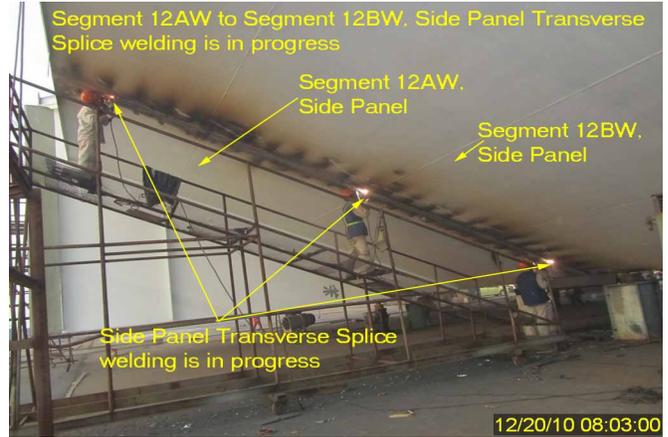
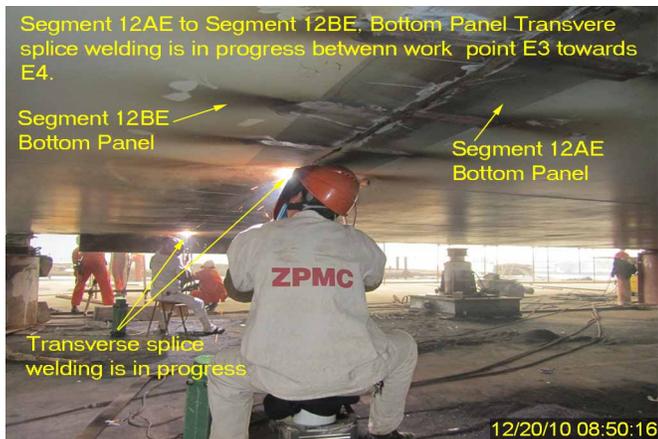
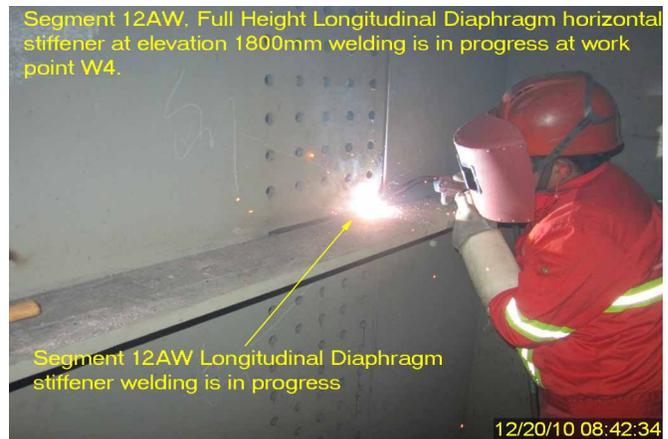
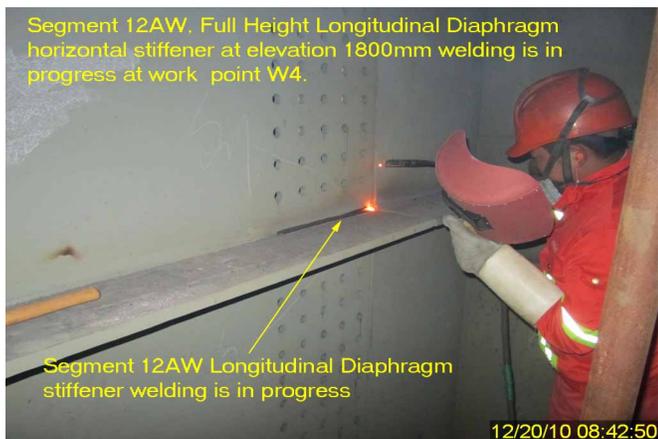
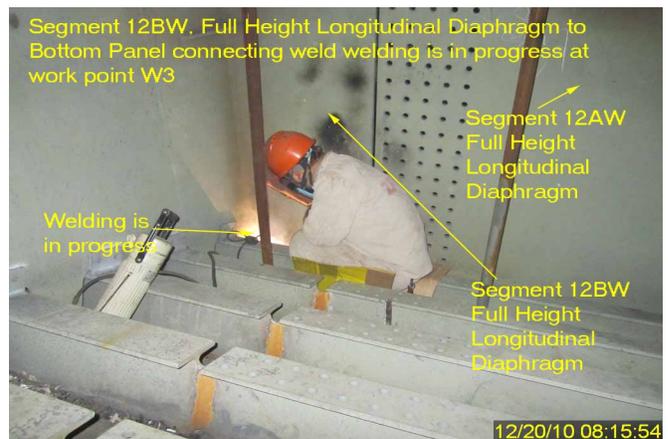
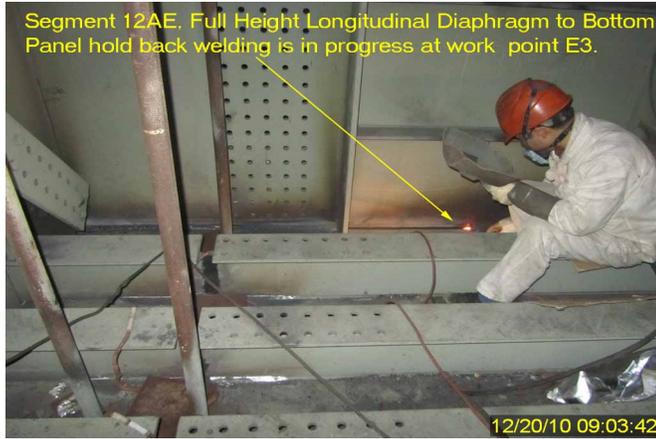
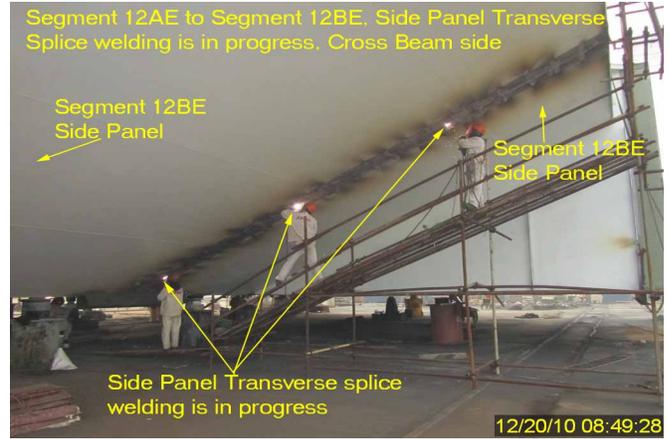
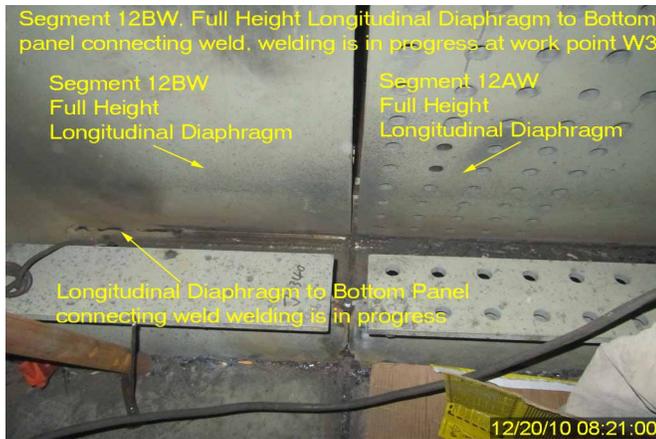
Please reference the pictures attached for more comprehensive details.

This QA Inspector observed the in-process welding by Shielded Metal Arc Welding (SMAW) process on a Complete Joint Penetration (CJP) groove weld. The Weld joint was designated as OBW12D-002. The welder identification was 040611 and 040656, observed welding in the 4G (Overhead) position using approved Welding Procedure Specification WPS-B-P-2214-B-U2-FCM-1. The piece mark was identified as the Side Panel, Cross Beam side at transverse splice.

This QA Inspector observed the in-process welding by Flux Cored Arc Welding (FCAW) process on a Complete Joint Penetration (CJP) groove weld. The Weld joint was designated as Seg3005M-090. The welder identification was 046704 and was observed welding in the 2G (Horizontal) position using approved Welding Procedure Specification WPS-B-T-2212-Tc-U4b-FCM-1. The piece mark was identified as full height Longitudinal Diaphragm web to Bottom Panel hold back weld at work point W3.

This QA Inspector observed the in-process welding by Shielded Metal Arc Welding (SMAW) process on a Complete Joint Penetration (CJP) groove weld. The Weld joint was designated as OBW12B-001. The welder identification was 053871 and 040320, observed welding in the 4G (Overhead) position using approved Welding Procedure Specification WPS-B-P-2214-B-U2-FCM-1. The piece mark was identified as the Bottom Panel at transverse splice.
