DEPARTMENT OF TRANSPORTATION

Contract #: 04-0120F4Cty: SF/ALA Rte: 80 PM: 13.2/13.9File #: 1.28**WELDING INSPECTION REPORT****Resident Engineer:** Siegenthaler, Peter**Address:** 333 Burma Road**City:** Oakland, CA 94607**Report No:** WIR-018989**Date Inspected:** 30-Dec-2010**Project Name:** SAS Superstructure**OSM Arrival Time:** 700**Prime Contractor:** American Bridge/Fluor Enterprises, a JV**OSM Departure Time:** 1530**Contractor:** American Bridge/Fluor Enterprises, a JV**Location:** Job Site**CWI Name:** Gary Ersham and Pat Swain**CWI Present:** Yes No**Inspected CWI report:** Yes No N/A**Rod Oven in Use:** Yes No N/A**Electrode to specification:** Yes No N/A**Weld Procedures Followed:** Yes No N/A**Qualified Welders:** Yes No N/A**Verified Joint Fit-up:** Yes No N/A**Approved Drawings:** Yes No N/A**Approved WPS:** Yes No N/A**Delayed / Cancelled:** Yes No N/A**Bridge No:** 34-0006**Component:** Orthotropic Box Girder**Summary of Items Observed:**

Caltrans Office of Structural Material (OSM) Quality Assurance Inspector (QAI) Joselito Lizardo was present at the Self Anchored Suspension (SAS) job site as requested to perform observations on the welding of components for the

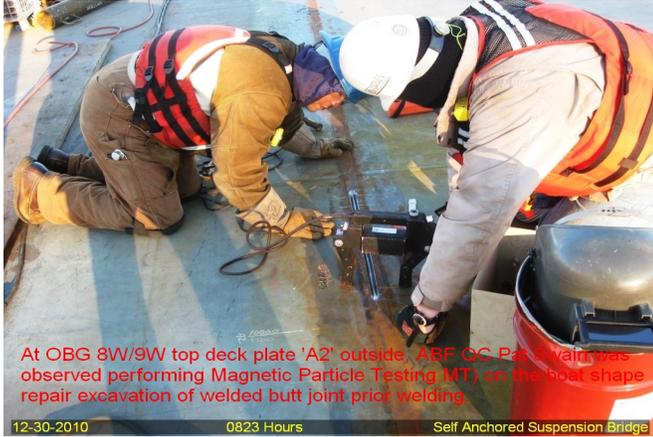
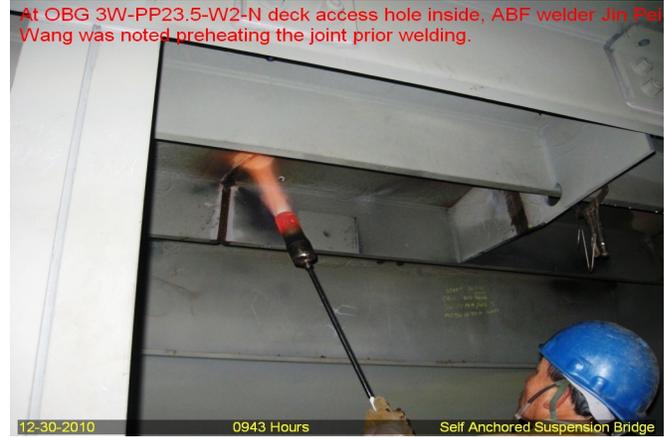
At OBG 8W/9W top deck plate 'A2' outside, QA randomly observed ABF/JV qualified welder Wai Kitlai perform CJP repair welding. The welder was noted welding in 1G (Flat) position utilizing Shielded Metal Arc Welding (SMAW) with 1/8" diameter E7018H4R electrode implementing Caltrans approved Welding Procedure Specification (WPS) ABF-WPS-D15-1001 Repairs. The four repairs were excavated to a boat shape profile and were tested with Magnetic Particle Testing (MT) prior welding. During welding, ABF QC Pat Swain was noted monitoring the welder and his welding parameters. Welding parameter measured at the time of welding was 140 amperes which appears in compliance to the WPS. The locations of the repairs were noted below;
