DEPARTMENT OF TRANSPORTATION

Contract #: 04-0120F4Cty: SF/ALA Rte: 80 PM: 13.2/13.9File #: 99.28**WELDING INSPECTION REPORT****Resident Engineer:** Siegenthaler, Peter**Address:** 333 Burma Road**City:** Oakland, CA 94607**Report No:** WIR-019006**Date Inspected:** 30-Dec-2010**Project Name:** SAS Superstructure**OSM Arrival Time:** 700**Prime Contractor:** American Bridge/Fluor Enterprises, a JV**OSM Departure Time:** 1900**Contractor:** Zhenhua Port Machinery Company, Ltd (ZPMC)**Location:** Shanghai, China**CWI Name:** Li Yang and Zhu Zhong Hai**CWI Present:** Yes No**Inspected CWI report:** Yes No N/A**Rod Oven in Use:** Yes No N/A**Electrode to specification:** Yes No N/A**Weld Procedures Followed:** Yes No N/A**Qualified Welders:** Yes No N/A**Verified Joint Fit-up:** Yes No N/A**Approved Drawings:** Yes No N/A**Approved WPS:** Yes No N/A**Delayed / Cancelled:** Yes No N/A**Bridge No:** 34-0006**Component:** OBG Trial Assembly**Summary of Items Observed:**

Orthotropic Box Girder (OBG) at Trial Assembly Areas

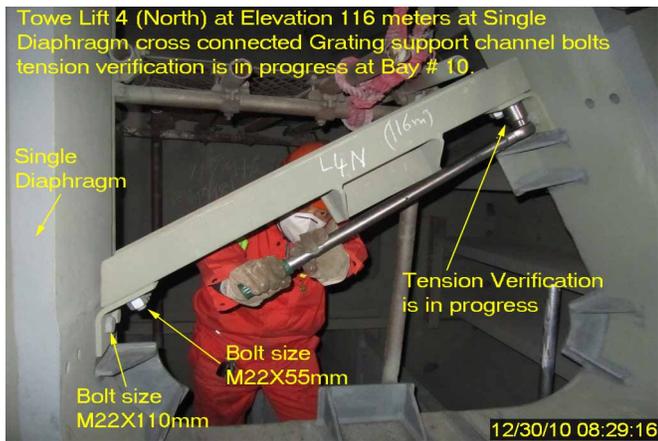
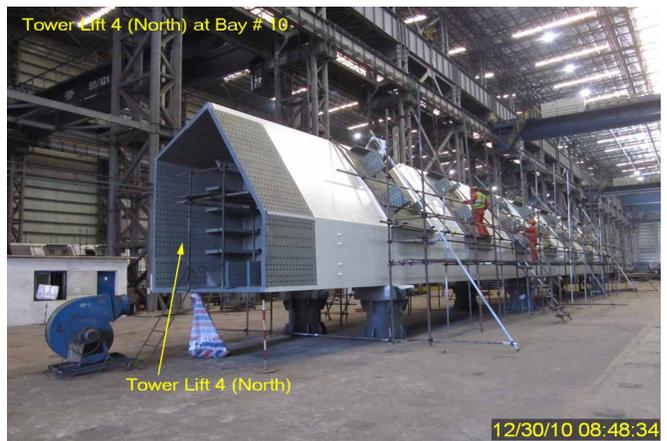
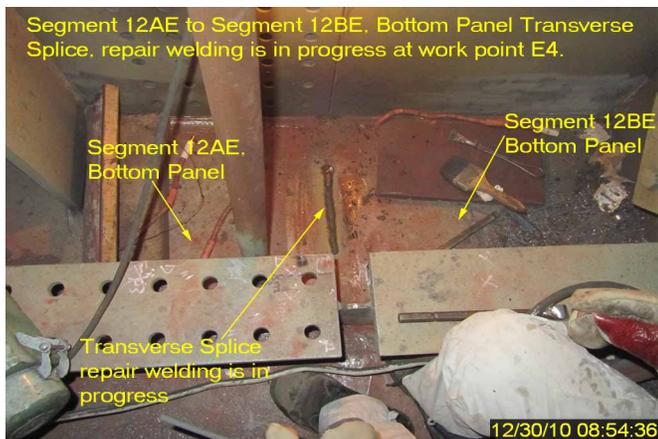
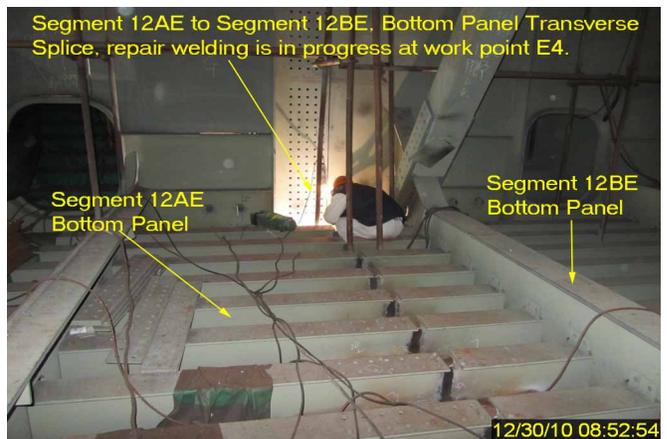
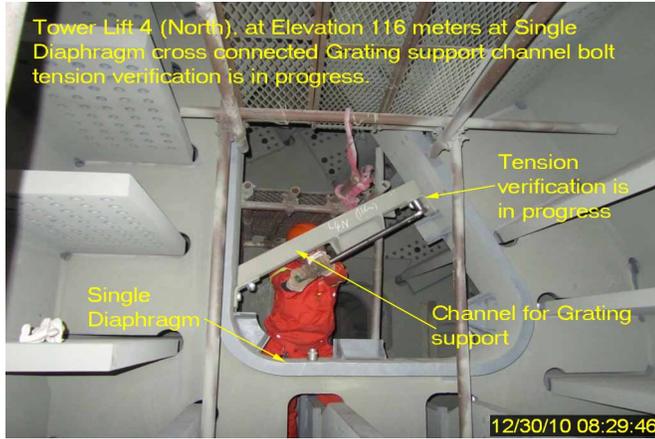
Please reference the pictures attached for more comprehensive details.

This Quality Assurance (QA) Inspector witnessed final bolt tension verification for Tower Lift 4 North. Bolts are installed for Diaphragm holding Angles and Grating channel at Single Diaphragm. Inspected 10% on a random basis and found the tension to be in general compliance. Inspection was performed against the Notification No. 00586 Dated December 30, 2010.

This Quality Assurance (QA) Inspector witnessed final bolt tension verification for Tower Lift 4 North. Bolts are installed at Angles connecting Grating Channels and 3 (three) Stiffeners welded on Tower Skin Plate “Face A” and Angles connecting Grating Channels and 2 (two) Stiffeners welded on Tower Skin Plate “Face B” at Inspected 10% on a random basis and found the tension to be in general compliance. Inspection was performed against the Notification No. 00586 Dated December 30, 2010.

This QA Inspector observed the repair welding by Shielded Metal Arc Welding (SMAW) process on a Complete Joint Penetration (CJP) groove weld. The Weld joint was designated as OBE12B-001. The welder identification was 050289 and observed welding in the 1G (Flat) position using approved Welding Procedure Specification WPS-345-SMAW-1G(1F)-FCM-Repair-1. The piece mark was identified as the Bottom Panel, at transverse splice. ZPMC performed repair welding in accordance with Welding Repair Report B-WR-19699 dated Dec 28, 2010.
