Contract #: 04-0120F4Cty: SF/ALA Rte: 80 PM: 13.2/13.9File #: 1.28**WELDING INSPECTION REPORT****Resident Engineer:** Siegenthaler, Peter**Address:** 333 Burma Road**City:** Oakland, CA 94607**Report No:** WIR-019170**Date Inspected:** 03-Jan-2011**Project Name:** SAS Superstructure**OSM Arrival Time:** 1000**Prime Contractor:** American Bridge/Fluor Enterprises, a JV**OSM Departure Time:** 1830**Contractor:** American Bridge/Fluor Enterprises, a JV**Location:** Job Site

Caltrans Office of Structural Material (OSM) Quality Assurance Inspector (QAI) Joselito Lizardo was present at the Self Anchored Suspension (SAS) job site as requested to perform observations on the welding of components for the San Francisco Oakland Bay Bridge (SFOBB) Project.

The following deck access holes (DAH) and lifting lug access holes (LLAH) infill plate to top deck plate welding activities were observed;

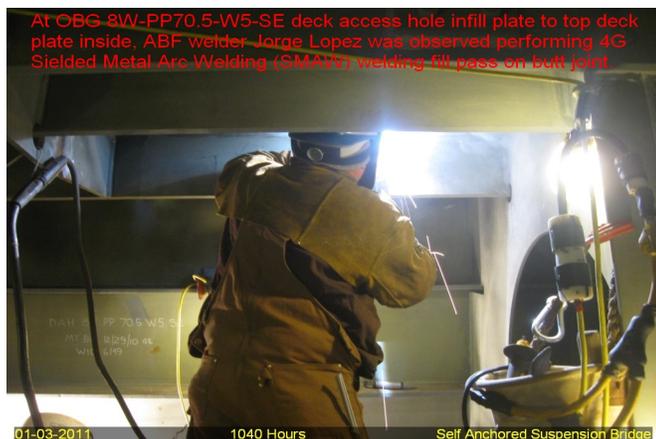
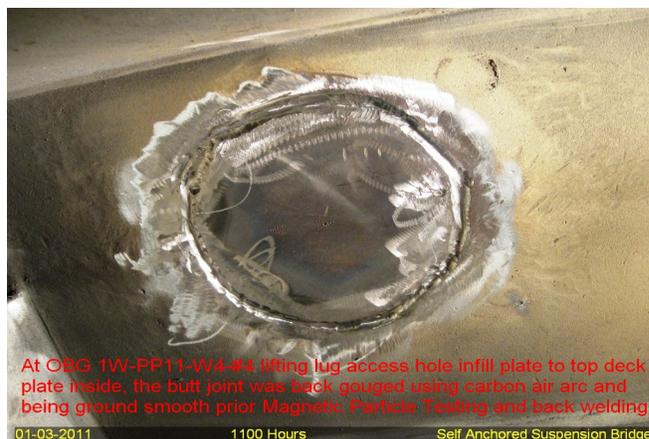
- At OBG 8W-PP70.5-W5-SE (DAH) inside – ABF welder Jorge Lopez was observed continuing to perform 4G Shielded Metal Arc Welding (SMAW) back welding fill pass on the infill plate to top deck plate butt joint. The welder was noted using 1/8" diameter E7018H4R electrode. At the end of the shift, fill pass welding was still in progress and should continue tomorrow.

- At OBG 1W-PP11-W4-#4 (LLAH) inside - ABF welder Mike Jimenez was observed back gouging the welded butt joint using carbon arc then ground smooth for Magnetic Particle Testing (MT) and back welding. After the completion of MT, the welder was observed 4G SMAW welding fill to cover pass on butt joint. The welder was

5. At OBG 1W-PP11-W3-#1 to #4 (LLAH) outside – ABF welder Darcel Jackson was observed 1G SMAW welding cover pass on four LLAH to top deck plate butt joints. After their completion, the welder has moved to 1W-PP9.5-W3-#2 and #4 (LLAH) and continued welding fill pass where these two access holes were previously/partly welded but were not completed. At the end of the shift, LLAH #4 was completed and # 2 was still in progress.
