DEPARTMENT OF TRANSPORTATION

Quality Assurance and Source Inspection

Contract #: 04-0120F4Cty: SF/ALA Rte: 80 PM: 13.2/13.9File #: 99.28**WELDING INSPECTION REPORT****Resident Engineer:** Siegenthaler, Peter**Address:** 333 Burma Road**City:** Oakland, CA 94607**Report No:** WIR-019308**Date Inspected:** 15-Jan-2011**Project Name:** SAS Superstructure**OSM Arrival Time:** 700**Prime Contractor:** American Bridge/Fluor Enterprises, a JV**OSM Departure Time:** 1900**Contractor:** Zhenhua Port Machinery Company, Ltd (ZPMC) Chanxing Island**Location:** Shanghai, China

| Bridge No: | 34-0006 | Component: | OBG Segment | |

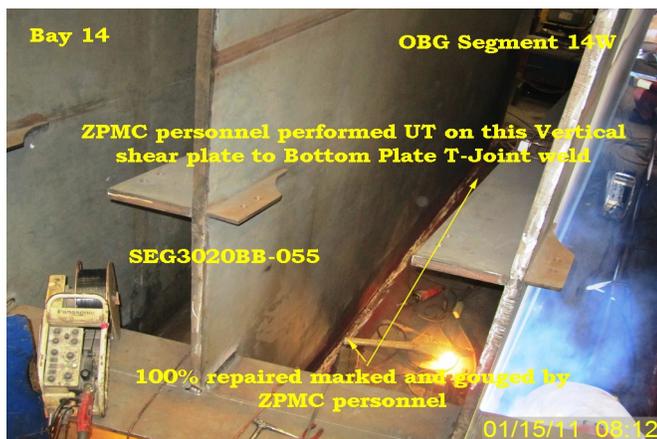
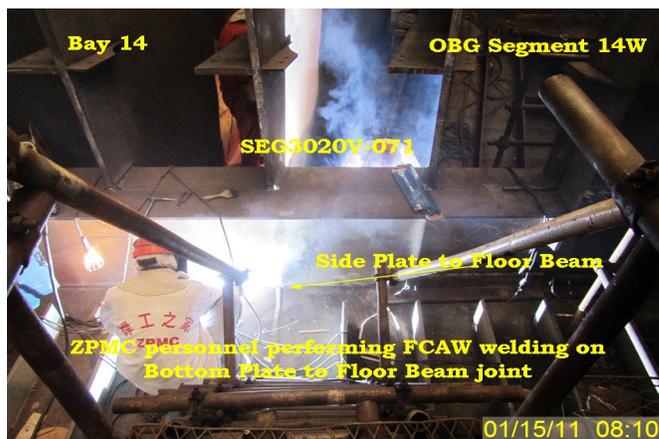
Shielded Metal Arc Welding (SMAW) repair welding of weld joint SEG3013BB-001 and 019 located on Vertical Shear to Bottom Plate of OBG Segment 14W. ZPMC Welder is identified as 066695. ZPMC Quality Control (QC) is identified as Mr. Sun Tian Liang. The welding variables recorded by QC appeared to comply with the Applicable WPS-345-SMAW-2G (2F) – FCM – Repair-1, which is used as per Welding Repair Report (WRR) B-WRR-20146.

This QA inspector observed ABF personnel performed Magnetic Particle Testing on Floor beam and Longitudinal Diaphragm Stiffeners of the OBG Segment 13BW at panel point 124.5 and 124 north side.
