DEPARTMENT OF TRANSPORTATION

Office of Structural Materials

Quality Assurance and Source Inspection

Contract #: 04-0120F4Cty: SF/ALA Rte: 80 PM: 13.2/13.9File #: 1.28**WELDING INSPECTION REPORT****Resident Engineer:** Siegenthaler, Peter**Address:** 333 Burma Road**City:** Oakland, CA 94607**Report No:** WIR-019454**Date Inspected:** 18-Jan-2011**Project Name:** SAS Superstructure**OSM Arrival Time:** 630**Prime Contractor:** American Bridge/Fluor Enterprises, a JV**OSM Departure Time:** 2130**Contractor:** American Bridge/Fluor Enterprises, a JV**Location:** Job Site**CWI Name:** Fred Von Hoff and Pat Swain**CWI Present:** Yes No**Inspected CWI report:** Yes No N/A**Rod Oven in Use:** Yes No N/A**Electrode to specification:** Yes No N/A**Weld Procedures Followed:** Yes No N/A**Qualified Welders:** Yes No N/A**Verified Joint Fit-up:** Yes No N/A**Approved Drawings:** Yes No N/A**Approved WPS:** Yes No N/A**Delayed / Cancelled:** Yes No N/A**Bridge No:** 34-0006**Component:** Orthotropic Box Girder**Summary of Items Observed:**

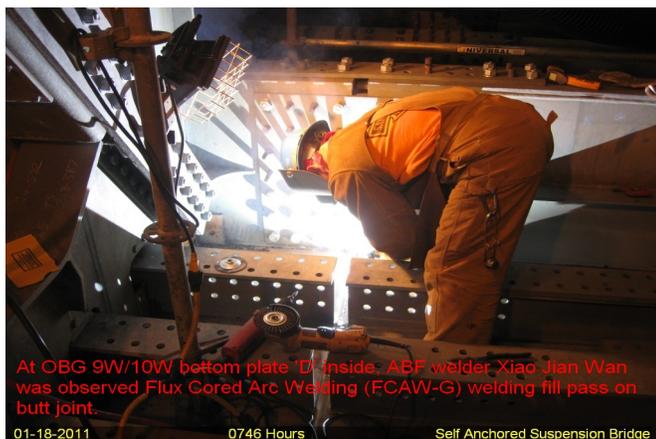
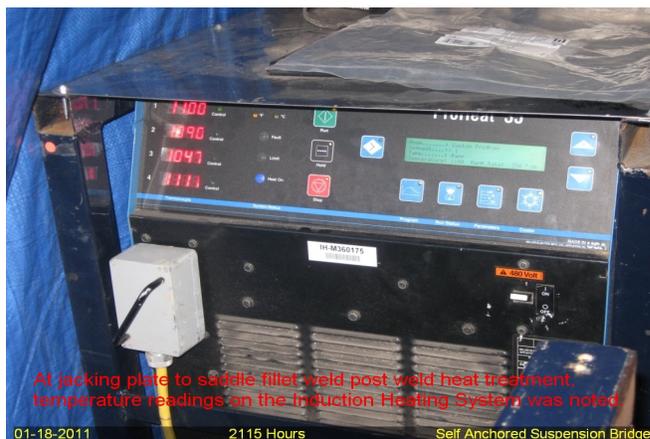
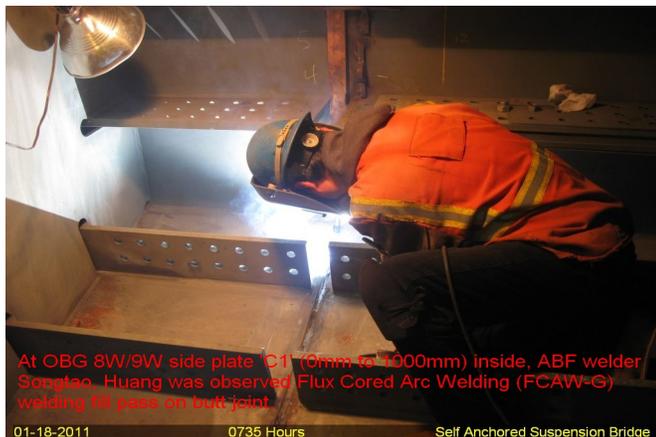
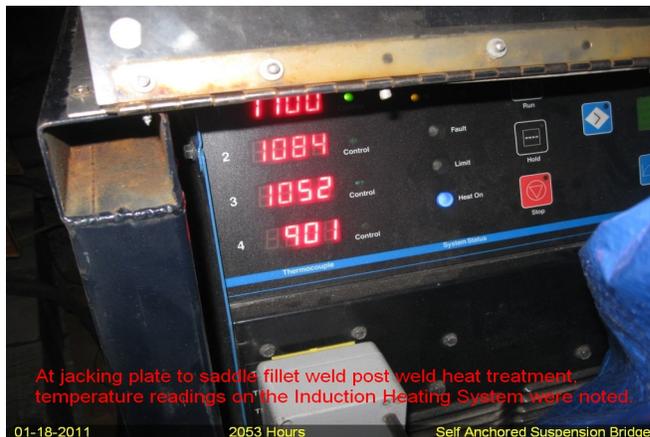
The four machines started to heat up again and noted that three machines have reached the required post weld temperature of 1100 degrees F before 2000hours while the fourth machine was still registering 1000 degrees F. At this time, fellow QA Joe Lanz came to relieve this QA and monitored the continuation and completion of the PWHT.

Jacking Frame to Saddle fillet welding. Upon arrival at the welding area, fillet welding on one side of the saddle to the jacking frame has been completed. ABF Mike Johnson inform this QA that he has accepted the fillet weld joint after performing visual inspection on the profile and measurement on the size of the fillet weld. QA performed verification by doing the same visual inspection and random measurement of the fillet weld using the 25mm fillet gauge. The fillet weld profile was noted satisfactory and the size was deemed adequate.

After the ABF QC inspection and QA verification was completed, ABF personnel were noted prepping the fillet weld joint to be post weld heat treated (PWHT). ABF personnel have changed the Miller Proheat 35 Induction Heating System regular heater blankets that were used to preheat the plates during welding to water cooled heater blankets for the PWHT. It took almost two hours before the PWHT set up was completed.

Less than one hour after the post weld temperature was rising, the electric power supply for the Induction Heating System broke down. The power breakdown lasted for approximately 40minutes (1830hours to 1910 hours) before the power was restored. The minimum temperature noted on all the four Induction Heating System machines after the power restored was more than 600 degrees Fahrenheit.
