DEPARTMENT OF TRANSPORTATION

Contract #: 04-0120F4Cty: SF/ALA Rte: 80 PM: 13.2/13.9File #: 1.28**WELDING INSPECTION REPORT****Resident Engineer:** Siegenthaler, Peter**Address:** 333 Burma Road**City:** Oakland, CA 94607**Report No:** WIR-019813**Date Inspected:** 27-Jan-2011**Project Name:** SAS Superstructure**OSM Arrival Time:** 1000**Prime Contractor:** American Bridge/Fluor Enterprises, a JV**OSM Departure Time:** 1830**Contractor:** American Bridge/Fluor Enterprises, a JV**Location:** Job Site

CWI Name:	Steve Jensen and Fred Von Hoff			CWI Present:	Yes	No	
Inspected CWI report:	Yes	No	N/A	Rod Oven in Use:	Yes	No	N/A
Electrode to specification:	Yes	No	N/A	Weld Procedures Followed:	Yes	No	N/A
Qualified Welders:	Yes	No	N/A	Verified Joint Fit-up:	Yes	No	N/A
Approved Drawings:	Yes	No	N/A	Approved WPS:	Yes	No	N/A
				Delayed / Cancelled:	Yes	No	N/A
Bridge No:	34-0006			Component:	Orthotropic Box Girder

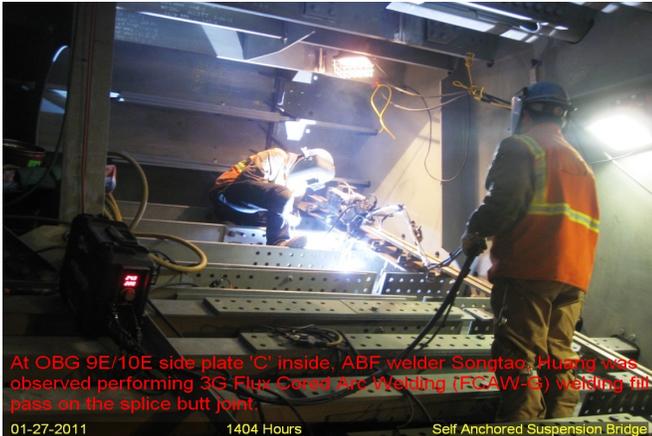
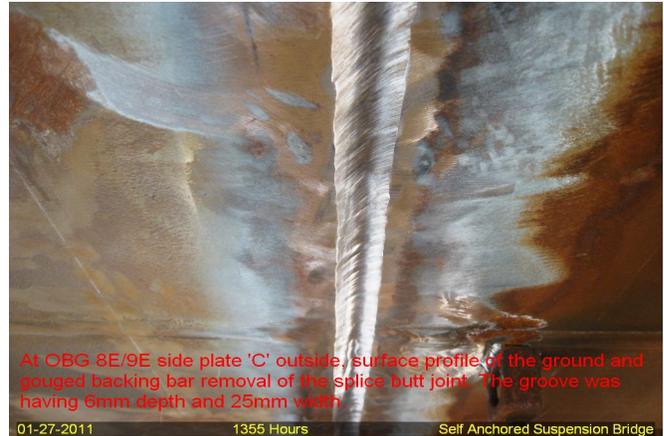
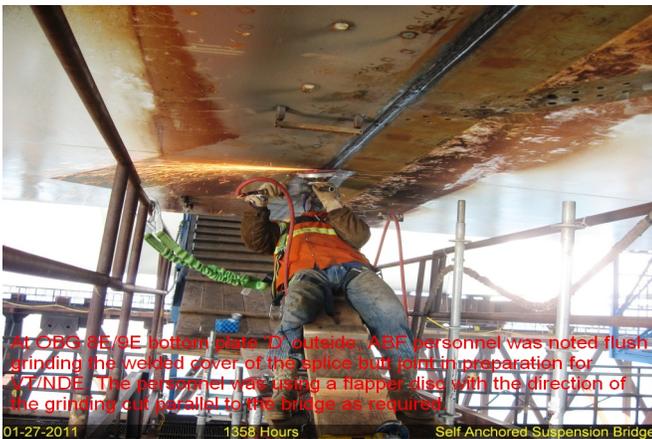
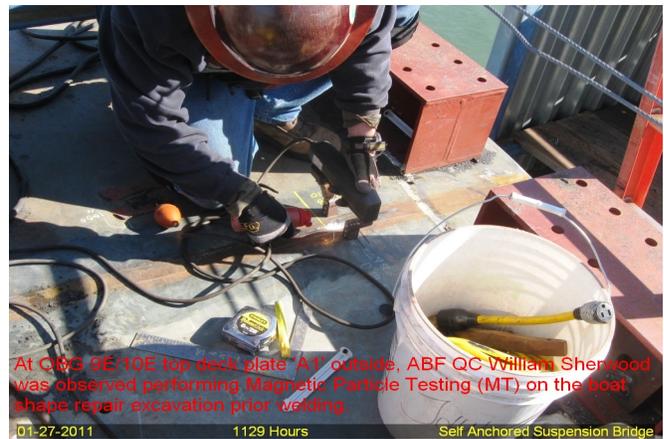
QA randomly observed ABF/JV qualified welder Rory Hogan (ID #3186) continuing to perform CJP groove welding cover pass on Orthotropic Box Girder (OBG) 8E/9E side plate 'C1' outside. The welder was observed welding in the 4G (overhead) position utilizing a dual shield Flux Cored Arc Welding (FCAW-G) with E71T-1M, 1/16" diameter wire electrode and implementing Caltrans approved Welding Procedure Specification (WPS) ABF-WPS-D15-3110-4. The welder was using a track mounted welder holder assembly that was remotely controlled. The joint being welded has the backing bar gouged using the Esab Plasma Arc machine and was ground smooth. The splice joint was preheated to greater than 150 degrees Fahrenheit prior welding and the vicinity was properly protected from wind. During welding, ABF Quality Control (QC) Steve Jensen was noted monitoring the welding parameters of the welder. At the end of the shift, fill pass welding was still continuing and should remain tomorrow.

At OBG 9E/10E side plate 'C1' inside, QA randomly observed ABF/JV qualified welder Sungtao, Huang ID # 3794 perform CJP groove (splice) welding fill pass on the splice butt joint. The welder was observed perform automatic welding in the 3G (vertical) position utilizing a dual shield Flux Cored Arc Welding (FCAW-G) with E71T-1M, 1/16" diameter wire electrode and implementing Caltrans approved Welding Procedure Specification (WPS) ABF-WPS-D15-3042B-1. The joint being welded has a single V-groove butt joint with backing bar. The splice joint was preheated and maintained to greater than 150 degrees Fahrenheit using Miller Proheat 35

At OBG 9E/10E top deck plate 'A1' outside, QA randomly observed ABF/JV qualified welder Wai Kitlai continuing to perform CJP repair welding. The welder was noted welding in 1G (Flat) position utilizing Shielded Metal Arc Welding (SMAW) with 1/8" diameter E7018H4R electrode implementing Caltrans approved Welding Procedure Specification (WPS) ABF-WPS-D15-1001 Repairs. The welding repair which was located at A1 Y=520mm was excavated to a boat shape profile of 110mm long x 28mm wide x 20mm deep was tested with Magnetic Particle Testing (MT) prior welding. During welding, ABF QC William Sherwood was noted monitoring the welder and his welding parameters. At the end of the shift, this last repair in this particular plate was completed.

At OBG 6E-PP44-E3-#2 lifting lug access hole to top deck outside, ABF welder Salvador Sandoval was observed 1G Shielded Metal Arc Welding (SMAW) welding fill pass to cover pass on the infill plate to top deck plate butt joint. The welder was noted using 1/8" diameter E7018H4R electrode implementing Caltrans approved Welding Procedure Specification (WPS) ABF-WPS-D15-1070. During the shift, cover pass welding was completed and the welder was noted preparing to move to another hole of the same location.

At OBG 8E/9E bottom plate 'D' outside, one ABF personnel was noted flush grinding the welded cover reinforcement using flapper disc. During the grinding process, the direction of the grinding cut was noted parallel to the direction of the tension of the bridge which was in compliance to the contract requirements.
