**DEPARTMENT OF TRANSPORTATION**

Contract #: 04-0120F4Cty: SF/ALA Rte: 80 PM: 13.2/13.9File #: 69.28**WELDING INSPECTION REPORT****Resident Engineer:** Siegenthaler, Peter**Address:** 333 Burma Road**City:** Oakland, CA 94607**Report No:** WIR-020731**Date Inspected:** 20-Feb-2011**Project Name:** SAS Superstructure**OSM Arrival Time:** 700**Prime Contractor:** American Bridge/Fluor Enterprises, a JV**OSM Departure Time:** 1900**Contractor:** Zhenhua Port Machinery Company, Ltd (ZPMC), Changxing Island **Location:** Shanghai, China**CWI Name:** Li Yang and Zhu Zhong Hai**CWI Present:** Yes No**Inspected CWI report:** Yes No N/A**Rod Oven in Use:** Yes No N/A**Electrode to specification:** Yes No N/A**Weld Procedures Followed:** Yes No N/A**Qualified Welders:** Yes No N/A**Verified Joint Fit-up:** Yes No N/A**Approved Drawings:** Yes No N/A**Approved WPS:** Yes No N/A**Delayed / Cancelled:** Yes No N/A**Bridge No:** 34-0006**Component:** OBG Trial Assembly**Summary of Items Observed:**

Orthotropic Box Girder (OBG) at Trial Assembly Areas

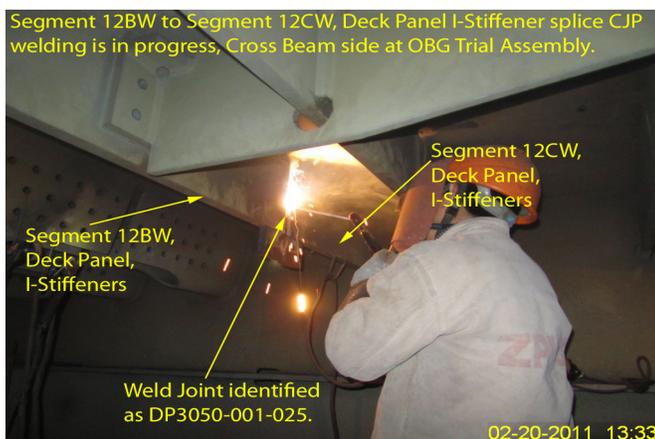
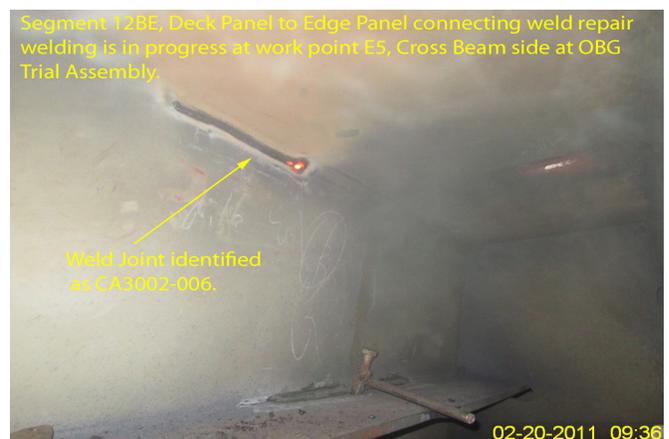
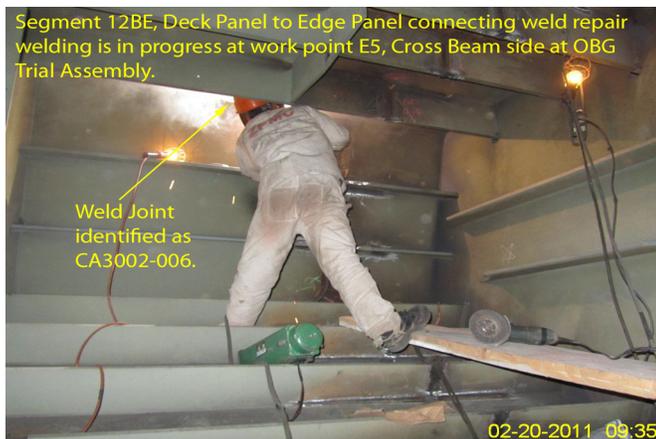
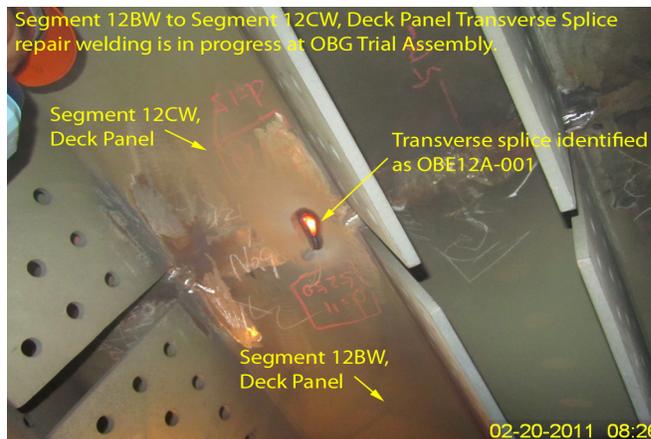
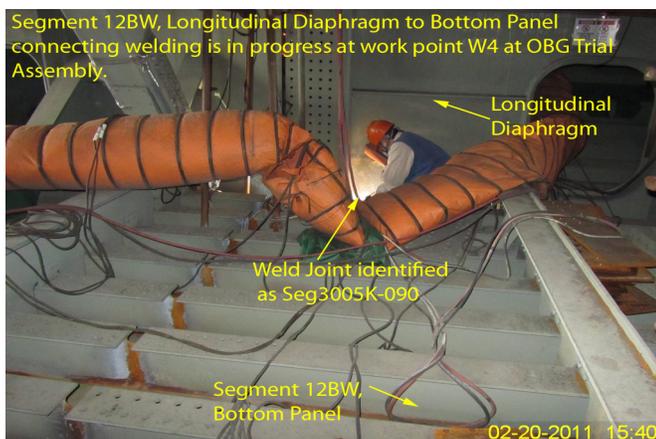
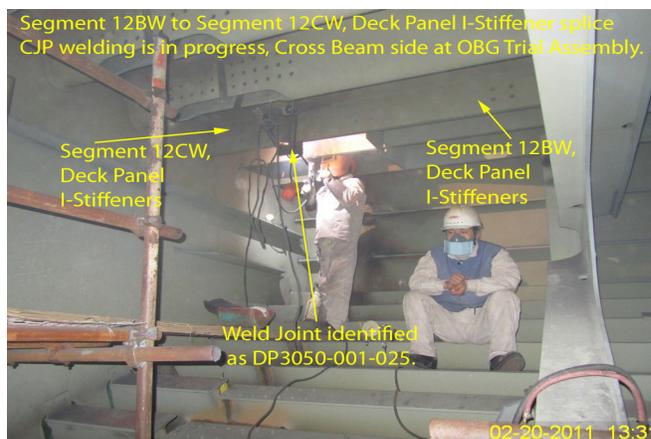
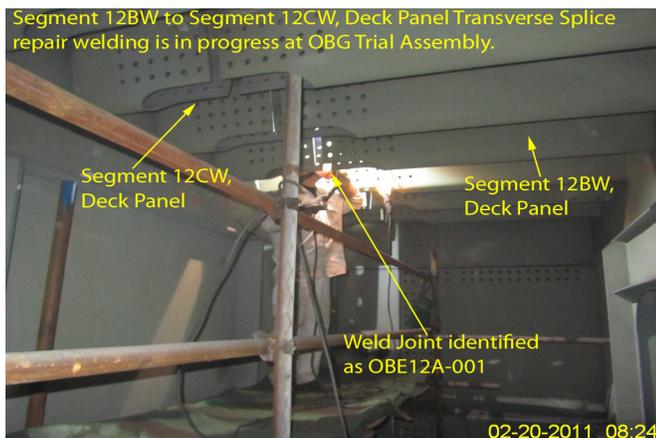
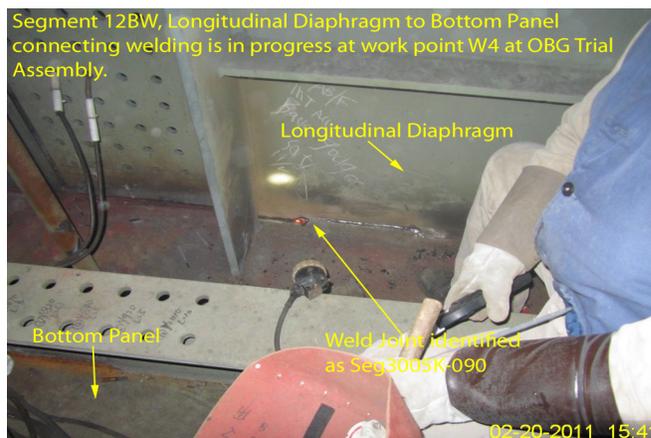
Please reference the pictures attached for more comprehensive details.

This QA Inspector observed the repair welding by Shielded Metal Arc Welding (SMAW) process on a Complete Joint Penetration (CJP) groove weld. The Weld joint was designated as CA3002-006. The welder identification was 044504 and observed welding in the 4G (Overhead) position using approved Welding Procedure Specification WPS-345-SMAW-4G(4F)-FCM-Repair-1. The piece mark was identified as the weld connecting the Deck Panel to Edge Panel at work point E5, Bike Path side. ZPMC performed repair welding in accordance with Welding Repair Report B-WR20200.

This QA Inspector observed the repair welding by Shielded Metal Arc Welding (SMAW) process on a Complete Joint Penetration (CJP) groove weld. The Weld joint was designated as OBE12A-002. The welder identification was 040320 and observed welding in the 4G (Overhead) position using approved Welding Procedure Specification WPS-345-SMAW-4G(4F)-FCM-Repair-1. The piece mark was identified as the weld connecting the Deck Panel Corner Assembly at transverse splice. ZPMC performed repair welding in accordance with Welding Repair Report B-WR20192.

This QA Inspector observed the repair welding by Flux Cored Arc Welding (FCAW) process on a Complete Joint Penetration (CJP) groove weld. The Weld joint was designated as OBE12E-003. The welder identification was 040367 and observed welding in the 3G (Vertical) position using approved Welding Procedure Specification WPS-345-FCAW-3G(3F)-ESAB-Repair. The piece mark was identified as the weld connecting the Side Panel at transverse splice, Bike Path side. ZPMC performed repair welding in accordance with Welding Repair Report B-WR20185.

This QA Inspector observed the repair welding by Flux Cored Arc Welding (FCAW) process on a Complete Joint Penetration (CJP) groove weld. The Weld joint was designated as CA6502-011. The welder identification was 052763 and observed welding in the 3G (Overhead) position using approved Welding Procedure Specification WPS-345-FCAW-3G(3F)-ESAB-Repair.. The piece mark was identified as the weld connecting the Side Panel Corner Assembly at transverse splice, Bike Path side. ZPMC performed repair welding in accordance with Welding Repair Report B- WR20185.

This QA Inspector observed the in-process welding by Shielded Metal Arc Welding (SMAW) process on a Complete Joint Penetration (CJP) groove weld. The Weld joint was designated as OBE12A-001. The welder identification was 041713 and observed welding in the 4G (Overhead) position using approved Welding Procedure Specification WPS-B-P-2214-B-U2-FCM-1. The piece mark was identified as weld connecting the Deck Panel at transverse splice.

This QA Inspector observed the in-process welding by Shielded Metal Arc Welding (SMAW) process on a Complete Joint Penetration (CJP) groove weld. The Weld joint was designated as OBE12A-002. The welder identification was 040656 and observed welding in the 4G (Overhead) position using approved Welding Procedure Specification WPS-B-P-2214-B-U2-FCM-1. The piece mark was identified as weld connecting the Deck Panel Corner Assembly at transverse splice.

This QA Inspector observed the in-process welding by Shielded Metal Arc Welding (SMAW) process on a Complete Joint Penetration (CJP) groove weld. The Weld joint was designated as Seg3005K-090. The welder identification was 046704 and observed welding in the 2G (Horizontal) position using approved Welding Procedure Specification WPS-B-P-2212-Tc-U4b-FCM-1. The piece mark was identified as weld connecting the Longitudinal Diaphragm to Bottom Panel at work point W4.

This QA Inspector observed the in process welding operation by the Shielded Metal Arc Welding (SMAW) process on a Complete Joint Penetration (CJP) groove weld. The weld joint was designated as DP3050-001-025. The welder identification was 041713 and was observed welding in the 3G (Vertical) position using approved Welding Procedure Specification WPS-B-T-3213-B-U3b-FCM-1. The piece mark was identified as the Deck Panel, I- Stiffener Splice weld at Cross Beam side.
