DEPARTMENT OF TRANSPORTATION

Contract #: 04-0120F4Cty: SF/ALA Rte: 80 PM: 13.2/13.9File #: 99.28**WELDING INSPECTION REPORT****Resident Engineer:** Siegenthaler, Peter**Address:** 333 Burma Road**City:** Oakland, CA 94607**Report No:** WIR-020734**Date Inspected:** 17-Feb-2011**Project Name:** SAS Superstructure**OSM Arrival Time:** 700**Prime Contractor:** American Bridge/Fluor Enterprises, a JV**OSM Departure Time:** 1900**Contractor:** Zhenhua Port Machinery Company, Ltd (ZPMC)**Location:** Shanghai, China**CWI Name:** Li Yang and Zhu Zhong Hai**CWI Present:** Yes No**Inspected CWI report:** Yes No N/A**Rod Oven in Use:** Yes No N/A**Electrode to specification:** Yes No N/A**Weld Procedures Followed:** Yes No N/A**Qualified Welders:** Yes No N/A**Verified Joint Fit-up:** Yes No N/A**Approved Drawings:** Yes No N/A**Approved WPS:** Yes No N/A**Delayed / Cancelled:** Yes No N/A**Bridge No:** 34-0006**Component:** OBG Trial Assembly**Summary of Items Observed:**

Orthotropic Box Girder (OBG) at Trial Assembly Areas

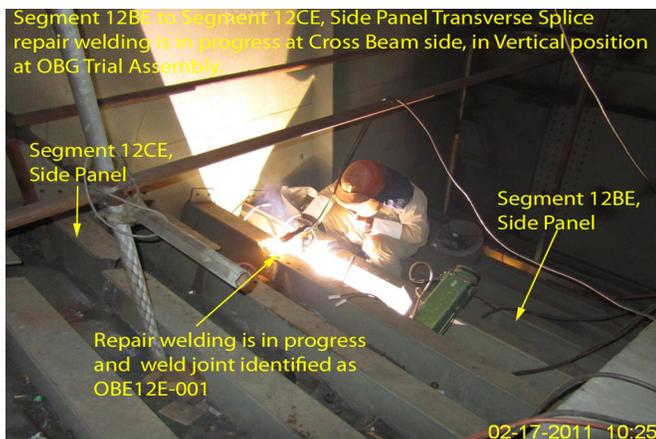
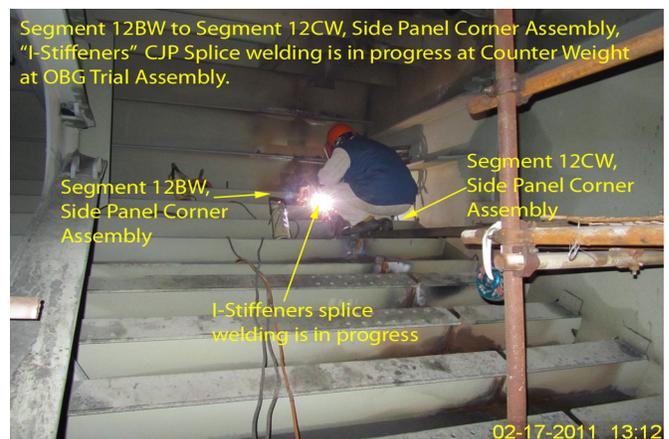
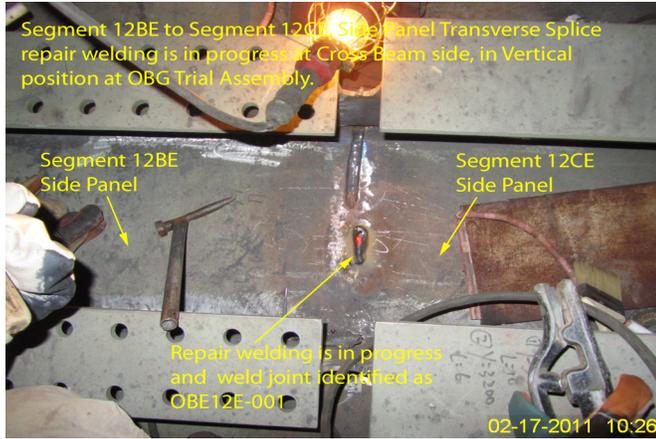
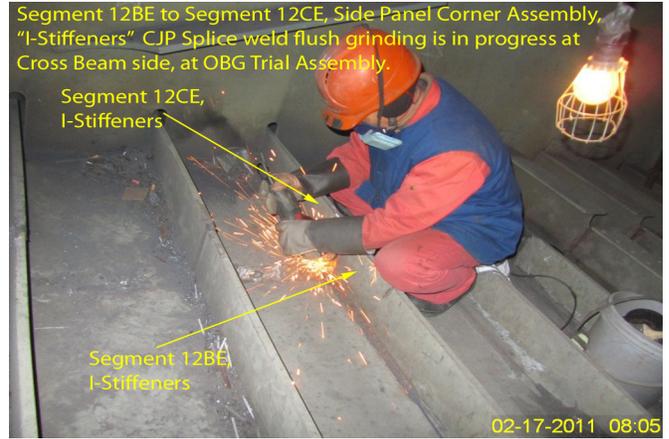
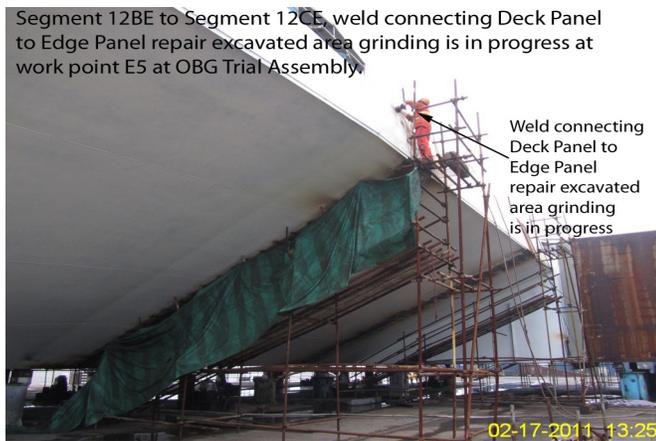
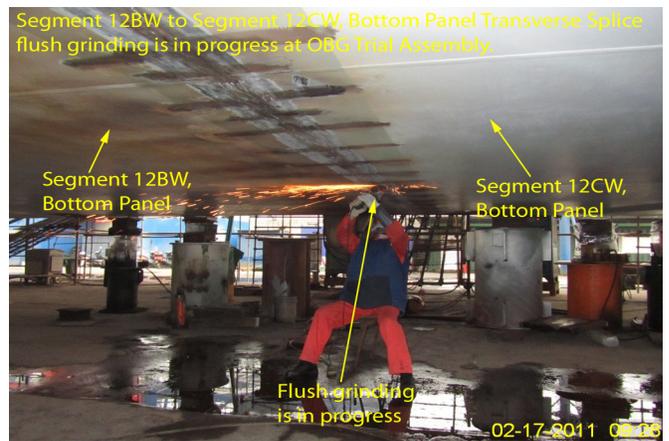
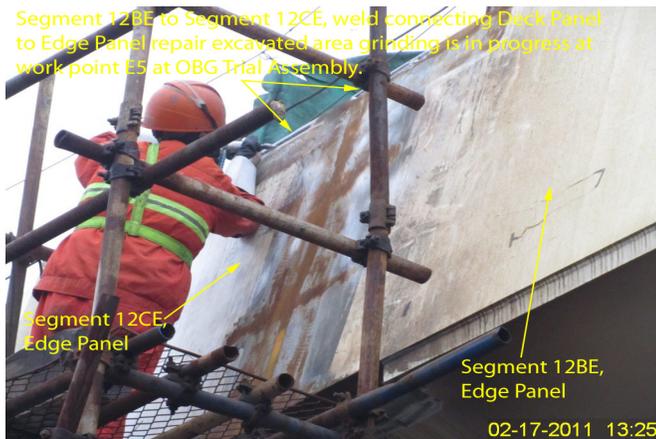
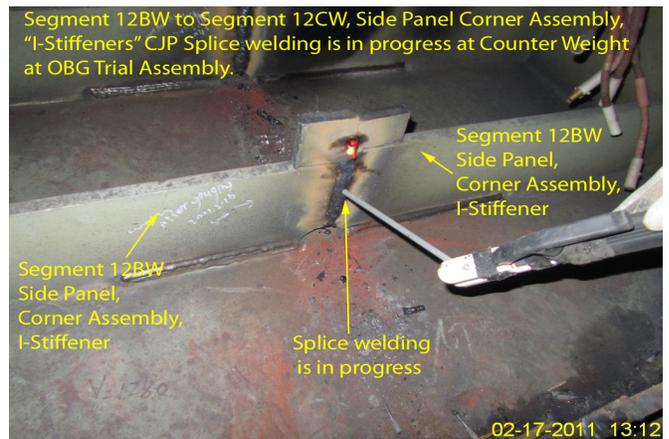
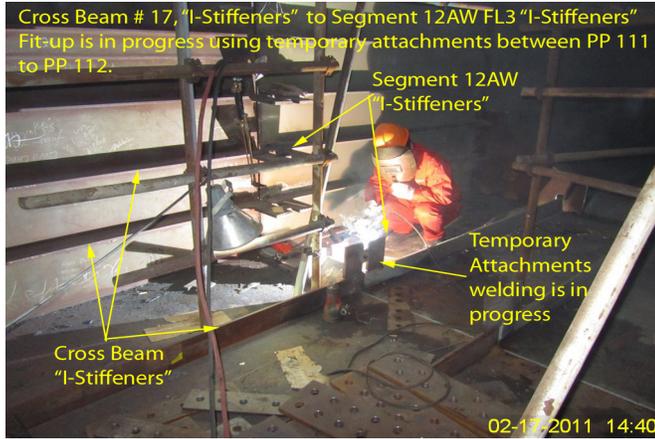
Please reference the pictures attached for more comprehensive details.

This QA Inspector observed the repair welding by Shielded Metal Arc Welding (SMAW) process on a Complete Joint Penetration (CJP) groove weld. The Weld joint was designated as OBE12C-001. The welder identification was 040320 and observed welding in the 1G (Flat) position using approved Welding Procedure Specification WPS-345-SMAW-1G(1F)-FCM-Repair-1. The piece mark was identified as the Bottom Panel, at transverse splice. ZPMC performed repair welding in accordance with Welding Repair Report B-WR20190.

This QA Inspector observed the repair welding by Shielded Metal Arc Welding (SMAW) process on a Complete Joint Penetration (CJP) groove weld. The Weld joint was designated as OBE12E-002. The welder identification was 044515 and observed welding in the 3G (Vertical) position using approved Welding Procedure Specification WPS-345-SMAW-3G(3F)-FCM-Repair-1. The piece mark was identified as the Side Panel Corner Assembly, Cross Beam side, at transverse splice. ZPMC performed repair welding in accordance with Welding Repair Report B-WR20176.

This QA Inspector observed the in-process welding by Shielded Metal Arc Welding (SMAW) process on a Complete Joint Penetration (CJP) groove weld. The Weld joint was designated as SP3053-001-032. The welder identification was 040611 and observed welding in the 4G (Overhead) position using approved Welding Procedure Specification WPS-B-P-2214-B-U2-FCM-1. The piece mark was identified as the Side Panel, I-Ribs at transverse splice, Counter Weight side.

This QA Inspector observed the in-process welding by Shielded Metal Arc Welding (SMAW) process on a Complete Joint Penetration (CJP) groove weld. The Weld joint was designated as EP3008-001-014. The welder identification was 044551 and observed welding in the 4G (Overhead) position using approved Welding Procedure Specification WPS-B-P-2214-B-U2-FCM-1. The piece mark was identified as the Edge Panel, I-Ribs at transverse splice.

This QA Inspector observed the in-process welding by Flux Cored Arc Welding (FCAW) process on a Fillet weld. The Weld joint was designated as EP3011-001-010. The welder identification was 041713 and observed welding in the 2F (Horizontal) position using approved Welding Procedure Specification WPS-B-P-2112-FCM-1. The piece mark was identified as the Edge Panel, I-Ribs hold back weld at Counter Weight side.

This QA Inspector observed the in-process welding by Flux Cored Arc Welding (FCAW) process on a Fillet weld. The Weld joint was designated as EP3008-001-010. The welder identification was 057333 and observed welding in the 2F (Horizontal) position using approved Welding Procedure Specification WPS-B-P-2112-FCM-1. The piece mark was identified as the Edge Panel, I-Ribs hold back weld at Cross Beam side.

This QA Inspector observed ZPMC personnel welding the temporary attachments for the I-Stiffeners on Segment 12AW FL3 Floor Beam to the I-Stiffeners on Cross Beam # 17 at PP 111. The welder was identified as 205616.

This QA Inspector observed ZPMC personnel performing grinding at I-Stiffeners splice weld connecting the Side Panel I-Stiffeners of Segment 12AE to Segment 12BE.

This QA Inspector observed ZPMC personnel performing flush grinding at Bottom Panel Transverse splice of Segment 12AW to Segment 12BW.

This QA Inspector observed ZPMC personnel performing grinding at the repair excavated areas for the weld connecting Deck Panel to Edge Panel repair excavated at work E5 at OBG Trial Assembly.
