DEPARTMENT OF TRANSPORTATION

Quality Assurance and Source Inspection

Contract #: 04-0120F4Cty: SF/ALA Rte: 80 PM: 13.2/13.9File #: 69.28**WELDING INSPECTION REPORT****Resident Engineer:** Siegenthaler, Peter**Address:** 333 Burma Road**City:** Oakland, CA 94607**Report No:** WIR-020929**Date Inspected:** 22-Feb-2011**Project Name:** SAS Superstructure**OSM Arrival Time:** 700**Prime Contractor:** American Bridge/Fluor Enterprises, a JV**OSM Departure Time:** 1900**Contractor:** Zhenhua Port Machinery Company, Ltd (ZPMC), Changxing Island **Location:** Shanghai, China**CWI Name:** Li Yang and Zhu Zhong Hai**CWI Present:** Yes No**Inspected CWI report:** Yes No N/A**Rod Oven in Use:** Yes No N/A**Electrode to specification:** Yes No N/A**Weld Procedures Followed:** Yes No N/A**Qualified Welders:** Yes No N/A**Verified Joint Fit-up:** Yes No N/A**Approved Drawings:** Yes No N/A**Approved WPS:** Yes No N/A**Delayed / Cancelled:** Yes No N/A**Bridge No:** 34-0006**Component:** OBG Trial Assembly**Summary of Items Observed:**

Orthotropic Box Girder (OBG) at Trial Assembly Areas

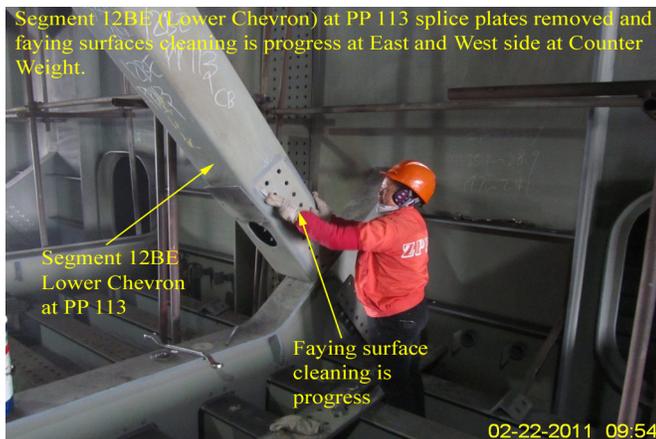
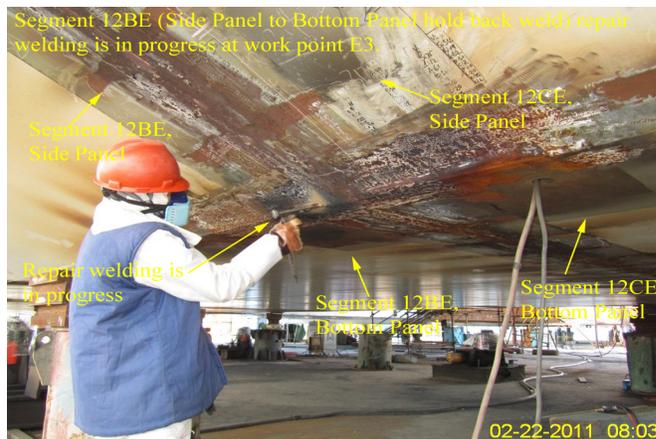
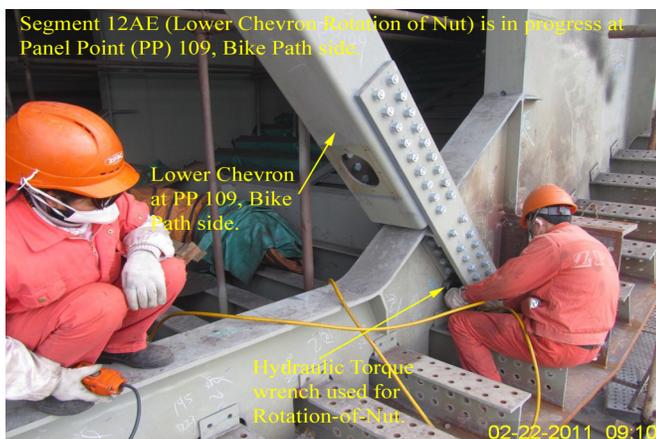
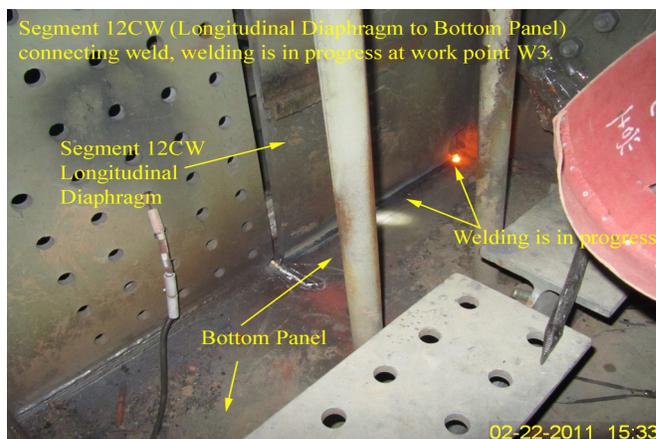
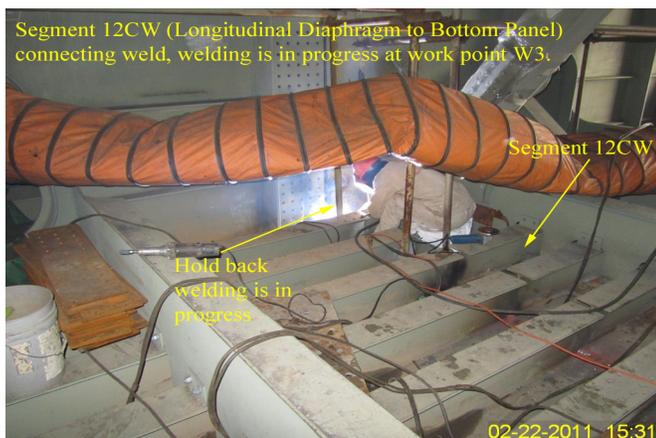
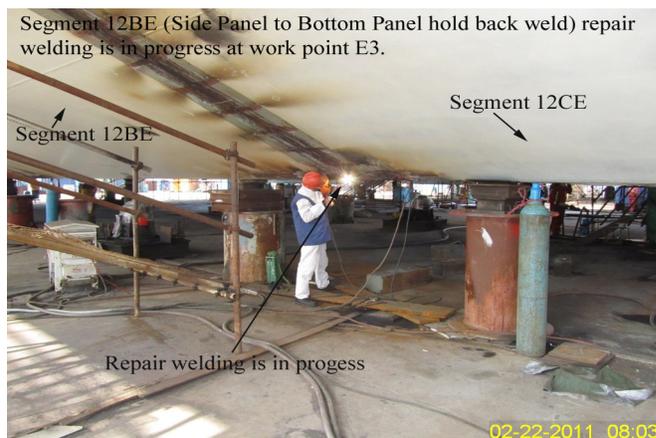
This QA Inspector performed Dimension Control Inspection for measuring offset on the U-Rib to U-Rib from Counter Weight side towards Cross Beam side at a total of 37 locations on Segment 12BW to Segment 12CW between Panel Points (PP) 114 to PP 115 at the following locations:

This QA Inspector observed the repair welding by Shielded Metal Arc Welding (SMAW) process on a Complete Joint Penetration (CJP) groove weld. The Weld joint was designated as Seg3002A-004. The welder identification was 052493 and observed welding in the 4G (Flat) position using approved Welding Procedure Specification WPS-345-SMAW-4G(4F)-FCM-Repair-1. The piece mark was identified as the weld connecting the Bottom Panel to Side Panel hold back weld; work point E3. ZPMC performed repair welding in accordance with Welding Repair Report B-WR20198.

This QA Inspector observed the in-process welding by Shielded Metal Arc Welding (SMAW) process on a Complete Joint Penetration (CJP) groove weld. The Weld joint was designated as Seg3006S-035. The welder identification was 046709 and observed welding in the 2G (Horizontal) position using approved Welding Procedure Specification WPS-B-T-2232-ESAB. The piece mark was identified as the weld connecting the Longitudinal Diaphragm to Bottom Panel hold back at work point W3.

This QA Inspector observed the in-process welding by Shielded Metal Arc Welding (SMAW) process on a Complete Joint Penetration (CJP) groove weld. The Weld joint was designated as DP3029-001-009. The welder identification was 052493 and observed welding in the 4G (Overhead) position using approved Welding Procedure Specification WPS-B-P-2214-Tc-U4b-FCM-1. The piece mark was identified as the weld connecting the Longitudinal Diaphragm to Deck Panel hold back at work point E3.

This QA Inspector observed the ZPMC personnel performing the faying surfaces cleaning between the Splice Plates to the Lower Chevron at East and West side at Cross Beam side.

This QA Inspector observed the ZPMC personnel performing Rotation-of-Nut for the bolts connecting the Lower Chevron H-Beam to the Floor Beam at west side.
