**DEPARTMENT OF TRANSPORTATION**

Contract #: 04-0120F4Cty: SF/ALA Rte: 80 PM: 13.2/13.9File #: 69.28**WELDING INSPECTION REPORT****Resident Engineer:** Siegenthaler, Peter**Address:** 333 Burma Road**City:** Oakland, CA 94607**Report No:** WIR-021996**Date Inspected:** 21-Mar-2011**Project Name:** SAS Superstructure**OSM Arrival Time:** 700**Prime Contractor:** American Bridge/Fluor Enterprises, a JV**OSM Departure Time:** 1900**Contractor:** Zhenhua Port Machinery Company, Ltd (ZPMC), Changxing Island **Location:** Shanghai, China**CWI Name:** Li Hua Jie**CWI Present:** Yes No**Inspected CWI report:** Yes No N/A**Rod Oven in Use:** Yes No N/A**Electrode to specification:** Yes No N/A**Weld Procedures Followed:** Yes No N/A**Qualified Welders:** Yes No N/A**Verified Joint Fit-up:** Yes No N/A**Approved Drawings:** Yes No N/A**Approved WPS:** Yes No N/A**Delayed / Cancelled:** Yes No N/A**Bridge No:** 34-0006**Component:** OBG Segments**Summary of Items Observed:**

On this date Caltrans OSM Quality Assurance (QA) Inspector, Dan Hernandez was present during the times noted above to observe the fit up, welding and related activities associated with the fabrication of the San Francis

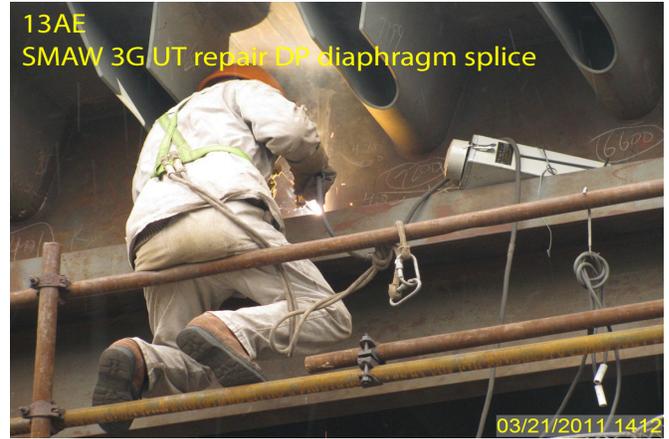
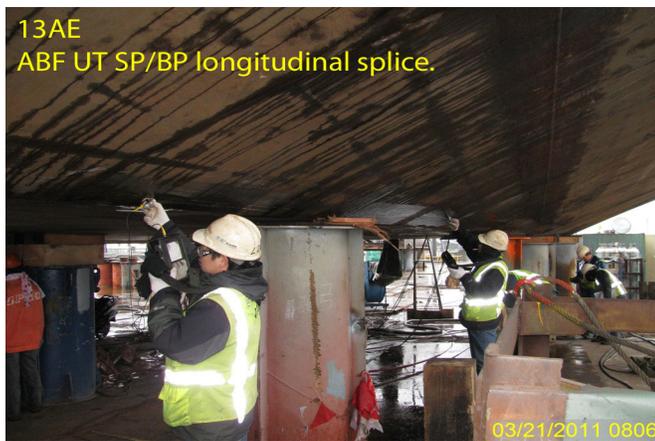
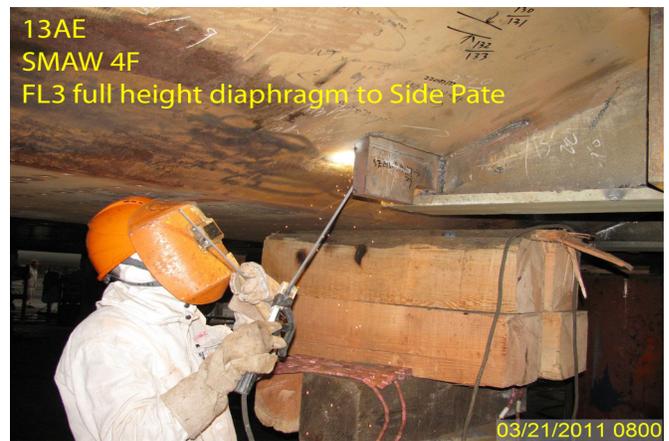
This QA Inspector observed Shielded Metal Arc Welding (SMAW) in progress of a UT repair on a Complete Joint Penetration (CJP) weld joint. The Weld joint is designated SEG3007R-001, Deck Plate Diaphragm splice. The welder is identified as #200113 and was observed welding in the 3G (vertical) position using approved Welding Procedure Specification WPS-345-3G (3F)-FCM-repair-1 for WR20472.

This QA Inspector observed Shielded Metal Arc Welding (SMAW) in progress of a fillet weld joint. The Weld joint is designated SEG3007AD-133, FL3 full height stiffener to Side Plate. The welder is identified as #037743 and was observed welding in the 4F (overhead) position using approved Welding Procedure Specification WPS-B-P-2114-FCM-1.

This QA Inspector observed Flux Cored Arc Welding (FCAW) in progress of a Complete Joint Penetration (CJP) weld joint. The Weld joint is designated SEG300AH-68, Floor Beam I-rib to K Plate I-rib splice. The welder is identified as #050242 and was observed welding in the 1G (flat) position using approved Welding Procedure Specification WPS-B-T-2231-ESAB.

This QA Inspector observed match drilling of bolt holes on the FL3 I-ribs and Side Panel horizontal I-ribs for the bolted splice plate at CB to 12AE connection at panel points 110.

This QA Inspector observed ABF personnel performing Magnetic Particle Testing on the fillet welds of the Partial Height Diaphragm at panel points 111 to 112.

This QA Inspector observed ABF personnel performing Ultrasonic Testing on the Side Plate to Bottom Plate longitudinal splice, D scan was performed.
