DEPARTMENT OF TRANSPORTATION

Contract #: 04-0120F4Cty: SF/ALA Rte: 80 PM: 13.2/13.9File #: 1.28**WELDING INSPECTION REPORT****Resident Engineer:** Siegenthaler, Peter**Address:** 333 Burma Road**City:** Oakland, CA 94607**Report No:** WIR-024519**Date Inspected:** 17-Jun-2011**Project Name:** SAS Superstructure**OSM Arrival Time:** 700**Prime Contractor:** American Bridge/Fluor Enterprises, a JV**OSM Departure Time:** 1530**Contractor:** American Bridge/Fluor Enterprises, a JV**Location:** Jobsite**CWI Name:** William Sherwood**CWI Present:** Yes No**Inspected CWI report:** Yes No N/A**Rod Oven in Use:** Yes No N/A**Electrode to specification:** Yes No N/A**Weld Procedures Followed:** Yes No N/A**Qualified Welders:** Yes No N/A**Verified Joint Fit-up:** Yes No N/A**Approved Drawings:** Yes No N/A**Approved WPS:** Yes No N/A**Delayed / Cancelled:** Yes No N/A**Bridge No:** 34-0006**Component:** SAS OBG**Summary of Items Observed:**

1. 9E PP77 E3 Lifting Lug Holes #1 and 3
2. 9W PP76 W4 Lifting Lug Holes #1 and 3
3. 2E PP18 E2.5 Storm Ties
4. Lifting Lug Lamination Scan (UT)

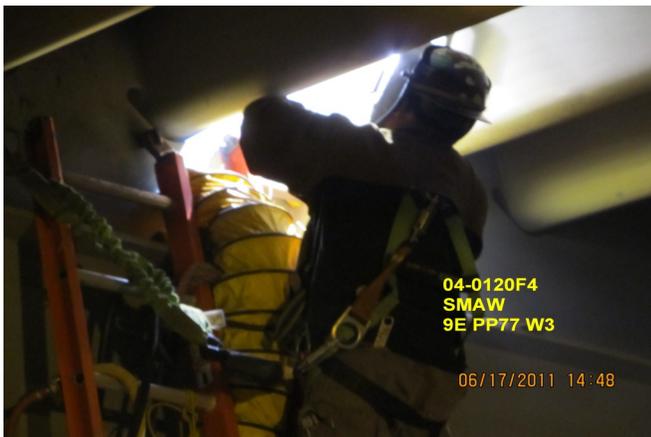
The QA Inspector made periodic observations of ABF welder Jorge Lopez performing Shielded Metal Arc Welding (SMAW) in the 4G overhead position on Lifting Lug Holes (LLH) #1 and 3 located at 9E PP77 E3. The QA Inspector observed the QC Inspector Fred Von Hoff as being present in order to monitor the progress and ensure the welding parameters were in compliance pertaining to ABF-WPS-D15-1110A Rev. 1. The work was completed on this date and the QA Inspector noted that the work appeared to be in general conformance with the contract documents.
