Contract #: 04-0120F4Cty: SF/ALA Rte: 80 PM: 13.2/13.9File #: 1.28**WELDING INSPECTION REPORT****Resident Engineer:** Siegenthaler, Peter**Address:** 333 Burma Road**City:** Oakland, CA 94607**Report No:** WIR-025389**Date Inspected:** 02-Aug-2011**Project Name:** SAS Superstructure**OSM Arrival Time:** 700**Prime Contractor:** American Bridge/Fluor Enterprises, a JV**OSM Departure Time:** 1530**Contractor:** American Bridge/Fluor Enterprises, a JV**Location:** Job Site**CWI Name:** William Sherwood**CWI Present:** Yes No**Inspected CWI report:** Yes No N/A**Rod Oven in Use:** Yes No N/A**Electrode to specification:** Yes No N/A**Weld Procedures Followed:** Yes No N/A**Qualified Welders:** Yes No N/A**Verified Joint Fit-up:** Yes No N/A**Approved Drawings:** Yes No N/A**Approved WPS:** Yes No N/A**Delayed / Cancelled:** Yes No N/A**Bridge No:** 34-0006**Component:** SAS Tower**Summary of Items Observed:**

Caltrans Office of Structural Material (OSM) Quality Assurance Inspector (QAI) Joselito Lizardo was present at the Self Anchored Suspension (SAS) job site as requested to perform observations on the welding of components for the San Francisco Oakland Bay Bridge (SFOBB) Project.

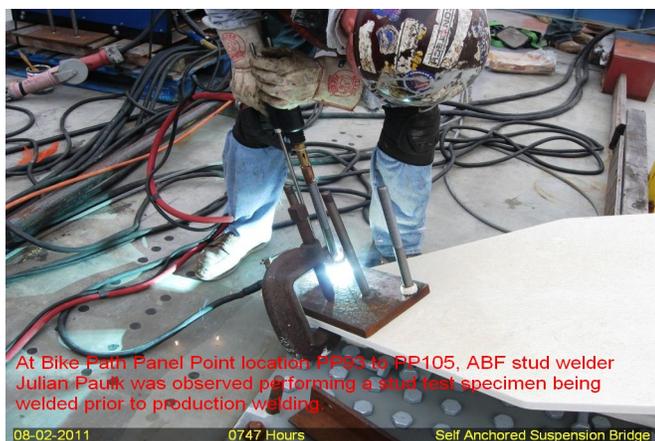
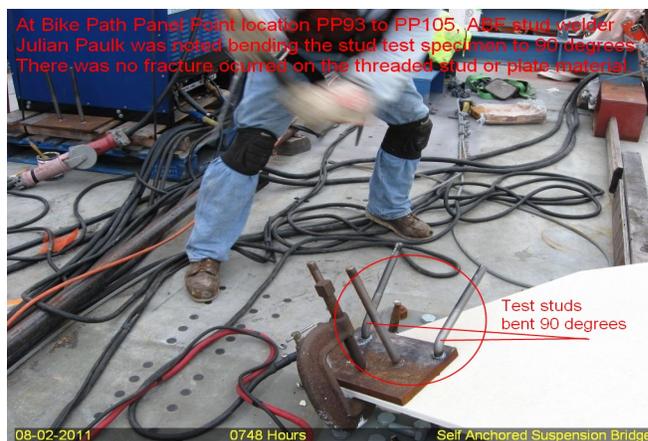
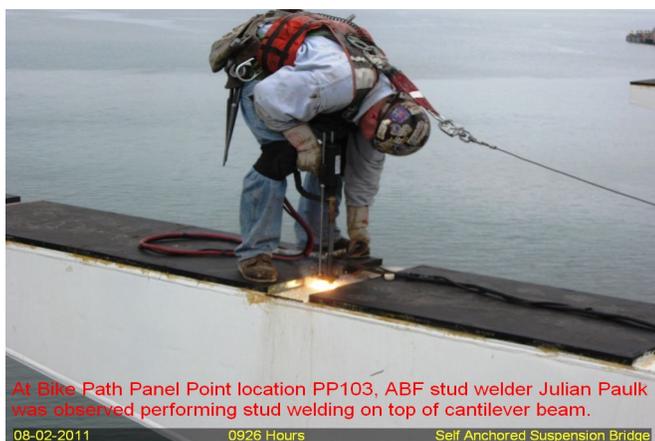
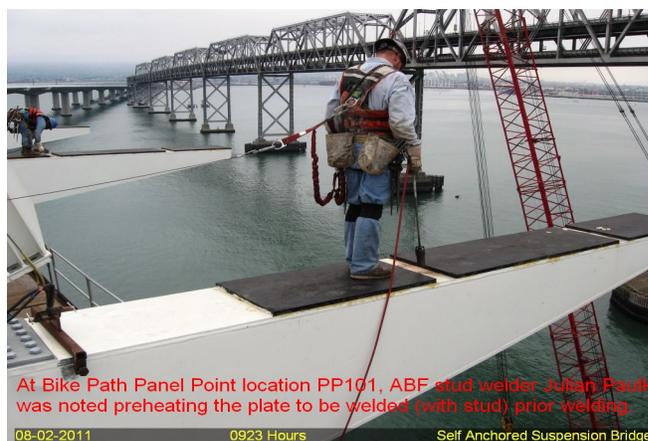
At East Bound Bike Path, this QA continuously observed ABF Stud welder Julian Paulk ID#7796 perform stud welding on top of the cantilever beam bike path support. The welder was noted stud welding 7/8" diameter 11 7/8" long with 9 threads per inch pitch threaded stud. The welder was also noted using the Tru Weld Equipment stud machine that was programmed to working current of 1900 amperes and welding time of 1.1 seconds implementing Caltrans approved welding procedure specification ABF-WPS-D15-5001-Stud.

Prior to welding the threaded studs, ABF welder Julian Paulk has welded two test studs similar to the studs to be welded and position that will be welded on top of the bike path cantilever beam. The two welded studs exhibited a full 360 degrees flash after welding. After ABF QC and this QA have completed the VT, the welder bent the two studs to 90 degrees using the 10 pounds sledge hammer exhibiting no fracture occurrence onto the weld and plate material.

The welder was noted welding at flat position using 7/8" diameter ceramic ferrules attached to the end of the stud being welded. The ceramic ferrules intended for flat position were noted new and dry. The top surface of the cantilever beam to be welded was ground and paint coating removed. The plate surface was preheated using a propylene gas torch prior stud welding. During welding, ABF QC William Sherwood was noted monitoring the welding parameters of the welder and checking each stud every panel point location. After QC has visually

The welded threaded studs at the following panel point locations were visually accepted by ABF QC and verified by this QA;
