Contract #: 04-0120F4Cty: SF/ALA Rte: 80 PM: 13.2/13.9File #: 99.28**WELDING INSPECTION REPORT**

Report No: WIR-026514
Date Inspected: 13-Oct-2011

Project Name: SAS Superstructure
Prime Contractor: American Bridge/Fluor Enterprises, a JV
Contractor: American Bridge/Fluor Enterprises, a JV

CWI Name:	See Below	CWI Present:	Yes	No
Inspected CWI report:	Yes No N/A	Rod Oven in Use:	Yes No N/A	
Electrode to specification:	Yes No N/A	Weld Procedures Followed:	Yes No N/A	
Qualified Welders:	Yes No N/A	Verified Joint Fit-up:	Yes No N/A	
Approved Drawings:	Yes No N/A	Approved WPS:	Yes No N/A	
		Delayed / Cancelled:	Yes No N/A	
Bridge No:	34-0006	Component:	OBG and Tower

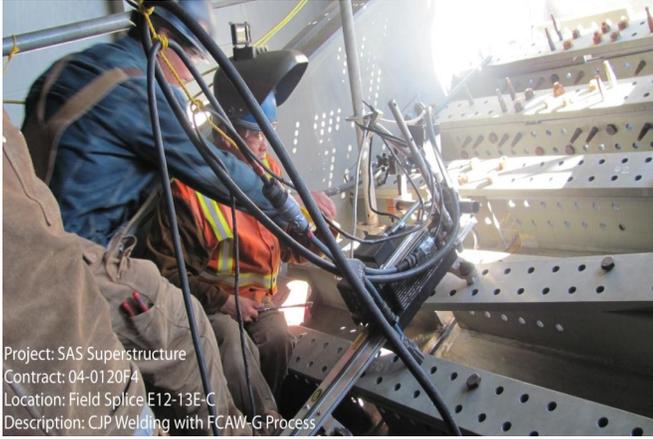
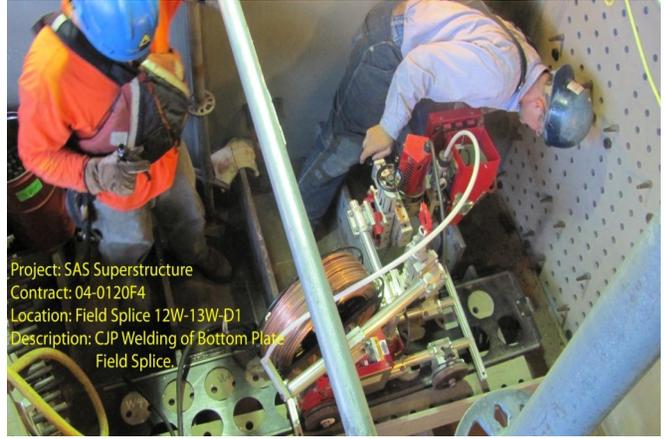
The digital photographs on page 4 of this report illustrate some of the activities observed during this shift.
