DEPARTMENT OF TRANSPORTATION

Office of Structural Materials

Quality Assurance and Source Inspection

Contract #: 04-0120F4Cty: SF/ALA Rte: 80 PM: 13.2/13.9File #: 1.28**WELDING INSPECTION REPORT****Resident Engineer:** Casey, William**Address:** 333 Burma Road**City:** Oakland, CA 94607**Report No:** WIR-026567**Date Inspected:** 25-Oct-2011**Project Name:** SAS Superstructure**OSM Arrival Time:** 700**Prime Contractor:** American Bridge/Fluor Enterprises, a JV**OSM Departure Time:** 1730**Contractor:** American Bridge/Fluor Enterprises, a JV**Location:** Job Site

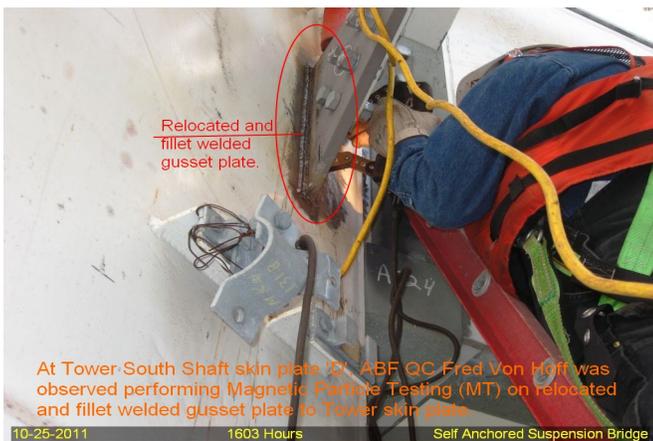
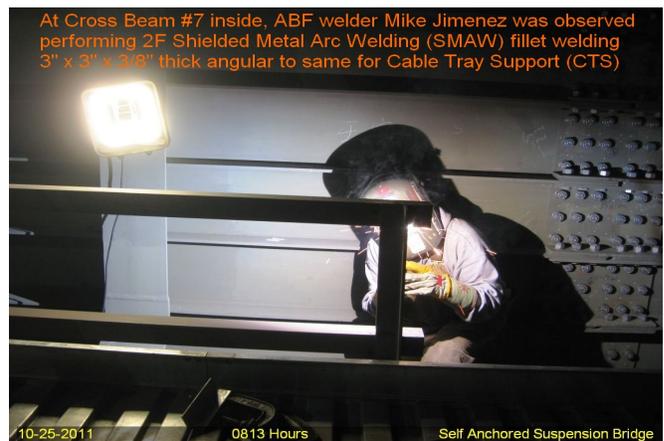
At Cross Beam #7 inside, this QA randomly observed ABF welder Mike Jimenez continuing to perform multiple position fillet welding between 3" x 3" x 3/8" thick angular to same for electrical Cable Tray Support (CTS). The welder was noted using Shielded Metal Arc Welding (SMAW) with 1/8" diameter E7018H4R electrode. ABF QC Steve Jensen was observed monitoring the welder with 125 Amps measured current during welding.

At Tower South Shaft elevation 53 meters, QA randomly observed ABF QC Fred Von Hoff perform Magnetic Particle Testing on the two (2) 20mm thick gusset plates that were relocated and welded to the Tower skin plate 'D'. QC has found no significant defects during the test. This QA randomly verified the MT performed by QC and noted same result.

At OBG 11E-PP100-E3-#1 & 2 lifting lug hole infill plate to top deck plate outside, ABF welder Fred Kaddu was observed 1G SMAW welding 1st time repair on the infill plate to top deck plate butt joint. The welder was noted

using 1/8" diameter E7018H4R electrode implementing Caltrans approved Welding Procedure Specification (WPS) ABF-WPS-D15-1001 Repair. Prior welding, ABF QC Fred Von Hoff was observed inspecting the excavation of the butt joints. During welding, ABF QC Fred Von Hoff was noted monitoring the welder's welding parameters. At the end of the shift, repair welding on hole #2 was completed while the 2 repairs on hole #1 was still in progress.

At location Panel Point PP46 to PP58 of grid line E5, this QA randomly observed FW Spencer qualified welder Curtis Jump perform Complete Joint Penetration (CJP) 2G (horizontal position) Shielded Metal Arc Welding (SMAW) welding root pass to cover pass on the 1" weldolet welded to 2.5" diameter domestic water line and 2" weldolet welded to 4" diameter compressed air line. The welder was noted welding the root pass with 3/32" diameter E6010 electrode and followed by fill pass to cover pass using 3/32" diameter E7018H4R electrode implementing Caltrans approved procedure FW Spencer WPS 1-12-1Rev 2. The welder was noted preheating and removing the moisture of the joint using a portable propane gas torch prior welding. During welding, ABF QC Steve Jensen was noted monitoring the parameters of the welder. At the end of the shift, three (3) 1" and three (3) 2" diameter weldolets were being welded and still in progress.
