DEPARTMENT OF TRANSPORTATION

Office of Structural Materials

Contract #: 04-0120F4Cty: SF/ALA Rte: 80 PM: 13.2/13.9File #: 1.28**WELDING INSPECTION REPORT****Resident Engineer:** Casey, William**Address:** 333 Burma Road**City:** Oakland, CA 94607**Report No:** WIR-026599**Date Inspected:** 29-Oct-2011**Project Name:** SAS Superstructure**OSM Arrival Time:** 700**Prime Contractor:** American Bridge/Fluor Enterprises, a JV**OSM Departure Time:** 1530**Contractor:** American Bridge/Fluor Enterprises, a JV**Location:** Job Site

CWI Name:	Jesse Cayabyab and Salvador Merino			CWI Present:	Yes	No	
Inspected CWI report:	Yes	No	N/A	Rod Oven in Use:	Yes	No	N/A
Electrode to specification:	Yes	No	N/A	Weld Procedures Followed:	Yes	No	N/A
Qualified Welders:	Yes	No	N/A	Verified Joint Fit-up:	Yes	No	N/A
Approved Drawings:	Yes	No	N/A	Approved WPS:	Yes	No	N/A
				Delayed / Cancelled:	Yes	No	N/A
Bridge No:	34-0006			Component:	SAS OBG

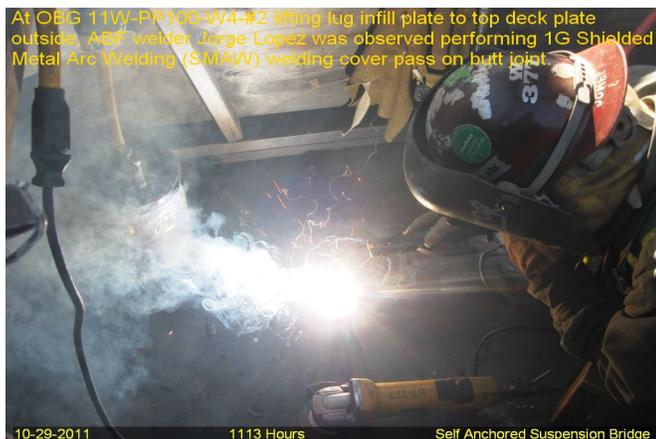
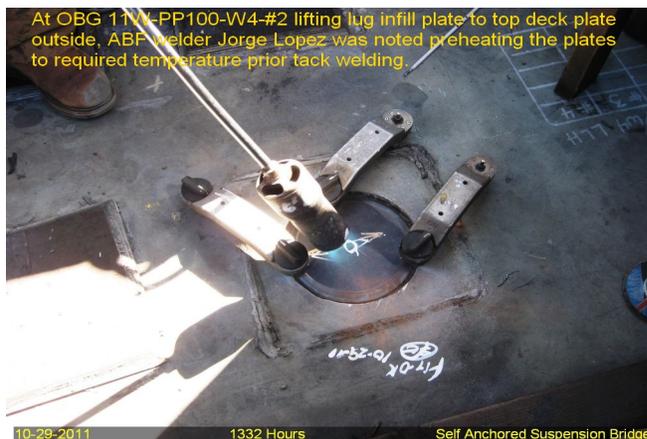
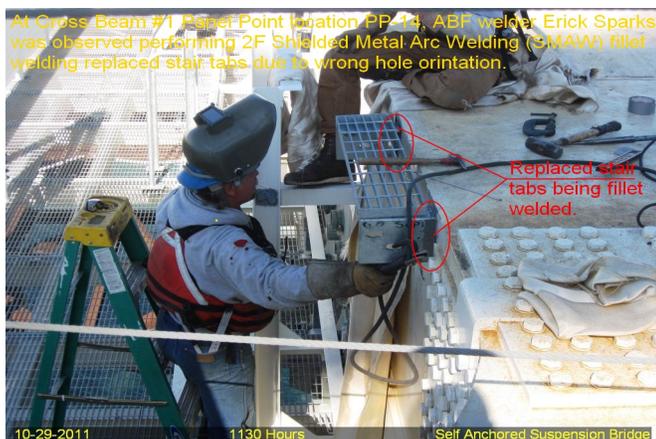
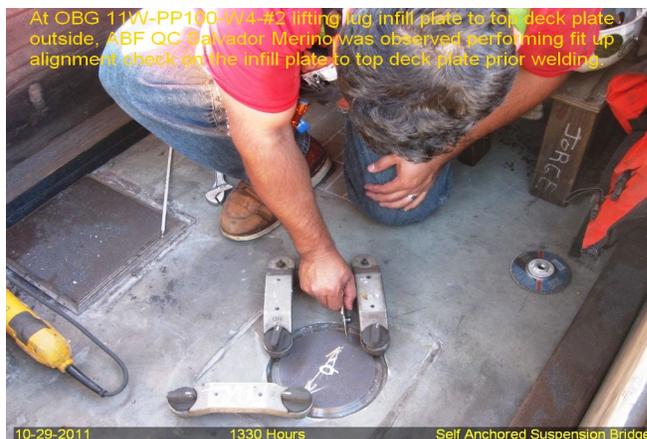
At OBG 11W-PP100-W4-# 2 lifting lug hole infill plate to top deck plate outside, ABF welder Jorge Lopez was observed 1G SMAW welding root pass to cover pass on the infill plate to top deck plate butt joint. The welder was noted using 5/32" diameter E7018H4R electrode implementing Welding Procedure Specification (WPS) ABF-WPS-D15-1070. Prior welding, ABF QC Salvador Merino was observed inspecting the fit up of the butt joints. QA verified the fit up alignment of the lifting lug hole which deemed acceptable to the contract requirements. During welding, ABF QC Salvador Merino was noted monitoring the welder's welding parameters with measured working current of 175 amperes. At the end of the shift, cover pass welding on the top side location of the butt joint was completed.

At Cross Beam #1 outside, ABF welder Erick Sparks was observed 2F fillet welding Service Platform Stair attachment tabs to Cross Beam #1 side plate. The welder was noted using 1/8" diameter E7018H4R electrode

implementing Welding Procedure Specification (WPS) ABF-WPS-D15-F1200A. The tabs being welded are replacements to the old tabs that were welded in ZPMC China due to wrong hole pattern. This work is also being done per Request for Information (RFI) ABF-RFI-002417R00 dated 19 April 2011. During welding, ABF QC Jesse Cayabyab was observed monitoring the welder with measured working current of 130 amperes. During the shift, fillet welding of the two attachment tabs for stair service platform was completed.
