DEPARTMENT OF TRANSPORTATION

Contract #: 04-0120F4Cty: SF/ALA Rte: 80 PM: 13.2/13.9File #: 1.28**WELDING INSPECTION REPORT****Resident Engineer:** Casey, William**Address:** 333 Burma Road**City:** Oakland, CA 94607**Report No:** WIR-026645**Date Inspected:** 05-Nov-2011**Project Name:** SAS Superstructure**OSM Arrival Time:** 700**Prime Contractor:** American Bridge/Fluor Enterprises, a JV**OSM Departure Time:** 1530**Contractor:** American Bridge/Fluor Enterprises, a JV**Location:** Job Site

| Bridge No: | 34-0006 | | | Component: | SAS OBG | | |

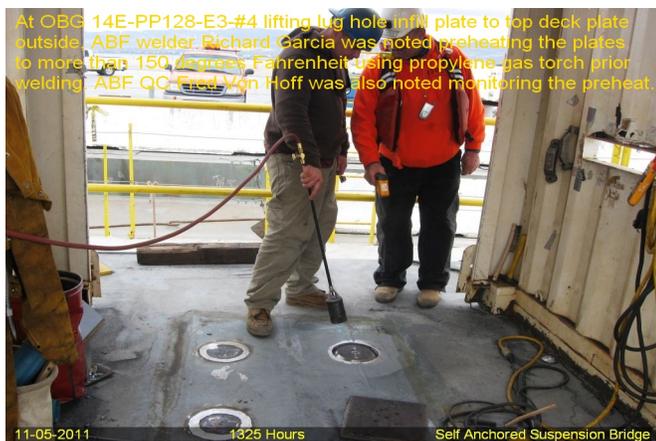
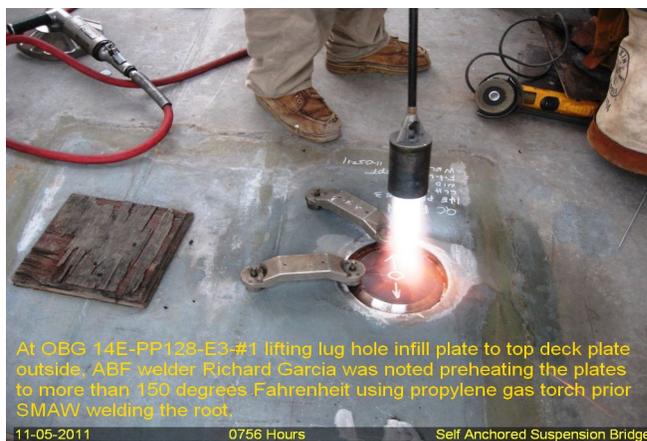
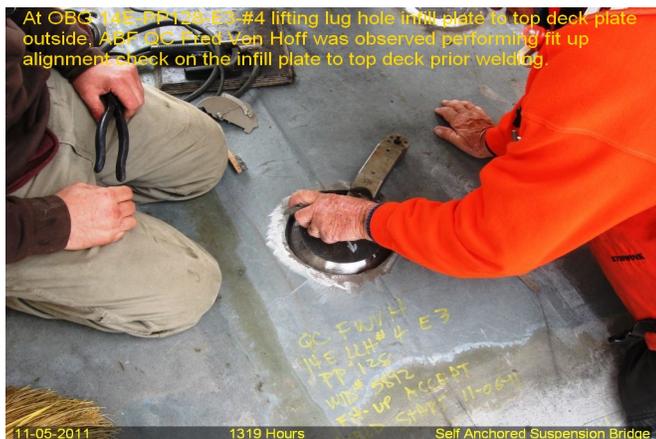
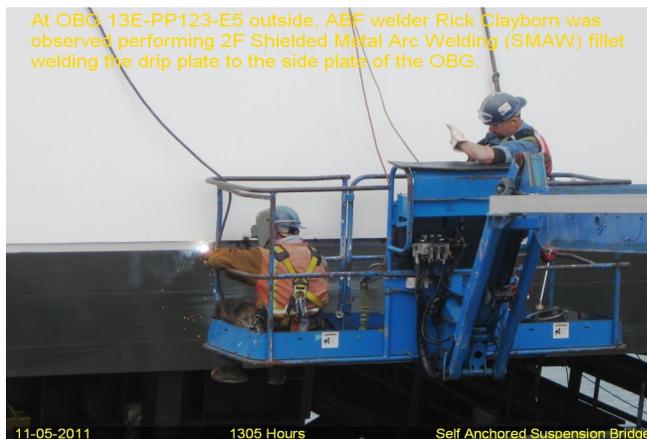
At OBG 14E-PP128-E3-# 1 lifting lug hole infill plate to top deck plate outside, ABF welder Richard Garcia was observed continuing to perform 1G SMAW welding fill pass to cover pass on the infill plate to top deck plate butt joint. The welder was noted using 1/8" diameter E7018H4R for root pass then switched to 5/32" diameter E7018H4R electrode for the fill to cover passes. The welder was noted implementing Welding Procedure Specification (WPS) ABF-WPS-D15-1050A-CU for the Seismic Performance Critical Members (SPCM) butt joint. Prior welding, ABF QC Fred Von Hoff was observed inspecting the fit up of the butt joints. QA verified the fit up alignment of the lifting lug hole which deemed acceptable to the contract requirements. During welding, ABF QC Fred Von Hoff was noted monitoring the welder's welding parameters with measured working current of 130 amperes on the 1/8" electrode while 185 amperes on the 5/32" electrode. The welder was noted preheating the plates to more than 150°F using propylene gas torch prior welding. During the shift, cover pass welding on the top side location of the butt joint was completed and the welder has moved to other lifting lug hole #4 of the same panel point location. At the new location, the welder did the fit up and ABF QC Fred Von Hoff performed the alignment check. This QA also verified the alignment with positive result. After the acceptance of the fit up alignment the welder resumed welding the root pass and fill pass and continued until the end of the shift.

At OBG 14E-PP128-E4-# 3 lifting lug hole infill plate to top deck plate outside, ABF welder Salvador Sandoval was observed continuing to perform 1G SMAW welding fill pass to cover pass on the infill plate to top deck plate

butt joint. The welder was noted using 1/8" diameter E7018H4R for root pass then switched to 5/32" diameter E7018H4R electrode for the fill to cover passes. The welder was noted implementing Welding Procedure Specification (WPS) ABF-WPS-D15-1050A-CU for the SPCM butt joint. Prior welding, ABF QC Fred Von Hoff was observed inspecting the fit up of the butt joints. QA verified the fit up alignment of the lifting lug hole which deemed acceptable to the contract requirements. During welding, ABF QC Fred Von Hoff was noted monitoring the welder's welding parameters with measured working current of 123 amperes on the 1/8" electrode while 180 amperes on the 5/32" electrode. The welder was noted preheating the plates to more than 150°F using propylene gas torch prior welding. During the shift, cover pass welding on the top side location of the butt joint was completed and the welder has moved to other lifting lug hole #2 of the same panel point location. At the new location, the welder did the fit up and ABF QC Fred Von Hoff performed the alignment check. This QA also verified the alignment with positive result. After the acceptance of the fit up alignment the welder resumed welding the root pass and fill pass and continued until the end of the shift.

At OBG 14E side plate 'E' outside, QA randomly observed ABF welder Rick Clayborn perform fillet and partial joint penetration (PJP) welding in 2F/2G position using Shielded Metal Arc Welding (SMAW) with 1/8" diameter E7018H4R electrode. The welder was welding on 2 1/4" wide x 3/8" thick drip plate to the side plate of the OBG at panel point PP123. The drip plate and the surface of the side plate (where the drip plate was welded) were noted ground and the paint coating removed. ABF QC Bernie Docena was noted monitoring the welding and its parameters. At the end of the shift, fillet and PJP welding of the drip plate to the side plate were completed and was visually accepted by QC Bernie Docena.
