Contract #: 04-0120F4Cty: SF/ALA Rte: 80 PM: 13.2/13.9File #: 82.28**WELDING INSPECTION REPORT**

Report No: WIR-026656
Date Inspected: 02-Nov-2011

Project Name: SAS Superstructure
Prime Contractor: American Bridge/Fluor Enterprises, a JV
Contractor: Westmont Industries

CWI Name:	Chris Concha	CWI Present:	Yes	No
Inspected CWI report:	Yes No N/A	Rod Oven in Use:	Yes No N/A	
Electrode to specification:	Yes No N/A	Weld Procedures Followed:	Yes No N/A	
Qualified Welders:	Yes No N/A	Verified Joint Fit-up:	Yes No N/A	
Approved Drawings:	Yes No N/A	Approved WPS:	Yes No N/A	
		Delayed / Cancelled:	Yes No N/A	
Bridge No:	34-0006 L & R	Component:	Maintenance Travelers

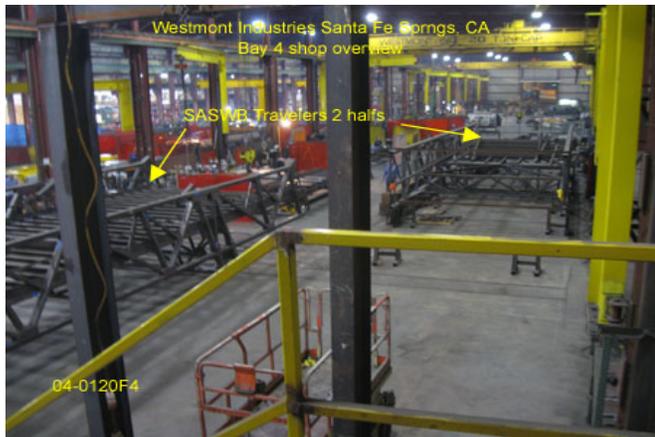
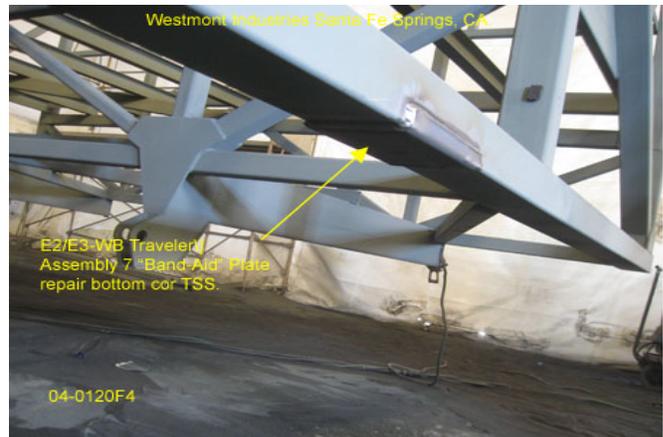
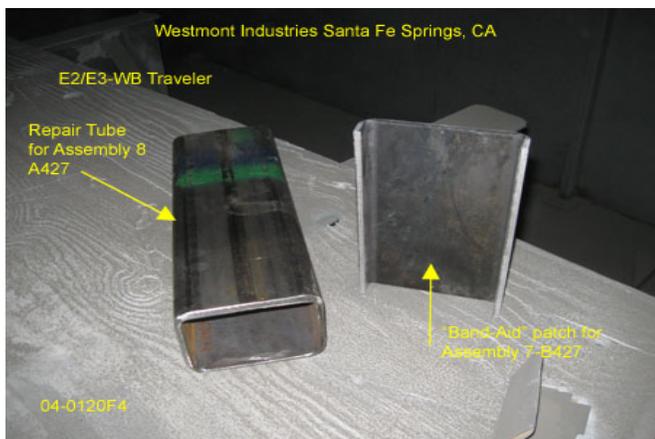
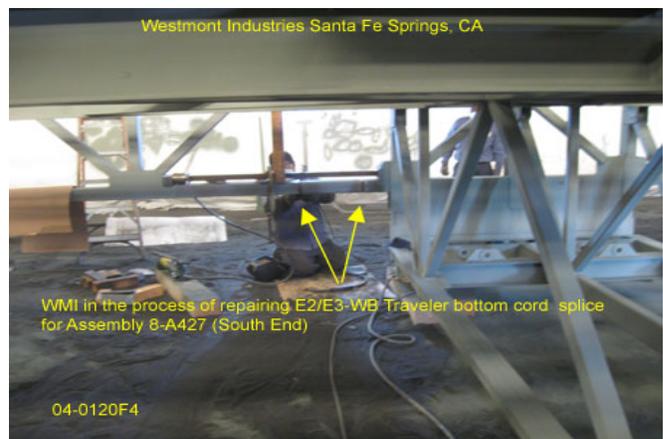
This QA Inspector randomly observed WMI production personnel Mr. Richard Fuentes WID#3201 and Mr. Jesus Rayas WID#3197 removing dented section from Assembly 8, A427 bottom chord TSS using a hack saw and a saber saw. Later in the shift QA Inspector randomly observed WMI personnel Mr. Fuentes and Mr. Rayas performing fit-up and tack welding on Assembly 8-A427 bottom chord splice (TSS 6"x4"x3/16") and Assembly 7-B427 bottom chord "Band-Aid" (10"x8-1/4"x10 GA, ASTM A572 GR. 50) for seal welding WJ# AR1, using approved FCAW process. Later in the day QA Inspector randomly observed WMI production welder Mr. Eutimo Lopez (WID # 3035) performing Flux Core Arc Welding (FCAW) activities on the E2/E3-WB Traveler, Assembly 7-B427, bottom chord "Band-Aid" repair seal welding. Welding completed on this date on Assembly 7-B427. Mr. Lopez then moved to Assembly 8-A427 bottom chord splice. Mr. Lopez completed welding the root pass at weld joint FSR #1 and FSR #2 only on this date. Welding not completed on this date and will continue tomorrow 11-3-11. For additional information on the above repair review contract document

This QA Inspector performed random shop observations and observed that RPI is on site to continuing with the coating application on the E2/E3 WB Traveler. QA Inspector was informed by RPI Coating Mr. Preston Keen that RPI is going to sand sections 1, 2 & 3 using 100 grit sand paper, pressure wash section 1 this morning and in the afternoon completed testing and apply a mist coat on section 1 using Sherwin Williams Polysiloxane XLE-80 today,. QA Inspector randomly observed that RPI personnel performing sanding, pressure washing activities on the E2/E3 WB Traveler. Environmental readings taken by RPI at the time of coating application are as follows respectively: Air Temperature 53/76 F, Relative Humidity 71/48%, Wet Bulb Temperature 48/64 F, Dew point 43/57 F and Surface Temperature 51/78 F. QA Inspector also, observed Mr. Keen documenting daily actives on RPI Coating QC Daily Inspection Report.

Mr. Keen informed QA Inspector that on the interim coating of the Sherman Williams Zinc Clad II, Inorganic Zinc Rich prime coating he would be performing ASTM D3363 - Film Hardness by Pencil Test, ASTM D4752 Measuring MEK Resistance to Ethyl Silicate (Inorganic) Zinc-Rich Primers by Solvent Rub and performing the Quarter test at section 1. Mr. Keen stated that he will be using Sherman Williams R7 KIII High Solids compliant thinner #1 for the solvent rub test. Testing observed is as follows:
Prime coated on 10-28-11 (section 1), Pencil Test (pass), Quarter Test (pass) and Rub test (pass).
